**ARLINGTON RIDGE  
COMMUNITY DEVELOPMENT DISTRICT**

## PROJECT MEMORANDUM

**Subject:** **Annual Inspection Report**

The purpose of this Project Memorandum is to document the annual site inspection associated with the Stormwater Management System (i.e., stormwater ponds, control structures, outfall pipes, and inflow pipes), as well as rights-of-way (roadways) and golf course. In addition, this Project Memorandum will also recommend the immediate drainage maintenance improvements (i.e., this current fiscal year) and the short-term drainage maintenance improvements (Fiscal Year 2022/2023).

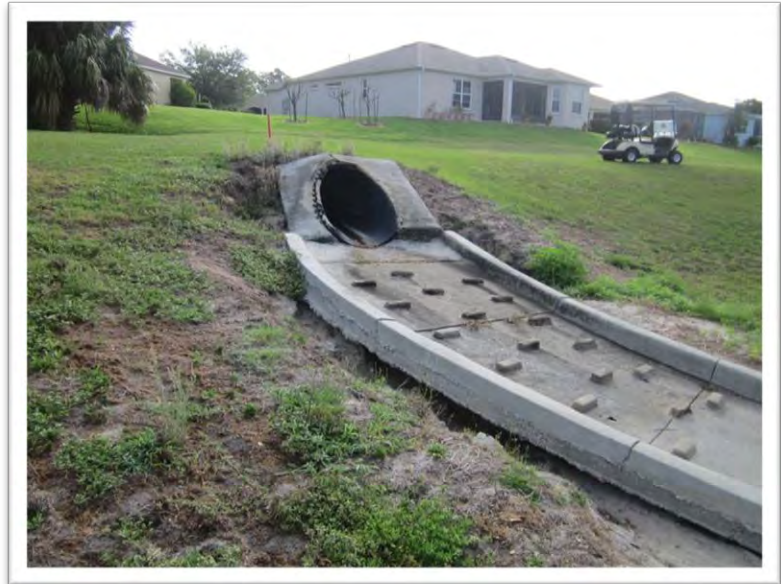
<b>Photograph No.</b>
3
<b>Photographer Location:</b>
Pond P-CH (Structure A)
<b>Pond Location:</b>
Hole #1 (Tee Box)
<b>Comments:</b>
Both sides of the concrete flume must be backfilled, compacted, and sodded.

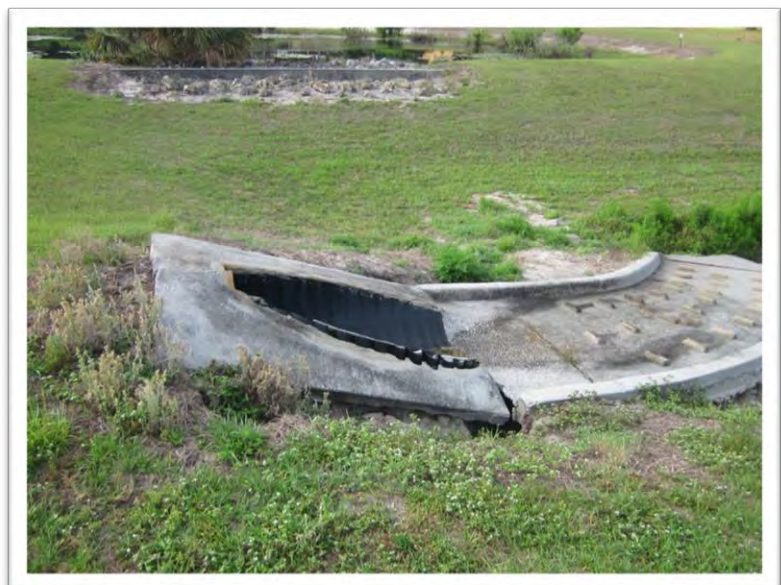
<b>Photograph No.</b>
4
<b>Photographer Location:</b>
Pond P-CH (Structure A)
<b>Pond Location:</b>
Hole #1 (Tee Box)
<b>Comments:</b>
Existing mitered end section has split into two (2) sections and must be removed and replaced.

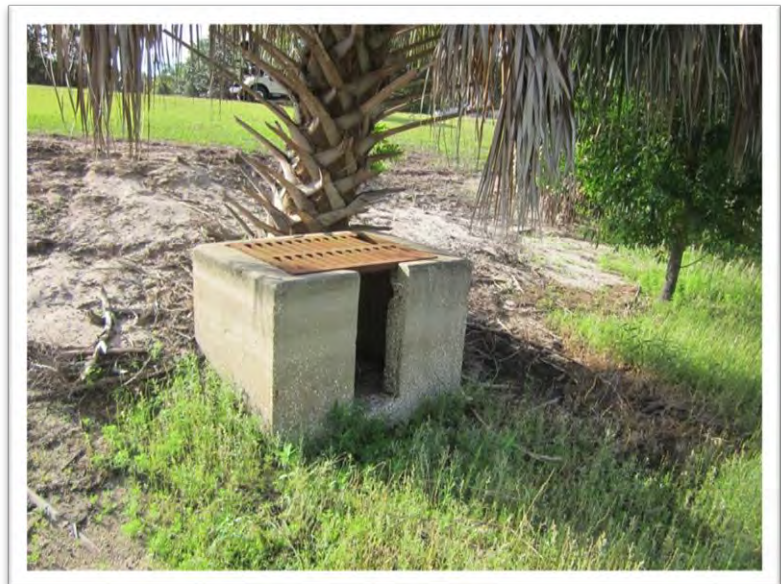
<b>Photograph No.</b>
10
<b>Photographer Location:</b>
Pond P-CH (Structure C)
<b>Pond Location:</b>
Hole #1 (Tee Box)
<b>Comments:</b>
12-inch wide weir opening. The weir opening is 30-inches below the cast iron grate. <b>Need to have Inframark remove the sabal palm tree.</b>

1. **Pond P-CH (Structure C)** – remove the sabal palm tree adjacent to the drainage structure (refer to Attachment “A”, Photograph No. 10).
2. **Pond P-CH (Structure D)** – remove the vegetation adjacent to the drainage structure and underneath the skimmer blade (refer to Attachment “A”, Photographs No. 18 and 20).
3. **Pond P-15-1 (Structure B)** – add sod to the pond side slope in the vicinity of the culvert (refer to Attachment “A”, Photograph No. 17).

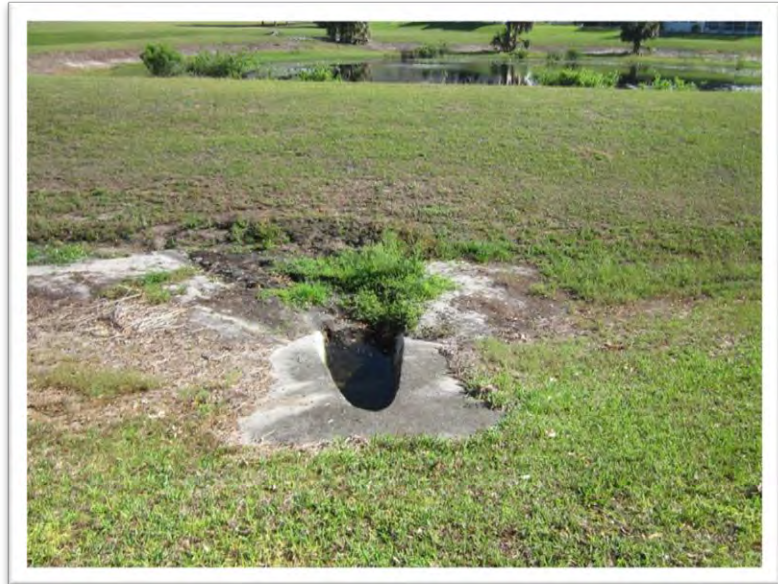
<b>Photograph No.</b>
11
<b>Photographer Location:</b>
Pond P-CH (Structure G)
<b>Pond Location:</b>
Hole #1 (Tee Box)
<b>Comments:</b>
Inflow pipe and concrete mitered end section from the Village Center parking lot. Minor erosion noted.

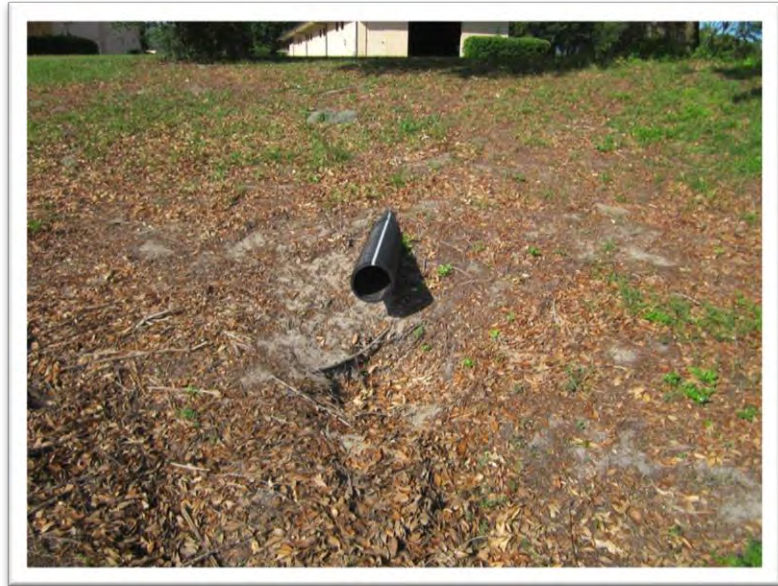
<b>Photograph No.</b>
15
<b>Photographer Location:</b>
Pond P-CH (north of Structure G)
<b>Pond Location:</b>
Hole #1 (Tee Box)
<b>Comments:</b>
8-inch HDPE inflow pipe with downstream erosion. This pipe is approximately 18 feet north of the 12-inch pipe in Photographs #13 and #14. Need to monitor the erosion from the minor inflow pipe.

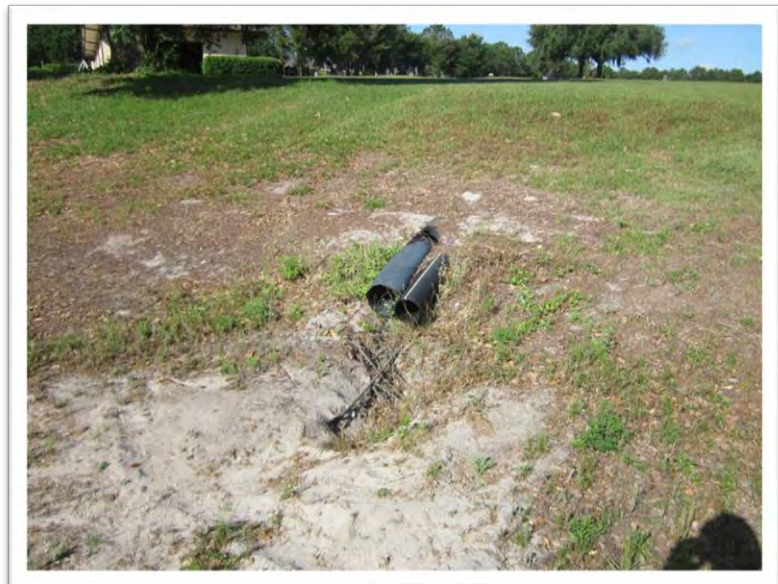
<b>Photograph No.</b>
16
<b>Photographer Location:</b>
Pond P-CH (north of Structure G)
<b>Pond Location:</b>
Hole #1 (Tee Box)
<b>Comments:</b>
8-inch and 6-inch HDPE inflow pipes with downstream erosion. Note the 8-inch pipe is broken on top and will need repairs. Need to monitor the erosion from the minor inflow pipes.

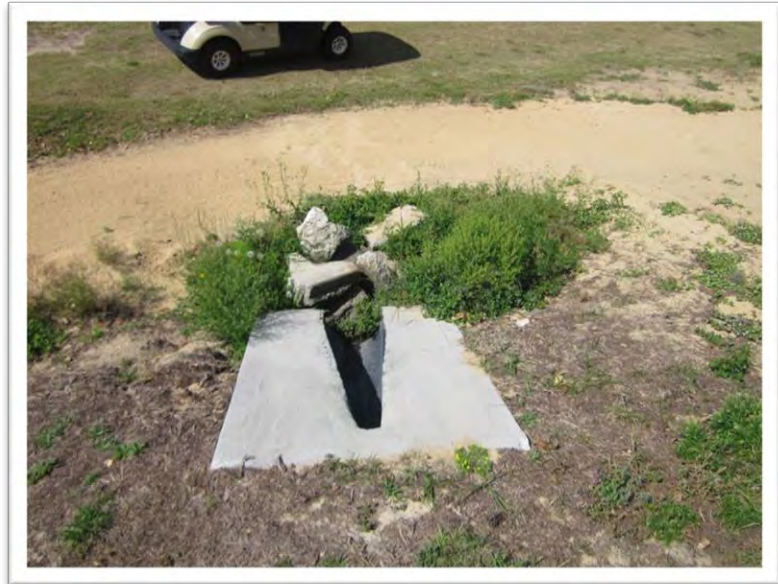
<b>Photograph No.</b>
43
<b>Photographer Location:</b>
Pond P-15-3 (Structure A)
<b>Pond Location:</b>
Hole #6 (Green)
<b>Comments:</b>
Broken concrete at outlet too large. Remove the existing riprap, re-grade outlet, and install concrete riprap with geotextile material.

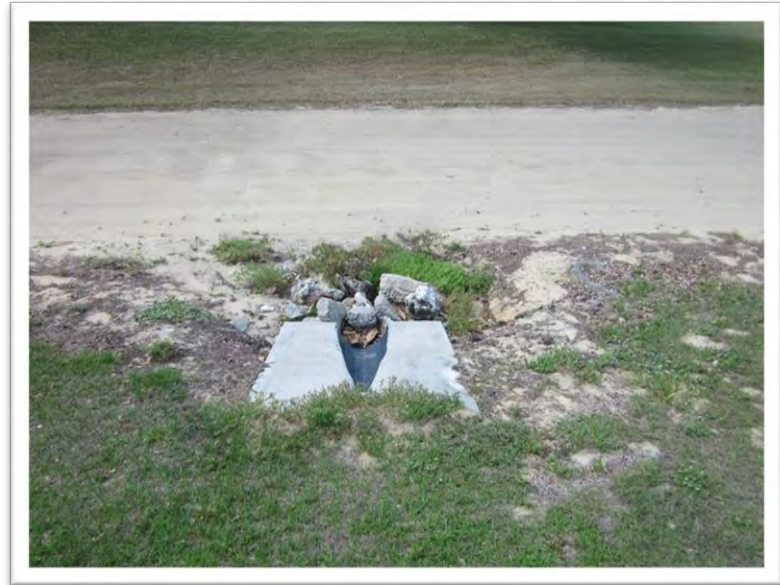
<b>Photograph No.</b>
45
<b>Photographer Location:</b>
Pond P-15-3 (Structure B)
<b>Pond Location:</b>
Hole #6 (Fairway)
<b>Comments:</b>
Broken concrete at outlet too large. Remove broken concrete, re-grade outlet, and install concrete riprap with geotextile material. Also, backfill, compact, and sod both sides of the mitered end section.

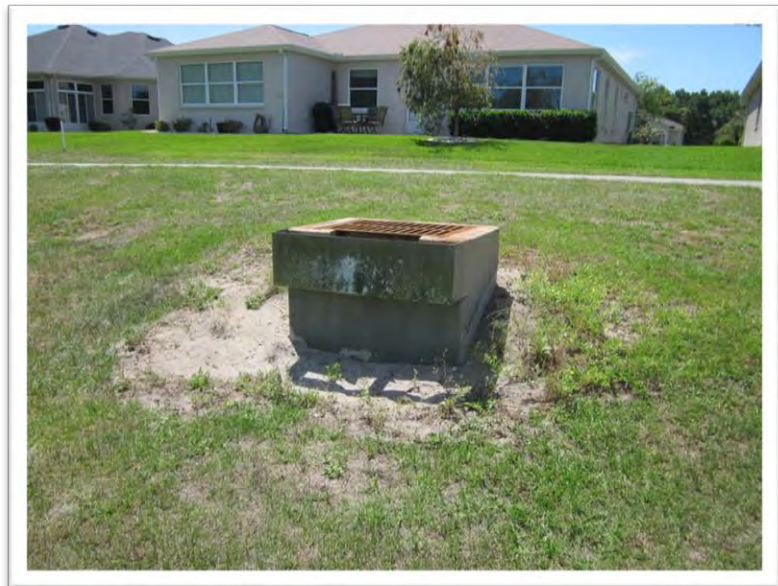
<b>Photograph No.</b>
57
<b>Photographer Location:</b>
Pond P-13-1 (Structure A)
<b>Pond Location:</b>
Hole #4 (south of Green)
<b>Comments:</b>
Need to sod all four (4) sides of the control structure.

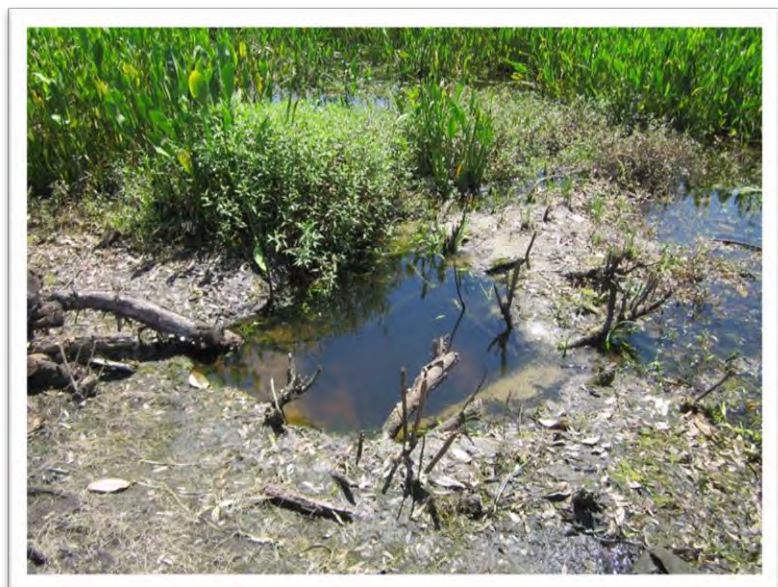
<b>Photograph No.</b>
58
<b>Photographer Location:</b>
Pond P-13-1 (Structure B)
<b>Pond Location:</b>
Hole #4 (northwest of Green)
<b>Comments:</b>
Inflow pipe and ditch bottom inlet originating from Arlington Ridge Boulevard. The ditch bottom inlet is missing the grate.

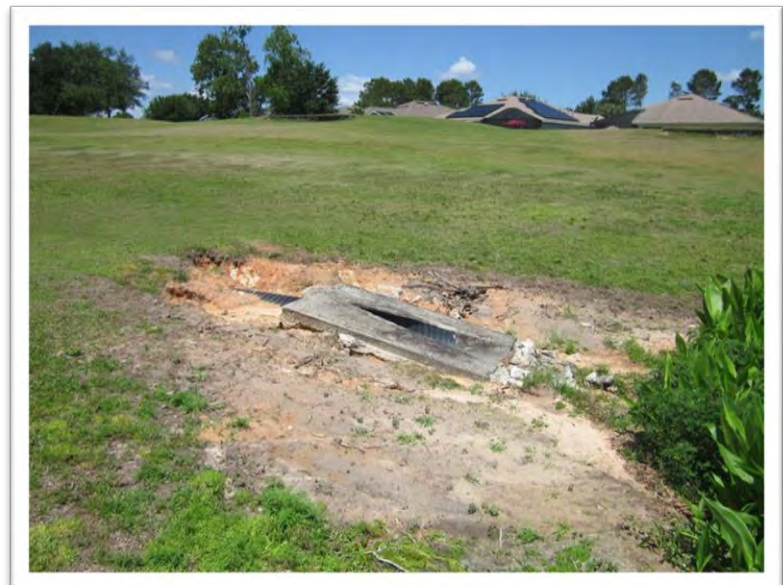
<b>Photograph No.</b>
64
<b>Photographer Location:</b>
Pond P-12-2 (Structure B)
<b>Pond Location:</b>
Hole #3 (Fairway)
<b>Comments:</b>
This area experiences significant erosion which has damaged the pipe and mitered end section.

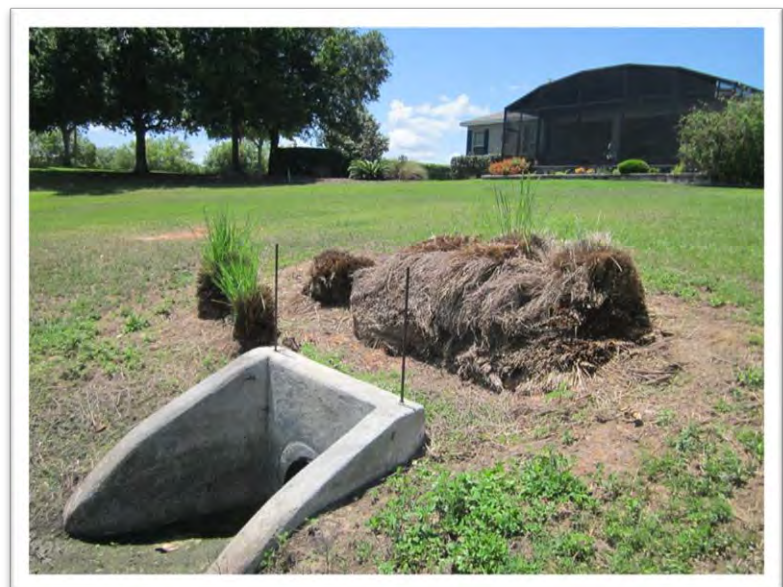
<b>Photograph No.</b>
70
<b>Photographer Location:</b>
Pond P-11-3 (Structure B)
<b>Pond Location:</b>
Hole #2 (Green)
<b>Comments:</b>
From a safety perspective, recommend that the exposed rebar be cut flush with the top of the U-Type endwall.

6. Pond P-11-3 (Structure B) – cut flush the rebar extending above the top of the concrete end treatment (refer to Attachment “A”, Photograph No. 70).
7. Pond P-B1 (Structure C) – re-attach the skimmer blade on the south side of the control structure and replace the cracked skimmer blade on the north end (refer to Attachment “A”, Photograph No. 88).

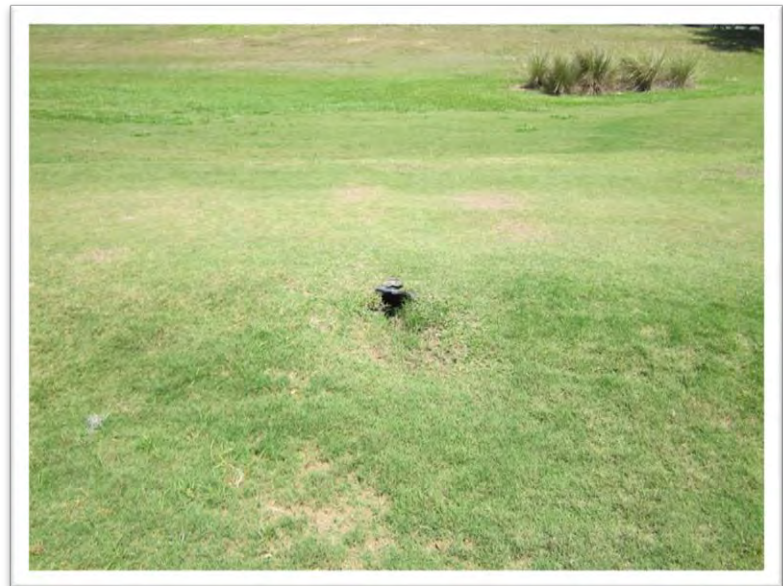
<b>Photograph No.</b>
71
<b>Photographer Location:</b>
Pond P-11-3 (Structure A)
<b>Pond Location:</b>
Hole #2 (Fairway)
<b>Comments:</b>
15-inch HDPE culvert under fairway. End of culvert is full of sediments and crushed and needs to be cleaned-out and repaired.

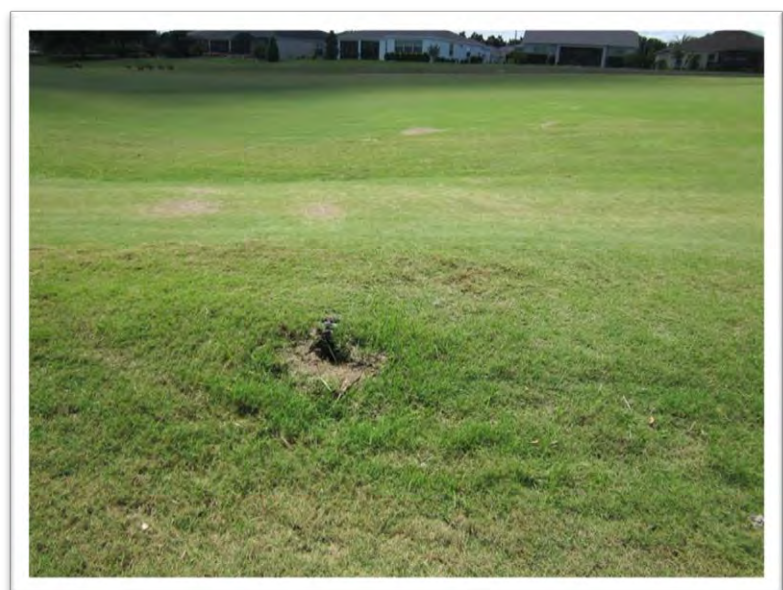
<b>Photograph No.</b>
72
<b>Photographer Location:</b>
Pond P-11-2 (Structure A)
<b>Pond Location:</b>
Hole #2 (Fairway)
<b>Comments:</b>
15-inch HDPE culvert under fairway. End of culvert is full of sediments and crushed and needs to be cleaned-out and repaired.

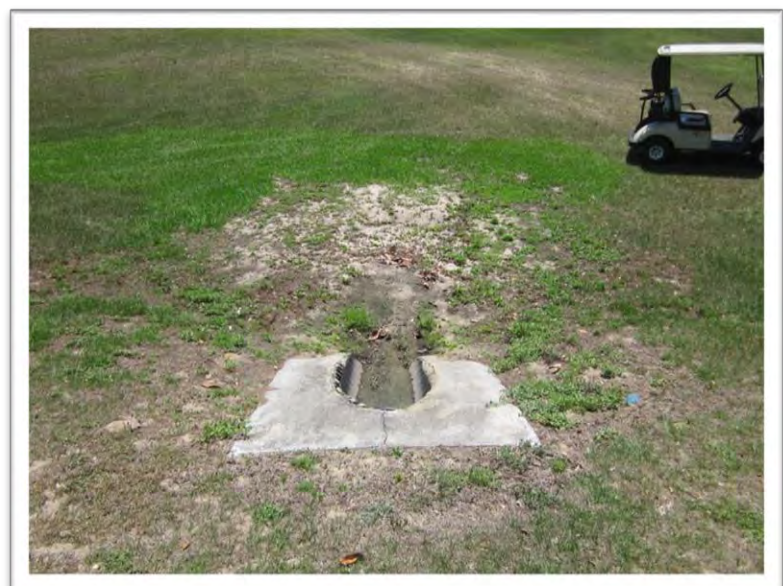
<b>Photograph No.</b>
80
<b>Photographer Location:</b>
Pond P-10-2 (Structure A)
<b>Pond Location:</b>
Hole #1 (Fairway)
<b>Comments:</b>
Monitor mitered end section since it is cracked down the middle.

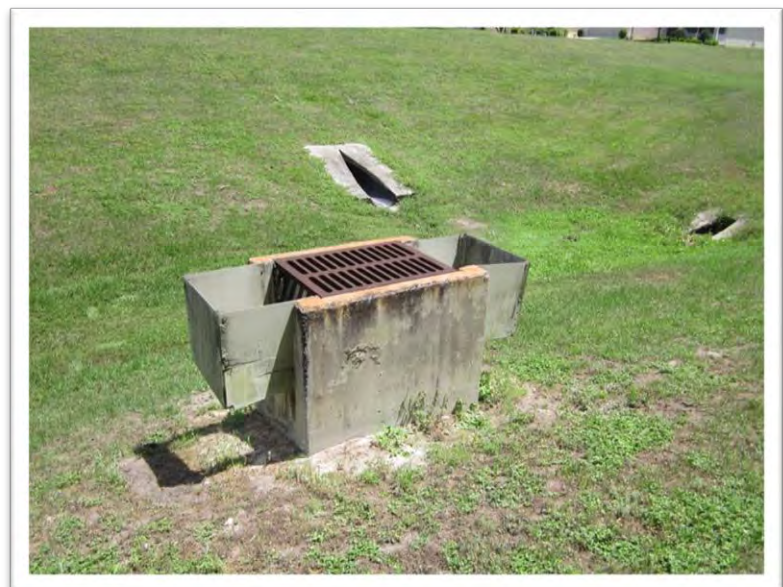
<b>Photograph No.</b>
88
<b>Photographer Location:</b>
Pond P-B1 (Structure C)
<b>Pond Location:</b>
West end of Heritage Trail
<b>Comments:</b>
Need to re-attach the skimmer blade to the control structure on the south end and replace the cracked skimmer blade on the north end.

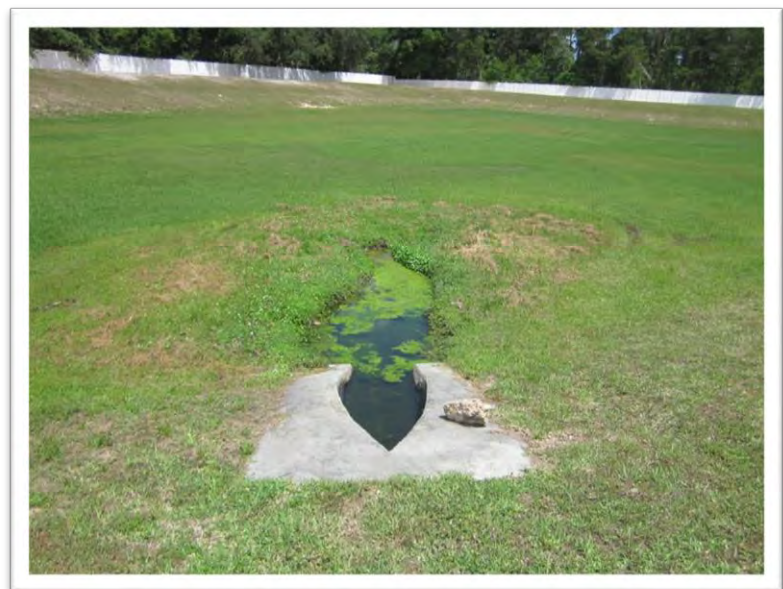
<b>Photograph No.</b>
90
<b>Photographer Location:</b>
Pond P-C1 (Structure A)
<b>Pond Location:</b>
Northeast of Heritage Trail
<b>Comments:</b>
Outlet is "sumped" below the pond bottom and causes standing water inside of pipe. Need to remove sediments, re-grade, install concrete riprap, and sod.

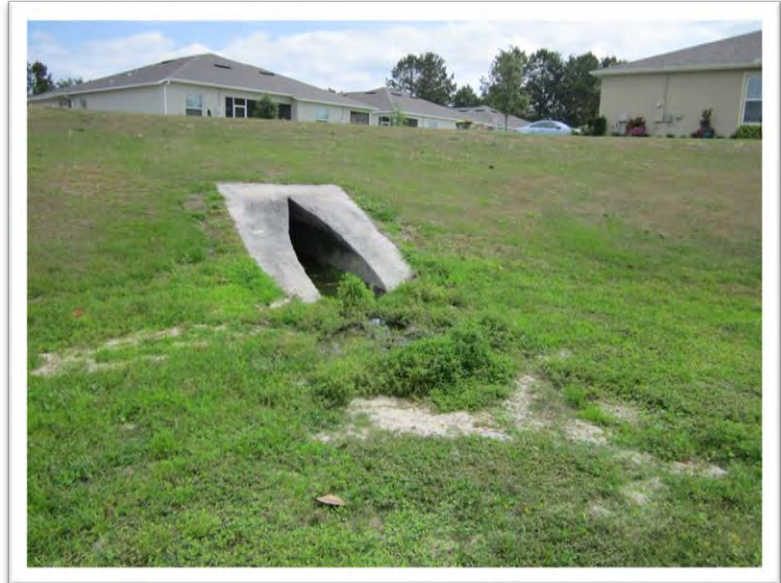
<b>Photograph No.</b>
1
<b>Photographer Location:</b>
Pond P-M (Structure A)
<b>Pond Location:</b>
Hole #10 (Tee Box)
<b>Comments:</b>
Inflow pipe and concrete mitered end section originating from White Plains Way and Bedford Way. Minor erosion noted.

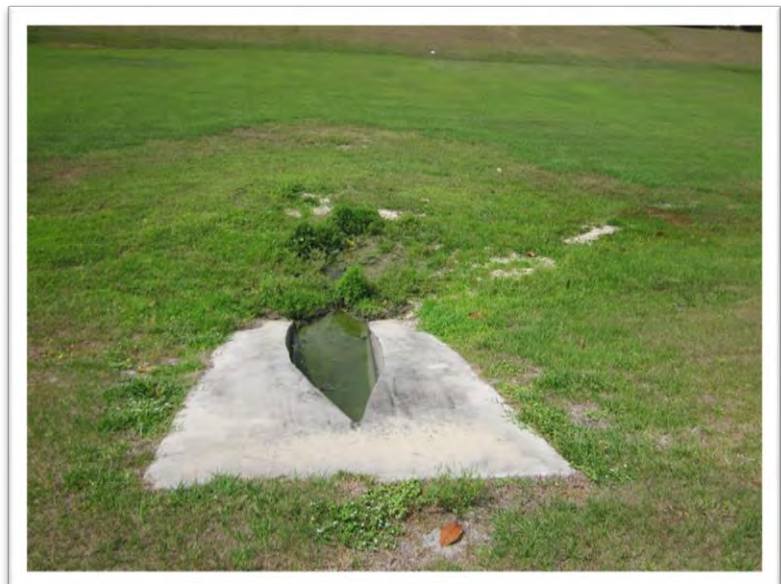
<b>Photograph No.</b>
2
<b>Photographer Location:</b>
Pond P-M (Structure A)
<b>Pond Location:</b>
Hole #10 (Tee Box)
<b>Comments:</b>
Remove sediments within pipe, re-grade, and add concrete riprap.

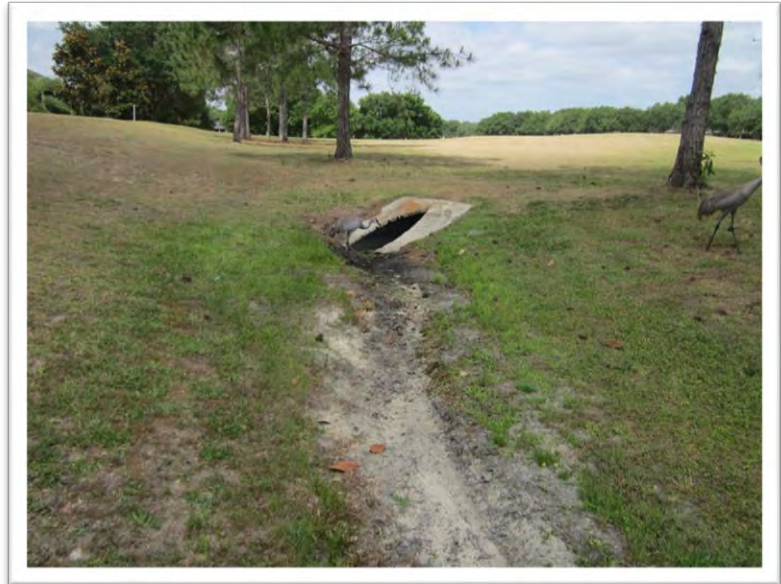
<b>Photograph No.</b>
3
<b>Photographer Location:</b>
Pond P-1-1 (Structure A)
<b>Pond Location:</b>
Hole #10 (Tee Box)
<b>Comments:</b>
Inflow pipe and concrete mitered end section originating from White Plains Way. Erosion noted due to an abrupt change in direction of flow.

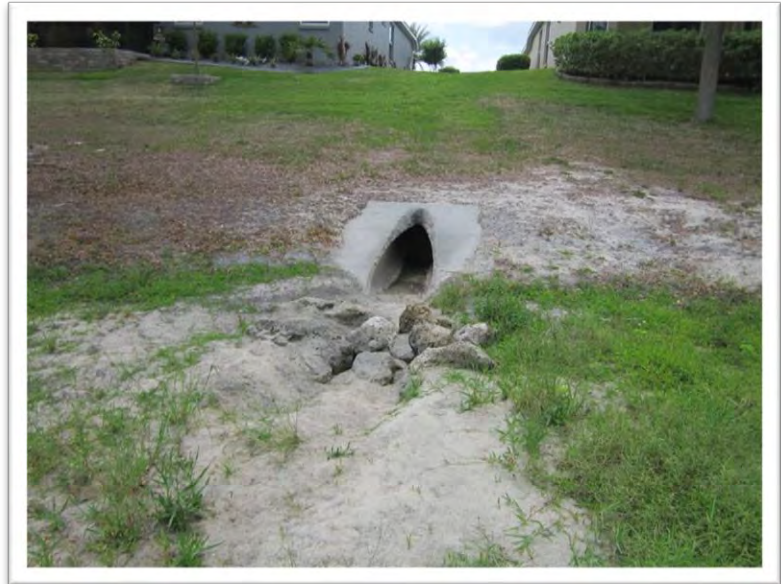
<b>Photograph No.</b>
33
<b>Photographer Location:</b>
Pond P-6-1 (Structure A)
<b>Pond Location:</b>
Hole #15 (Tee Box)
<b>Comments:</b>
Inflow pipe and concrete mitered end section originating from James River Circle. Significant erosion was noted.

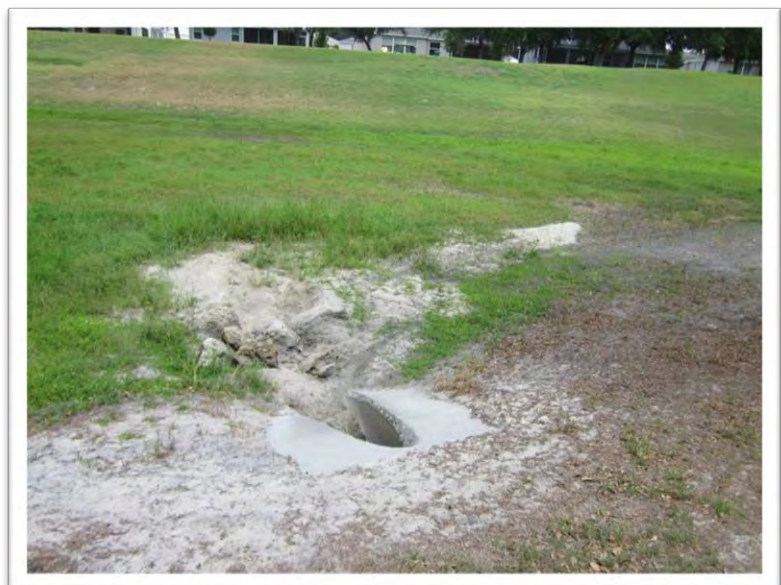
<b>Photograph No.</b>
34
<b>Photographer Location:</b>
Pond P-6-1 (Structure A)
<b>Pond Location:</b>
Hole #15 (Tee Box)
<b>Comments:</b>
Need to remove riprap, re-grade pond bottom, install geotextile underlayment, and install concrete riprap.

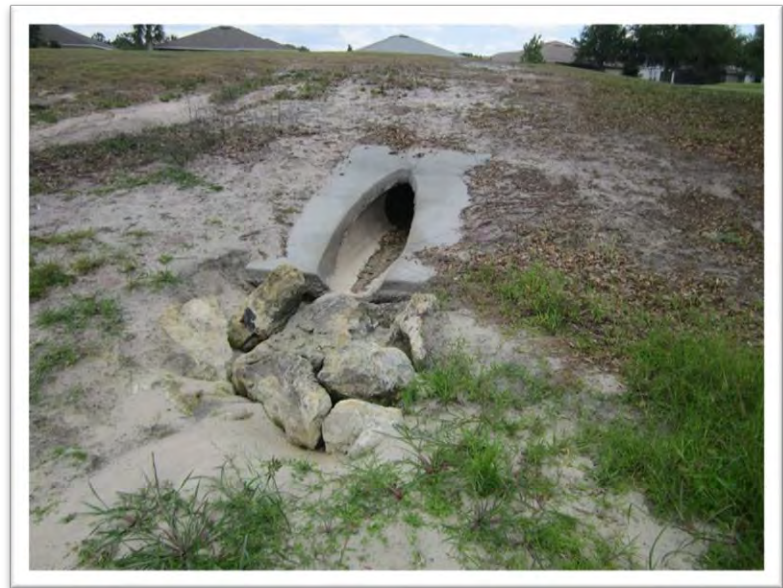
<b>Photograph No.</b>
35
<b>Photographer Location:</b>
Pond P-6-2 (Structure A)
<b>Pond Location:</b>
Hole #15 (Green)
<b>Comments:</b>
Inflow pipe and concrete mitered end section originating from Arlington Ridge Boulevard. Significant erosion and undermining was noted. Need to remove riprap, re-grade pond bottom, install geotextile underlayment, and install concrete riprap.

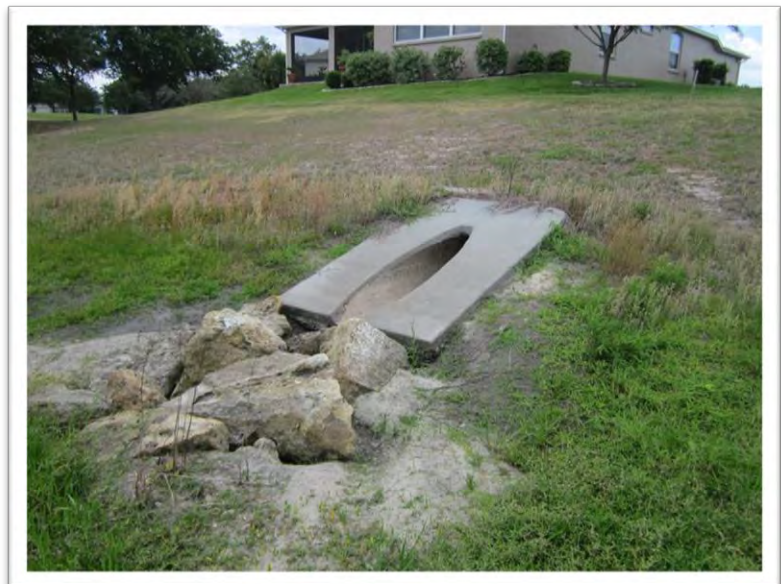
<b>Photograph No.</b>
38
<b>Photographer Location:</b>
Pond P-6-2 (Structure C)
<b>Pond Location:</b>
Hole #16 (Tee Box)
<b>Comments:</b>
Inflow pipe and concrete mitered end section originating from James River Circle. Significant erosion and undermining was noted.

- **Pond P-6-2 (Structure C) (Hole #16 Tee Box)** - Backfill, compact, re-grade, install turf reinforcement mat, geotextile blanket, concrete riprap, and sod (refer to Attachment “B”, Photograph No. 38).
- **Pond P-14-1 (Structure D) (Hole #5 Fairway)** – Backfill, compact, and sod all three (3) sides of the mitered end section. Also, remove the sediments within the pipe, re-grade, and install concrete riprap (refer to Attachment “A”, Photograph No. 54).

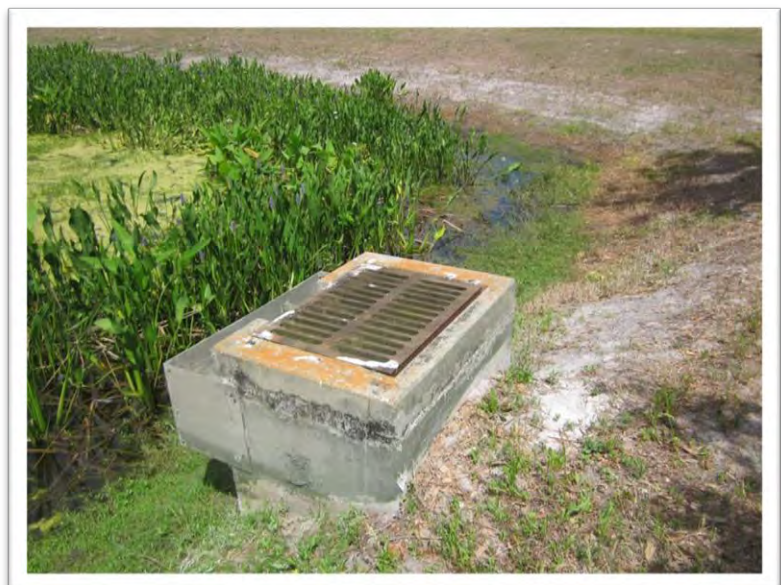
<b>Photograph No.</b>
46
<b>Photographer Location:</b>
Pond P-8-1 (Structure A)
<b>Pond Location:</b>
Hole #17 (Tee Box)
<b>Comments:</b>
Type "C" ditch bottom inlet with skimmer blade (control structure). Need to replace the skimmer blade to meet the proper elevations.

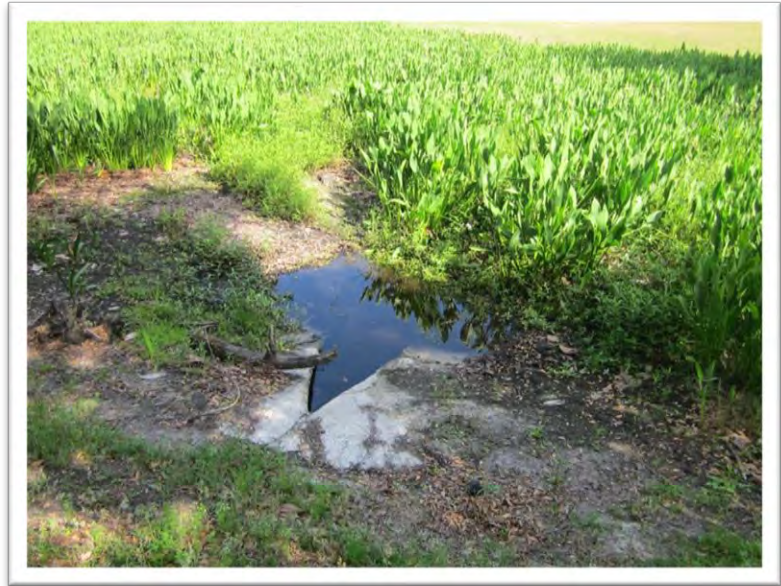
<b>Photograph No.</b>
57
<b>Photographer Location:</b>
Pond P-17-3 (Structure B)
<b>Pond Location:</b>
Hole #9 (Green)
<b>Comments:</b>
Investigate the outlet during dryer conditions to determine if re-grading or removal of sediments are required.

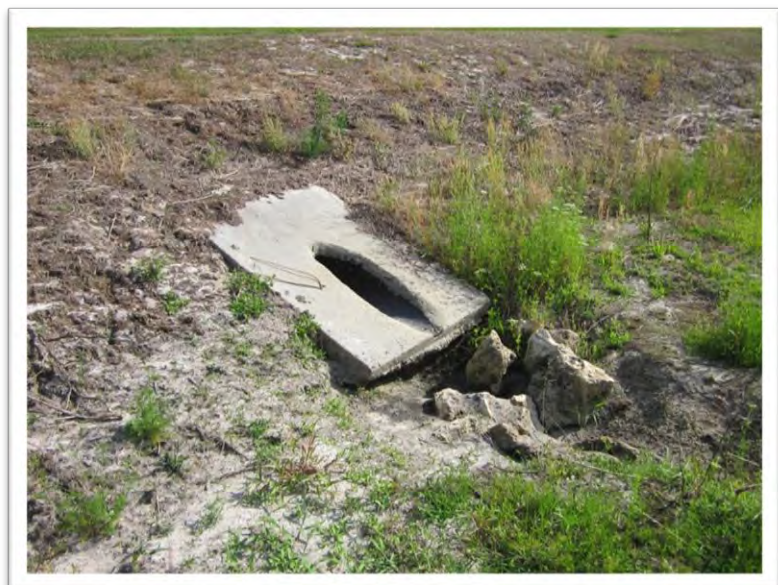
<b>Photograph No.</b>
66
<b>Photographer Location:</b>
Pond P-17-4 (Structure B)
<b>Pond Location:</b>
Hole #9 (Tee Box)
<b>Comments:</b>
Inflow pipe and concrete mitered end section originating from Bent Creek Lane. Significant erosion and undermining noted.

- **Pond P-17-4 (Structure B) (Hole #9 Tee Box)** – Backfill, compact, re-grade, install turf reinforcement mat, geotextile blanket, concrete riprap, and sod (refer to Photograph 6).
