**ARLINGTON RIDGE  
COMMUNITY DEVELOPMENT DISTRICT**

## PROJECT MEMORANDUM

**Subject:** **Annual Inspection Report**

The purpose of this Project Memorandum is to document the annual site inspection associated with the Stormwater Management System (i.e., stormwater ponds, control structures, outfall pipes, and inflow pipes), as well as rights-of-way (roadways) and golf course. In addition, this Project Memorandum will also recommend the immediate drainage maintenance improvements (i.e., this current fiscal year) and the short-term drainage maintenance improvements (Fiscal Year 2022/2023).

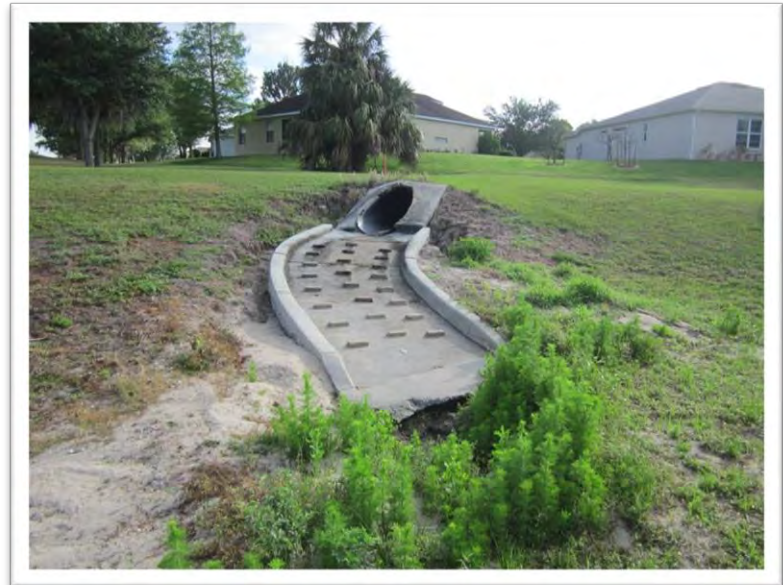
<b>Photograph No.</b>
1
<b>Photographer Location:</b>
Pond P-CH (Structure A)
<b>Pond Location:</b>
Hole #1 (Tee Box)
<b>Comments:</b>
Inflow pipe, concrete mitered end section, and concrete flume with energy dissipator. Note significant undermining at the end of the flume.

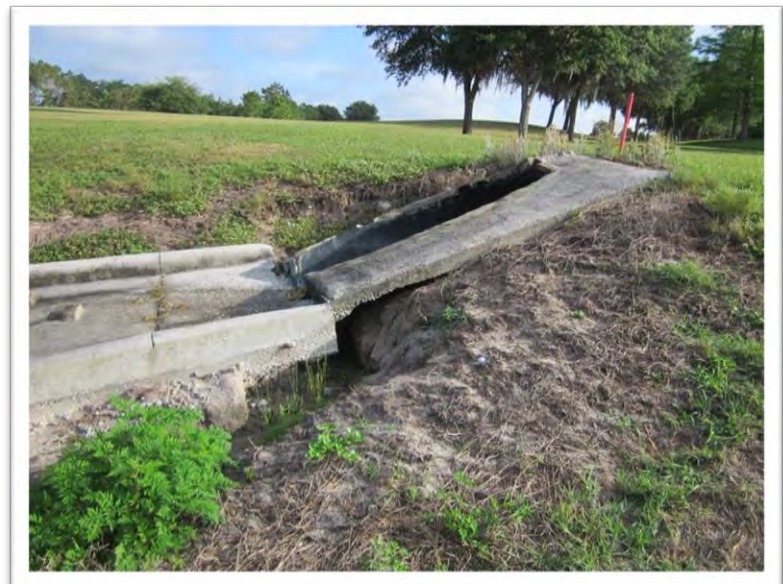
<b>Photograph No.</b>
2
<b>Photographer Location:</b>
Pond P-CH (Structure A)
<b>Pond Location:</b>
Hole #1 (Tee Box)
<b>Comments:</b>
Significant erosion and undermining on both sides of structure, as well as underneath the mitered end section.

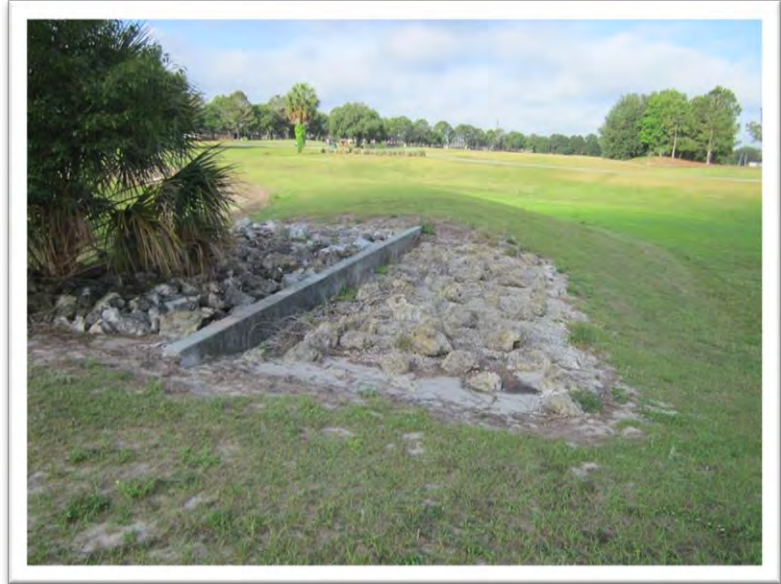
<b>Photograph No.</b>
5
<b>Photographer Location:</b>
Pond P-CH (Structure B)
<b>Pond Location:</b>
Hole #1 (Tee Box)
<b>Comments:</b>
Concrete overflow weir between Pond P-CH and the wetland conservation area.

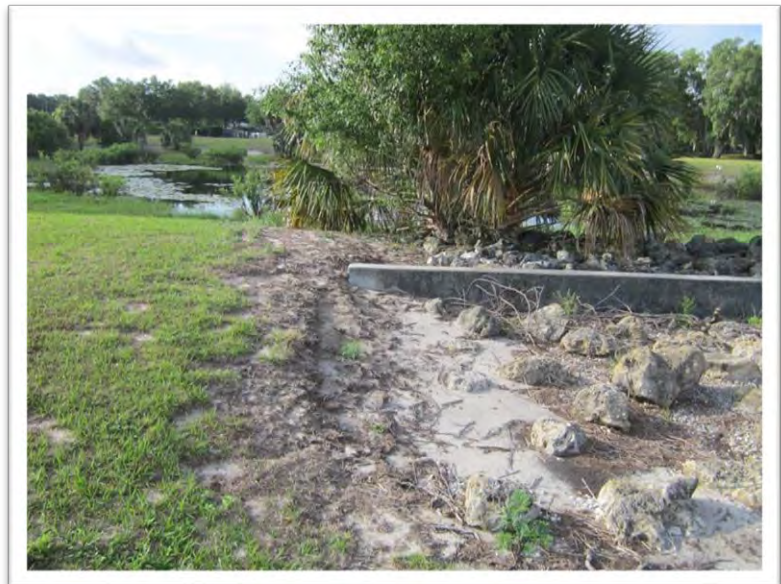
<b>Photograph No.</b>
6
<b>Photographer Location:</b>
Pond P-CH (Structure B)
<b>Pond Location:</b>
Hole #1 (Tee Box)
<b>Comments:</b>
To avoid short-circuiting, the earthen berms at both ends need to be raised above the ends of the concrete weir.

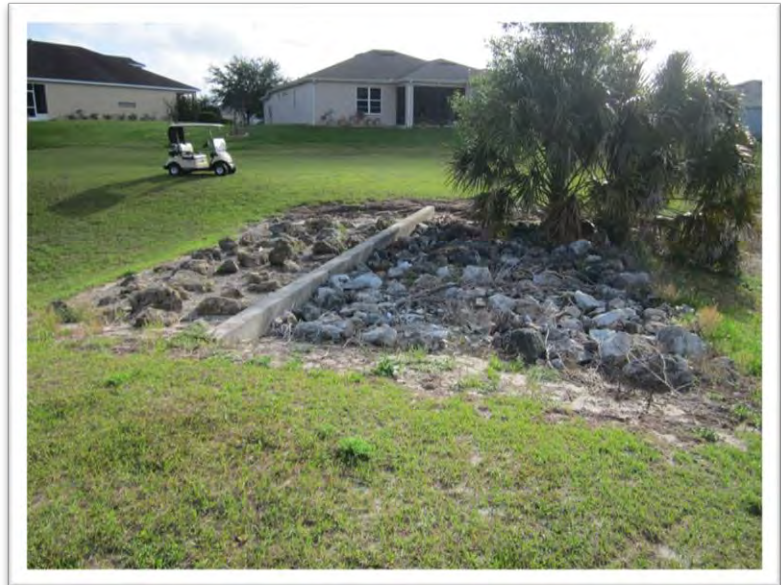
<b>Photograph No.</b>
7
<b>Photographer Location:</b>
Pond P-CH (Structure B)
<b>Pond Location:</b>
Hole #1 (Tee Box)
<b>Comments:</b>
Concrete overflow weir between Pond P-CH and the wetland conservation area.

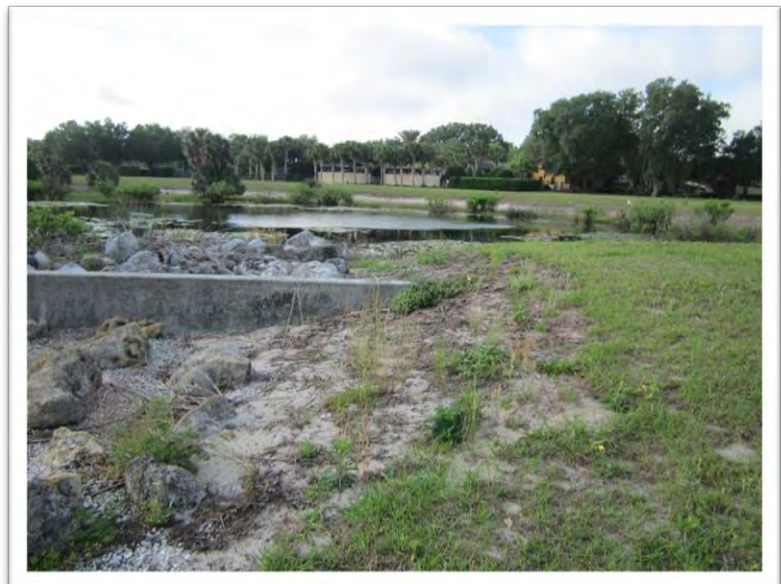
<b>Photograph No.</b>
8
<b>Photographer Location:</b>
Pond P-CH (Structure B)
<b>Pond Location:</b>
Hole #1 (Tee Box)
<b>Comments:</b>
To avoid short-circuiting, the earthen berms at both ends need to be raised above the ends of the concrete weir.

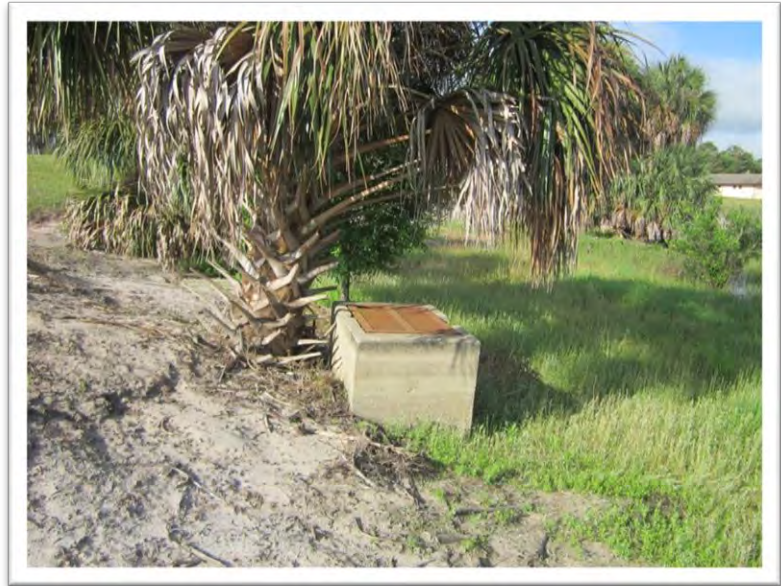
<b>Photograph No.</b>
9
<b>Photographer Location:</b>
Pond P-CH (Structure C)
<b>Pond Location:</b>
Hole #1 (Tee Box)
<b>Comments:</b>
Type "C" ditch bottom inlet (bubble-up structure) located within the conservation area.

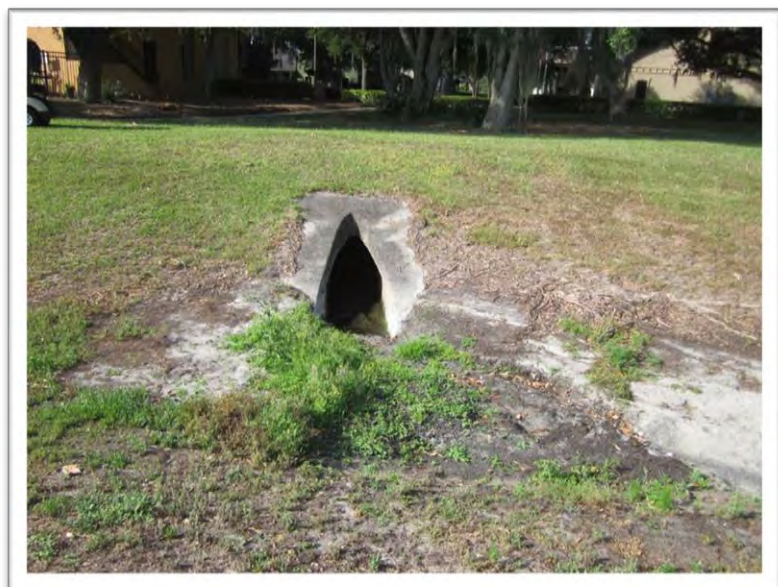
<b>Photograph No.</b>
12
<b>Photographer Location:</b>
Pond P-CH (Structure G)
<b>Pond Location:</b>
Hole #1 (Tee Box)
<b>Comments:</b>
Need to re-grade the eroded area and add concrete riprap.

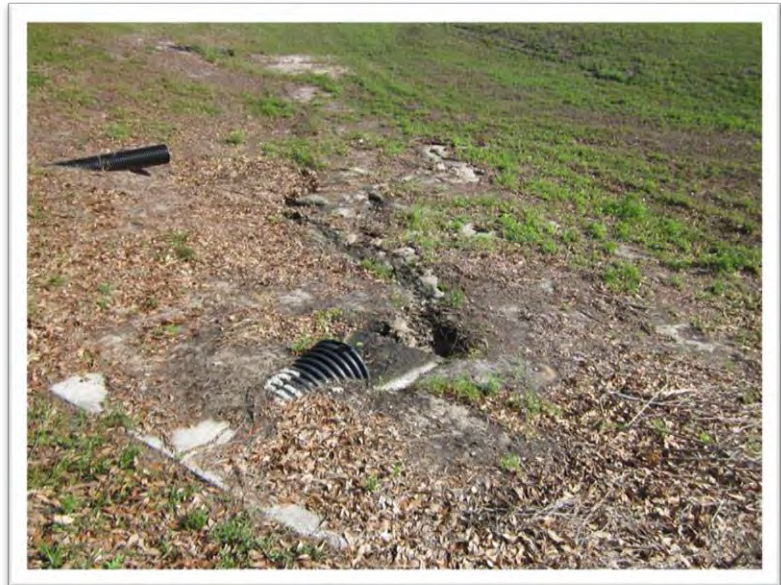
<b>Photograph No.</b>
13
<b>Photographer Location:</b>
Pond P-CH (north of Structure G)
<b>Pond Location:</b>
Hole #1 (Tee Box)
<b>Comments:</b>
12-inch HDPE inflow pipe with downstream erosion. Inflow pipe originates between Fairfax Hall and the Cart Building.

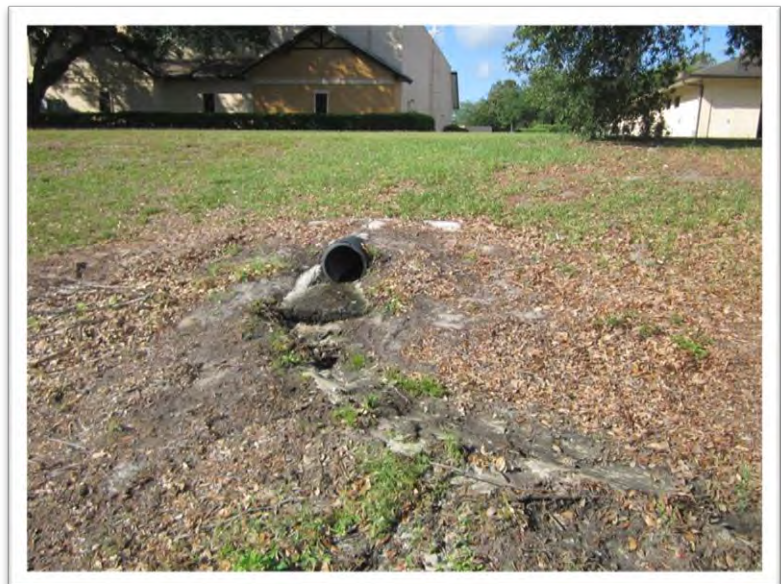
<b>Photograph No.</b>
14
<b>Photographer Location:</b>
Pond P-CH (north of Structure G)
<b>Pond Location:</b>
Hole #1 (Tee Box)
<b>Comments:</b>
Need to monitor the erosion from the minor inflow pipe.

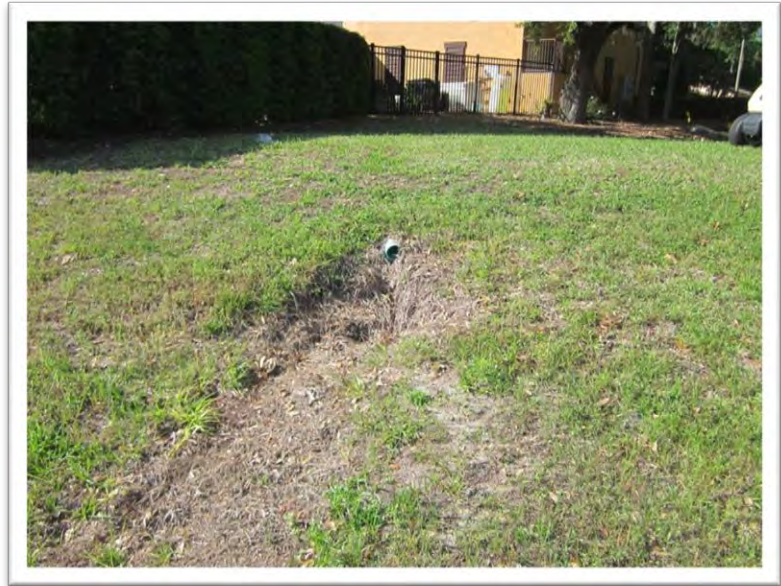
<b>Photograph No.</b>
17
<b>Photographer Location:</b>
Pond P-CH (north of Structure G)
<b>Pond Location:</b>
Hole #1 (Tee Box)
<b>Comments:</b>
4-inch PVC inflow pipe with downstream erosion and located approximately 40-feet south of Structure G.

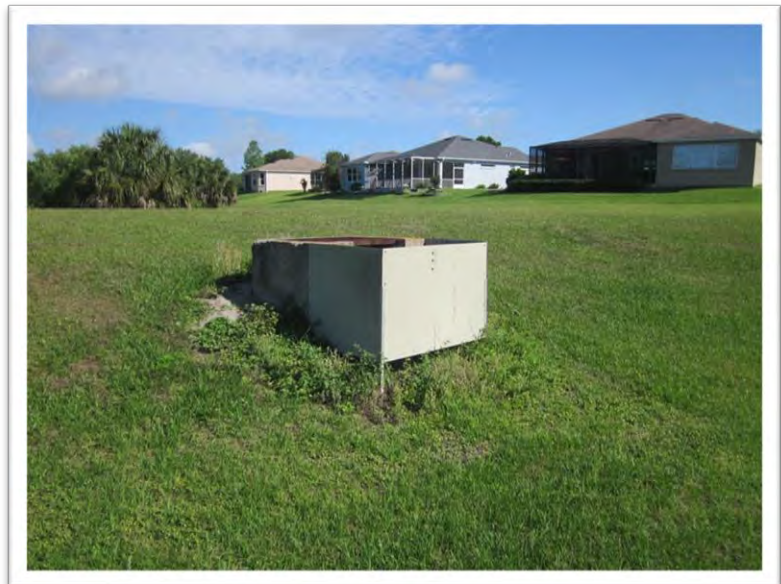
<b>Photograph No.</b>
18
<b>Photographer Location:</b>
Pond P-CH (Structure D)
<b>Pond Location:</b>
Hole #1 (Tee Box)
<b>Comments:</b>
Type "C" ditch bottom inlet with skimmer blade (control structure). <b>Need to remove vegetation adjacent to structure and underneath skimmer blade.</b>

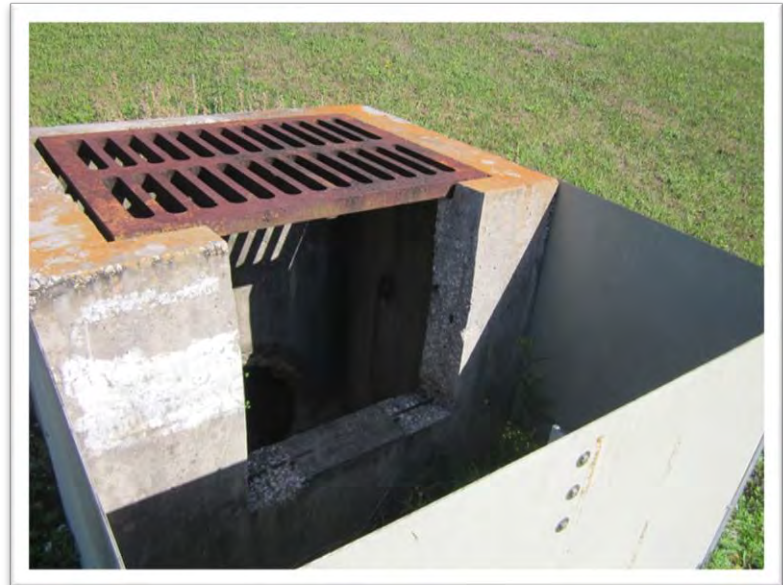
<b>Photograph No.</b>
19
<b>Photographer Location:</b>
Pond P-CH (Structure D)
<b>Pond Location:</b>
Hole #1 (Tee Box)
<b>Comments:</b>
25-inch wide weir opening. The weir opening is 26.5-inches below the cast iron grate.

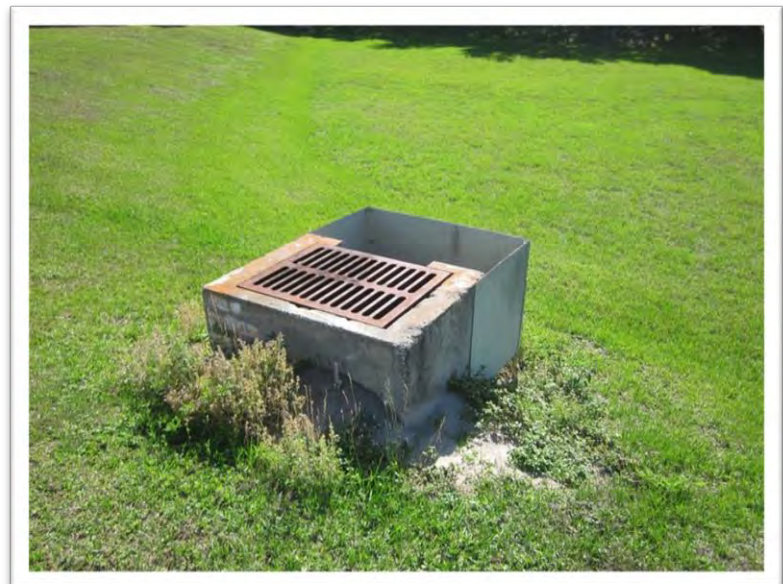
<b>Photograph No.</b>
20
<b>Photographer Location:</b>
Pond P-CH (Structure D)
<b>Pond Location:</b>
Hole #1 (Tee Box)
<b>Comments:</b>
Remove vegetation adjacent to the control structure.

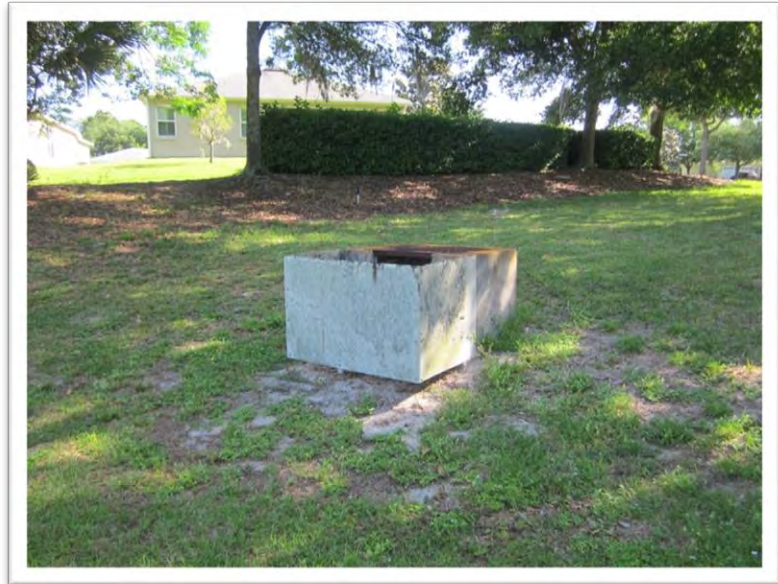
<b>Photograph No.</b>
21
<b>Photographer Location:</b>
Pond P-CH (Structure E)
<b>Pond Location:</b>
Hole #1 (Tee Box)
<b>Comments:</b>
Type "C" ditch bottom inlet with skimmer blade (control structure).

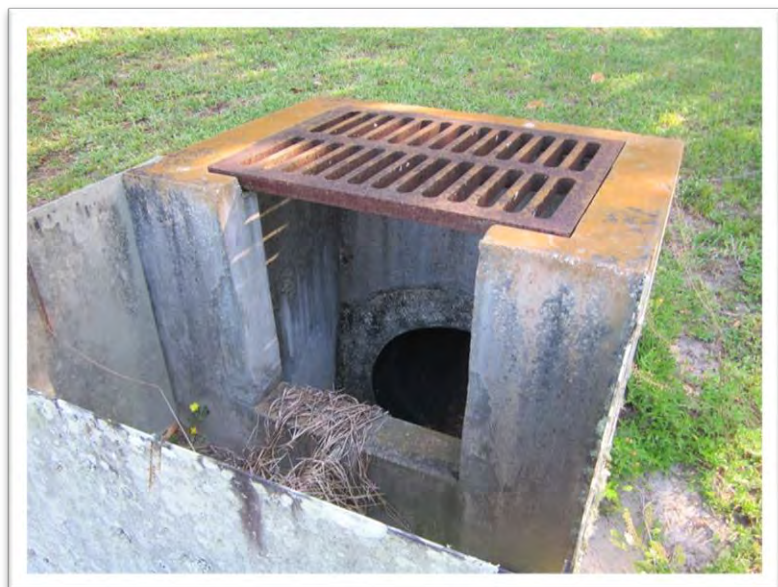
<b>Photograph No.</b>
22
<b>Photographer Location:</b>
Pond P-CH (Structure E)
<b>Pond Location:</b>
Hole #1 (Tee Box)
<b>Comments:</b>
25-inch wide weir opening. The weir opening is 26-inches below the cast iron grate.

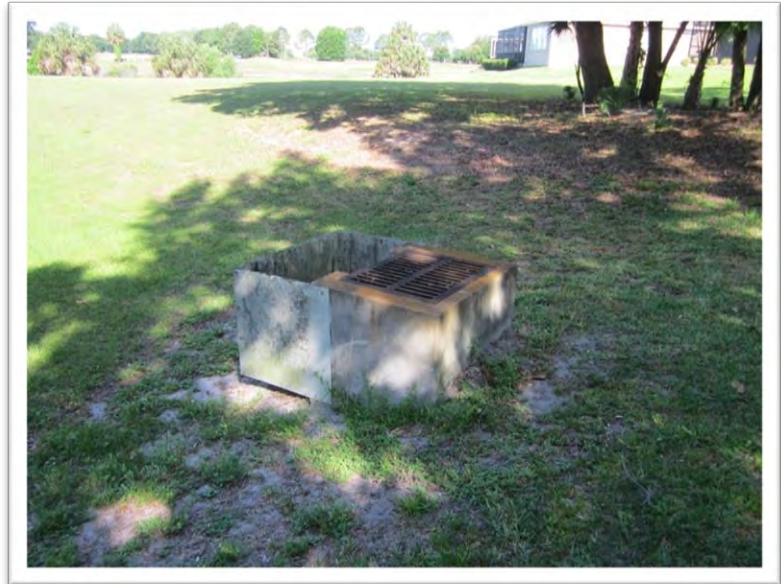
<b>Photograph No.</b>
23
<b>Photographer Location:</b>
Pond P-CH (Structure E)
<b>Pond Location:</b>
Hole #1 (Tee Box)
<b>Comments:</b>
Need to increase the distance between the bottom of the skimmer blade and the pond bottom.

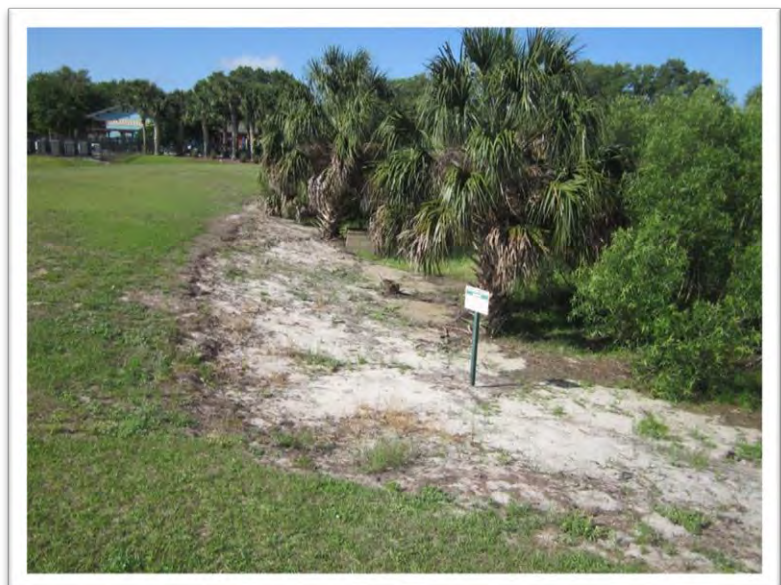
<b>Photograph No.</b>
24
<b>Photographer Location:</b>
Pond P-CH (east of Structure C)
<b>Pond Location:</b>
Hole #1 (Tee Box)
<b>Comments:</b>
Need to monitor the non-vegetated area within the conservation area.

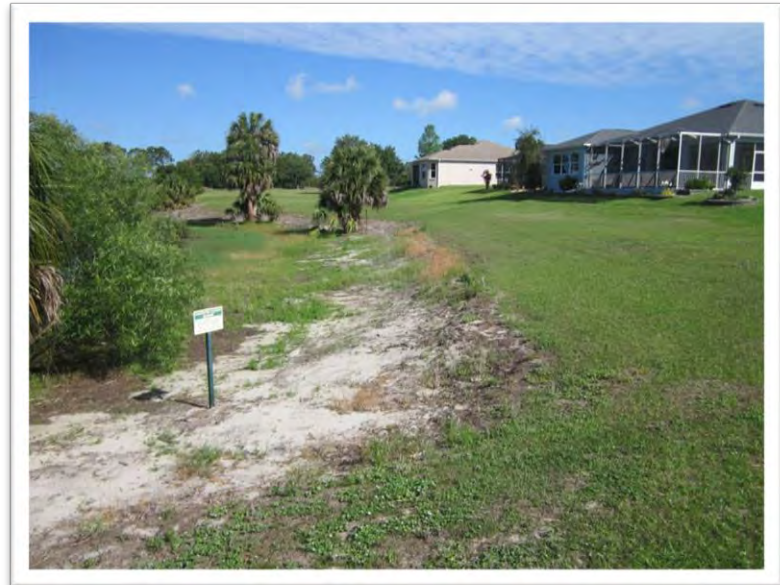
<b>Photograph No.</b>
25
<b>Photographer Location:</b>
Pond P-CH (east of Structure C)
<b>Pond Location:</b>
Hole #1 (Tee Box)
<b>Comments:</b>
Need to monitor the non-vegetated area within the conservation area.

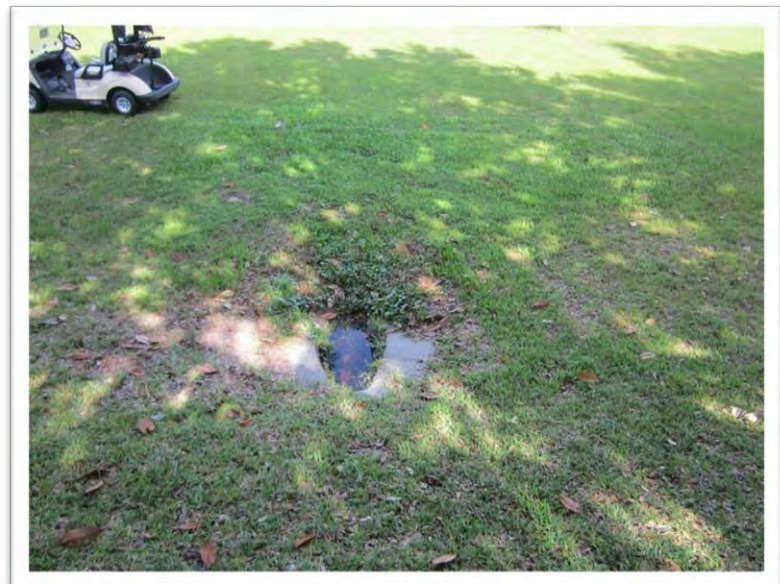
<b>Photograph No.</b>
26
<b>Photographer Location:</b>
Pond P-CH (Structure F)
<b>Pond Location:</b>
Hole #1 (Tee Box)
<b>Comments:</b>
Inflow pipe and concrete mitered end section originating from Arlington Ridge Boulevard.

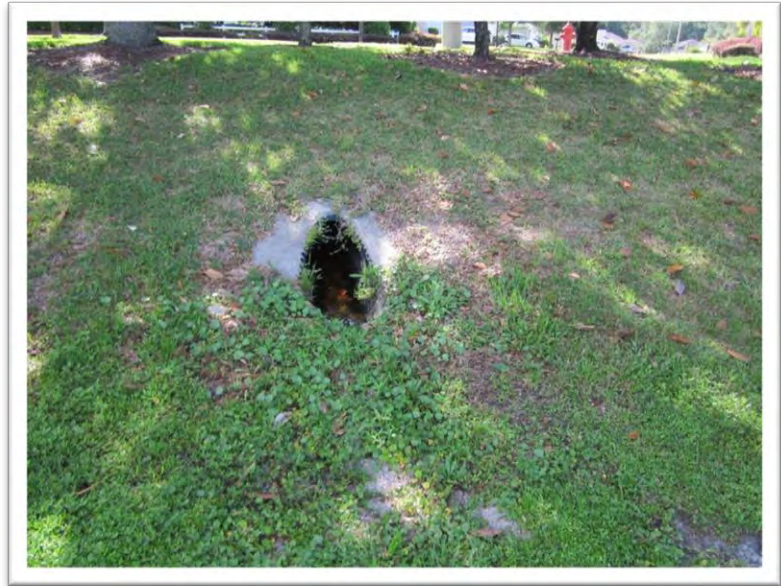
<b>Photograph No.</b>
27
<b>Photographer Location:</b>
Pond P-CH (Structure F)
<b>Pond Location:</b>
Hole #1 (Tee Box)
<b>Comments:</b>
Outlet is partially blocked and needs to be re-graded to create positive drainage and prevent standing water within pipe.

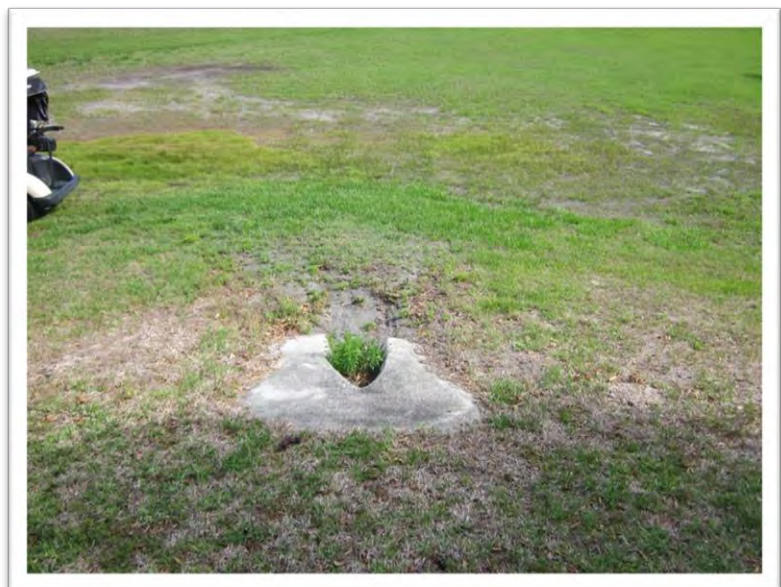
<b>Photograph No.</b>
28
<b>Photographer Location:</b>
Pond P-CH (Structure H)
<b>Pond Location:</b>
Hole #1 (Tee Box)
<b>Comments:</b>
Inflow pipe and mitered end section originating from the fitness center parking lot.

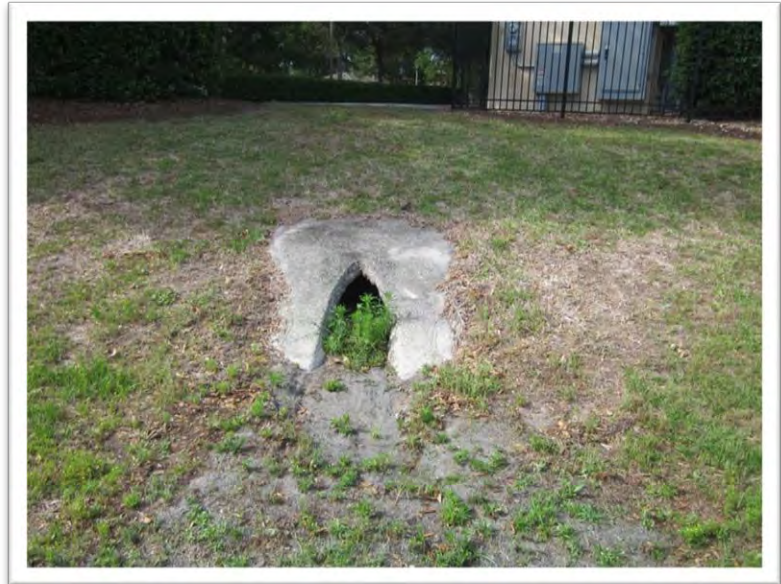
<b>Photograph No.</b>
29
<b>Photographer Location:</b>
Pond P-CH (Structure H)
<b>Pond Location:</b>
Hole #1 (Tee Box)
<b>Comments:</b>
Remove sediments within pipe.

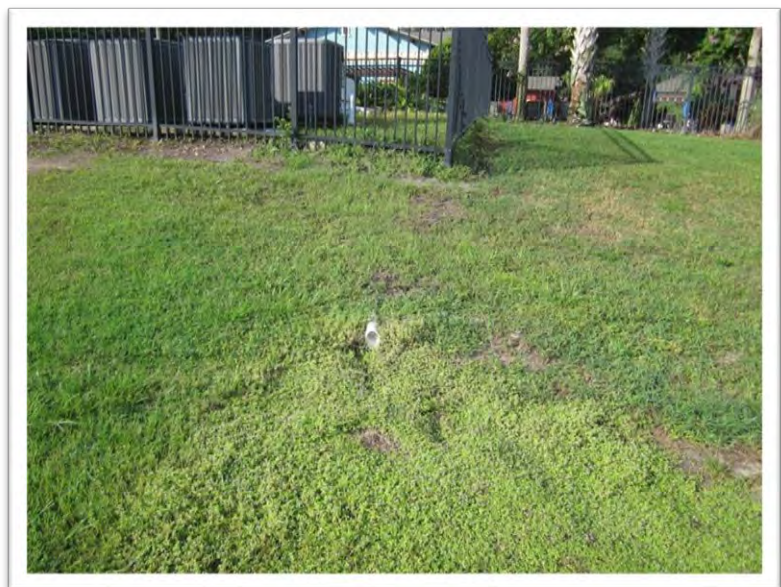
<b>Photograph No.</b>
30
<b>Photographer Location:</b>
Pond P-CH (near Structure H)
<b>Pond Location:</b>
Hole #1 (Tee Box)
<b>Comments:</b>
3-inch PVC inflow pipe from A/C units located approximately 40-feet north of Structure H.

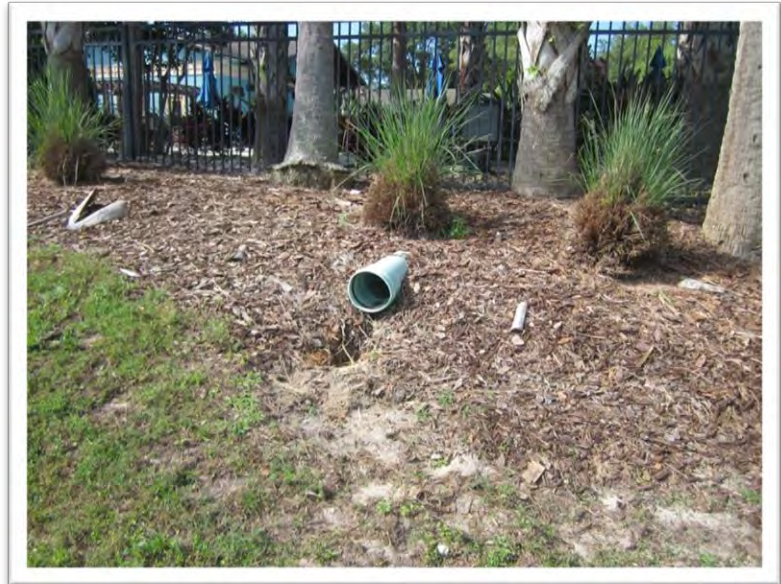
<b>Photograph No.</b>
31
<b>Photographer Location:</b>
Pond P-CH
<b>Pond Location:</b>
Hole #1 (Tee Box)
<b>Comments:</b>
8-inch PVC inflow pipe with minor downstream erosion associated with pool area. This pipe is located approximately 40-feet north of the pipe in Photograph #30.

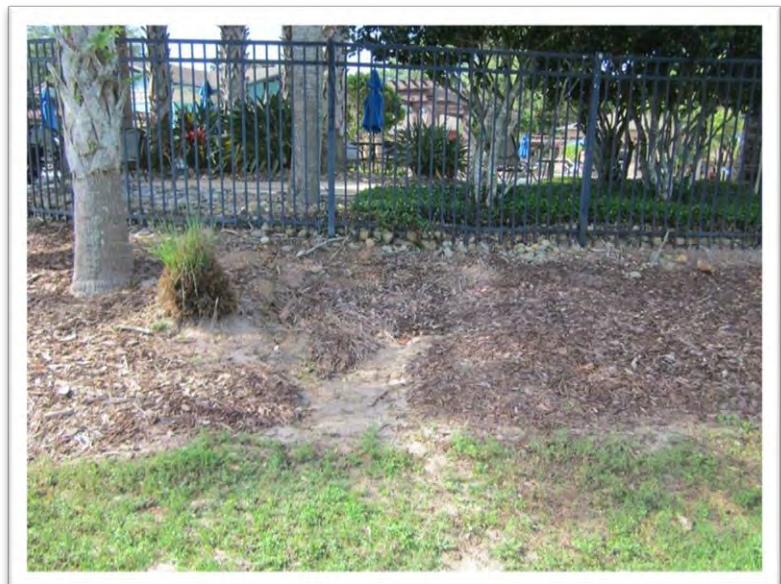
<b>Photograph No.</b>
32
<b>Photographer Location:</b>
Pond P-CH (adjacent to pool area)
<b>Pond Location:</b>
Hole #1 (Tee Box)
<b>Comments:</b>
Erosion Area #1 located north of the pipe in Photograph #31.

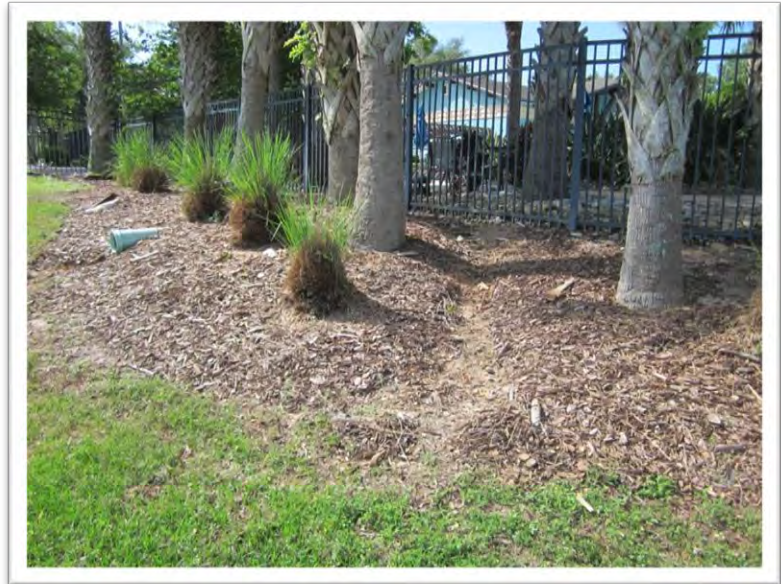
<b>Photograph No.</b>
33
<b>Photographer Location:</b>
Pond P-CH (adjacent to pool area)
<b>Pond Location:</b>
Hole #1 (Tee Box)
<b>Comments:</b>
Erosion Area #2 located north of the pipe in Photograph #31.

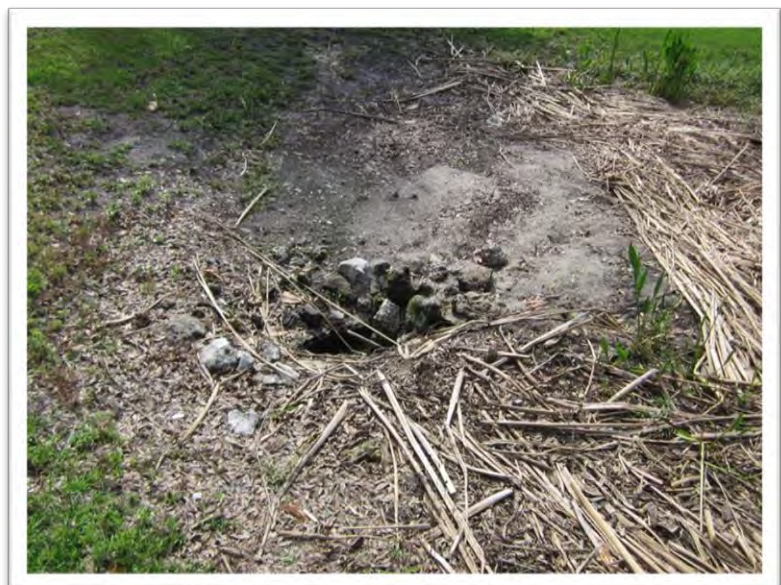
<b>Photograph No.</b>
34
<b>Photographer Location:</b>
Pond P-15-1 (Structure A)
<b>Pond Location:</b>
Hole #6 (Green)
<b>Comments:</b>
Inflow pipe and concrete mitered end section originating from Arlington Ridge Boulevard.

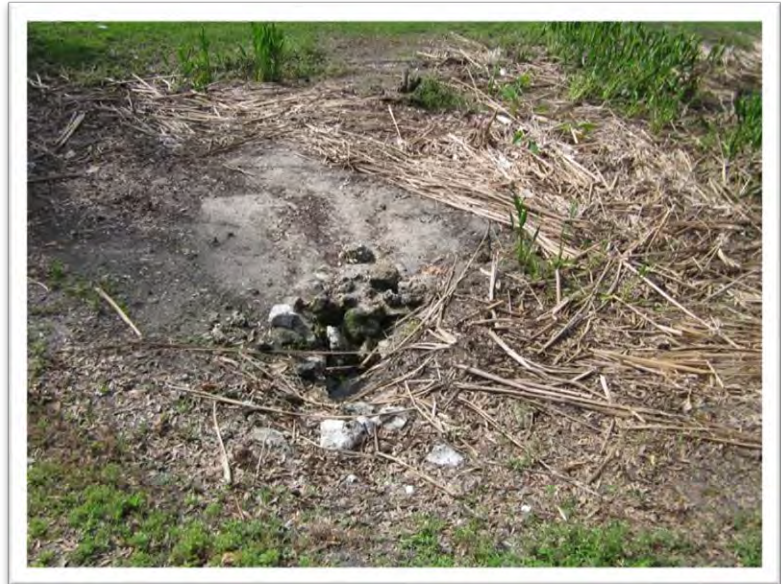
<b>Photograph No.</b>
35
<b>Photographer Location:</b>
Pond P-15-1 (Structure A)
<b>Pond Location:</b>
Hole #6 (Green)
<b>Comments:</b>
Existing inflow pipe is "sumped" below the downstream sediments.

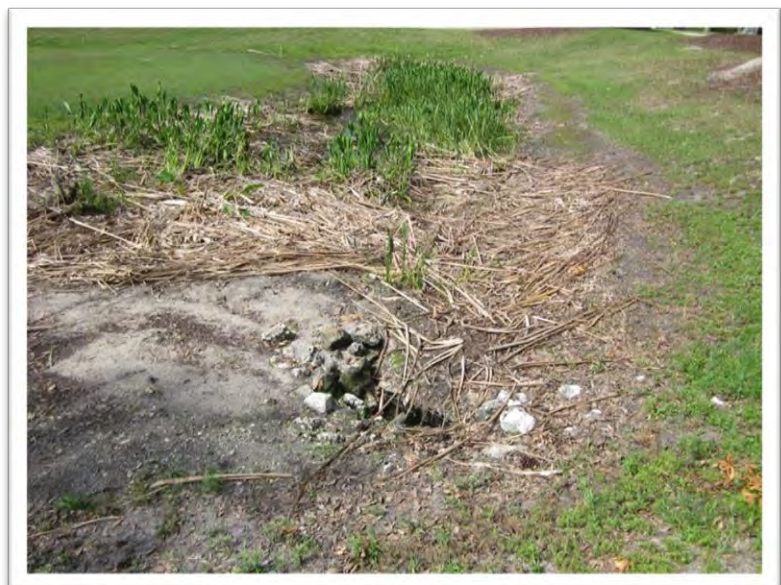
<b>Photograph No.</b>
36
<b>Photographer Location:</b>
Pond P-15-1 (Structure A)
<b>Pond Location:</b>
Hole #6 (Green)
<b>Comments:</b>
Need to remove the sediments, re-grade for positive drainage, and install concrete riprap.

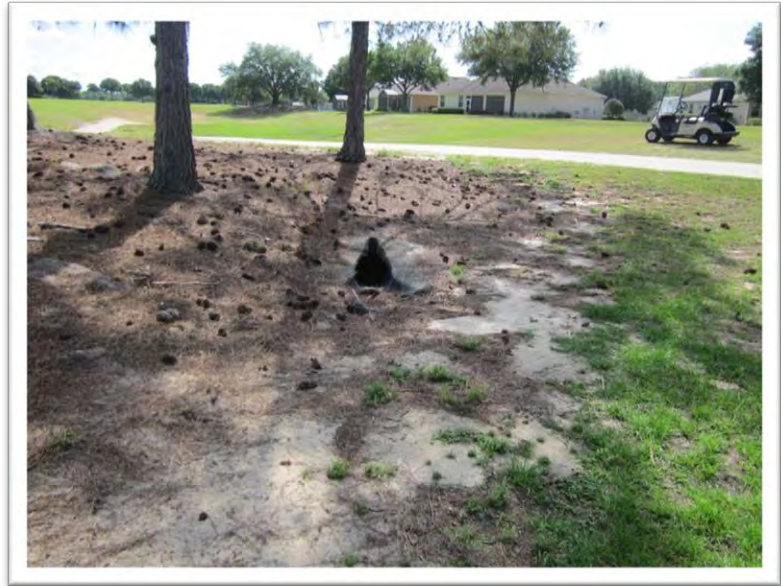
<b>Photograph No.</b>
37
<b>Photographer Location:</b>
Pond P-15-1 (Structure B)
<b>Pond Location:</b>
Hole #6 (Green)
<b>Comments:</b>
Concrete mitered end section associated with culvert under the cart path. Consider adding sod to the side slope.

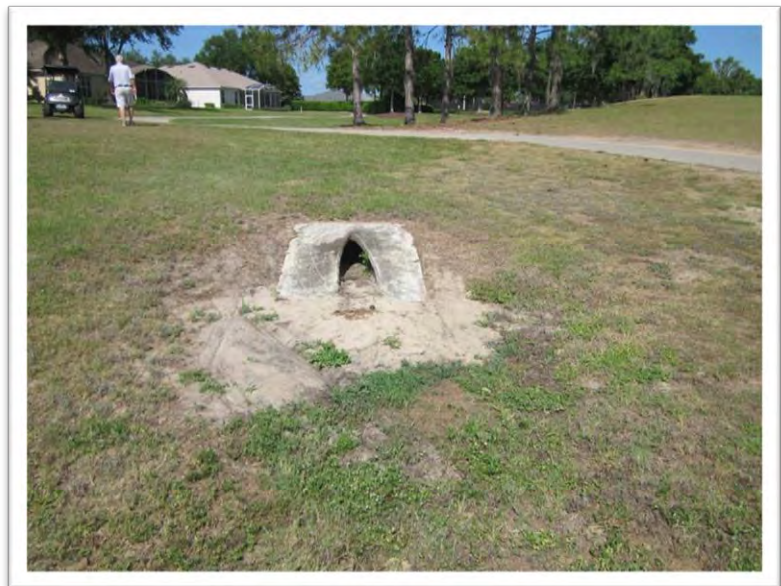
<b>Photograph No.</b>
38
<b>Photographer Location:</b>
Pond P-15-1 (Structure C)
<b>Pond Location:</b>
Hole #6 (Green)
<b>Comments:</b>
Concrete mitered end section associated with culvert under the cart path. Remove sediments within culvert and add sod.

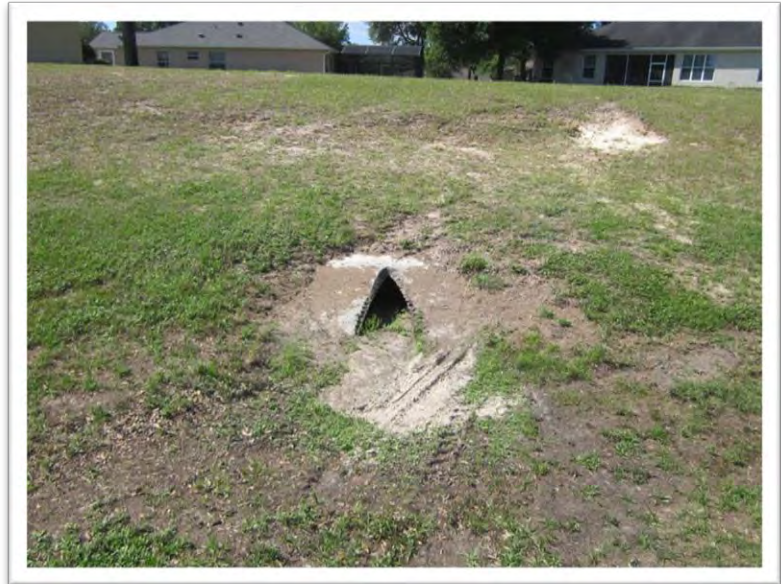
<b>Photograph No.</b>
39
<b>Photographer Location:</b>
Pond P-15-1 (Structure D)
<b>Pond Location:</b>
Hole #6 (Green)
<b>Comments:</b>
Inflow pipe and concrete mitered end section from River Watch Court. Remove sediments within pipe and add sod.

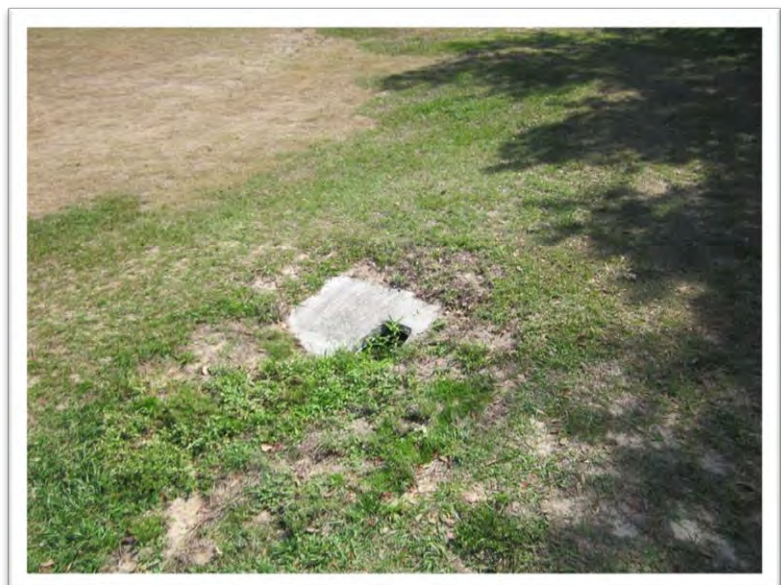
<b>Photograph No.</b>
40
<b>Photographer Location:</b>
Pond P-15-1 (Structure E)
<b>Pond Location:</b>
Hole #6 (Green)
<b>Comments:</b>
Appears to be the overflow structure from Pond P-15-1 to the Palatlahaka River (need to review permitted construction plans to confirm).

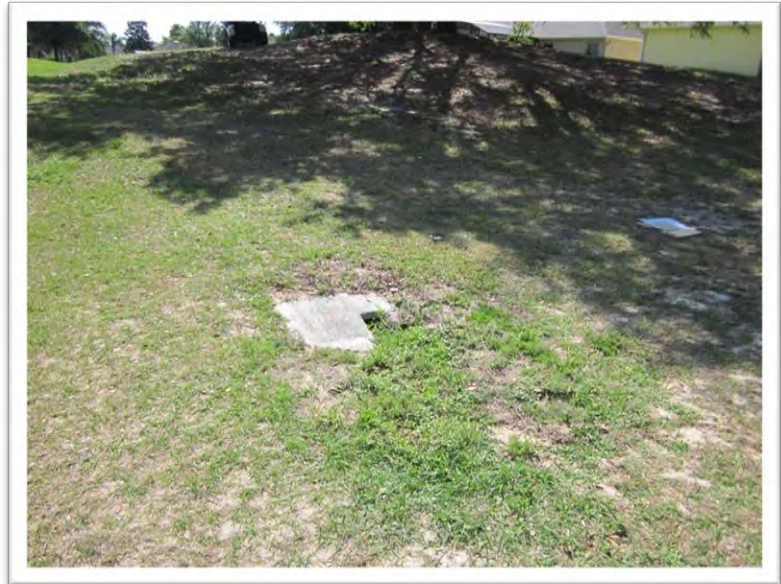
<b>Photograph No.</b>
41
<b>Photographer Location:</b>
Pond P-15-1 (Structure E)
<b>Pond Location:</b>
Hole #6 (Green)
<b>Comments:</b>
Need to remove sediments within the PVC pipe and re-grade the area and sod.

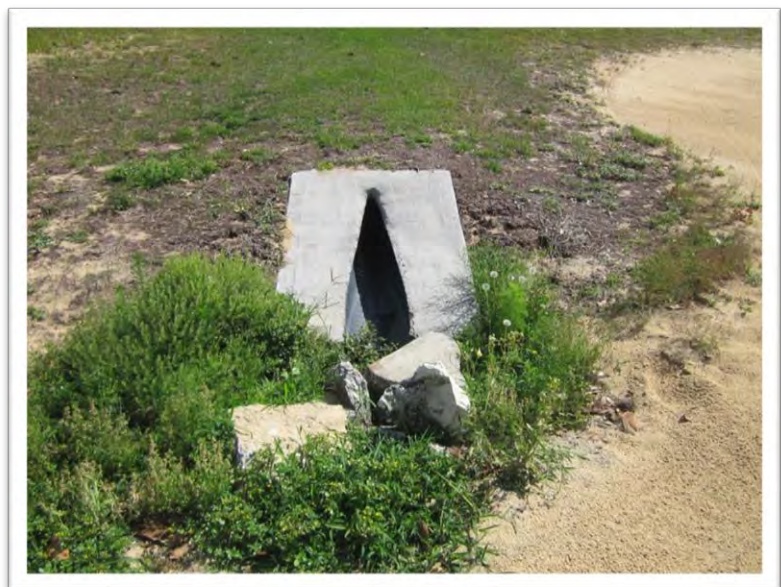
<b>Photograph No.</b>
42
<b>Photographer Location:</b>
Pond P-15-3 (Structure A)
<b>Pond Location:</b>
Hole #6 (Green)
<b>Comments:</b>
Inflow pipe and concrete mitered end section originating from Arlington Ridge Boulevard.

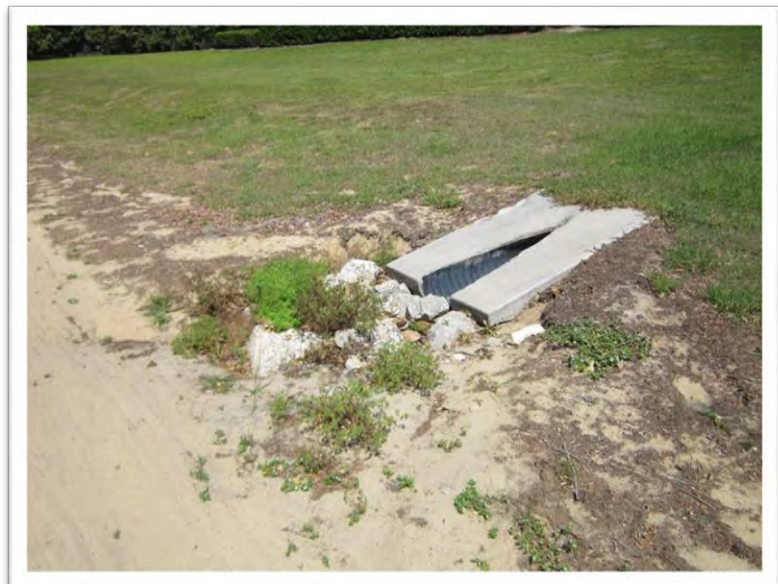
<b>Photograph No.</b>
44
<b>Photographer Location:</b>
Pond P-15-3 (Structure B)
<b>Pond Location:</b>
Hole #6 (Fairway)
<b>Comments:</b>
Inflow pipe and concrete mitered end section originating from Arlington Ridge Boulevard.

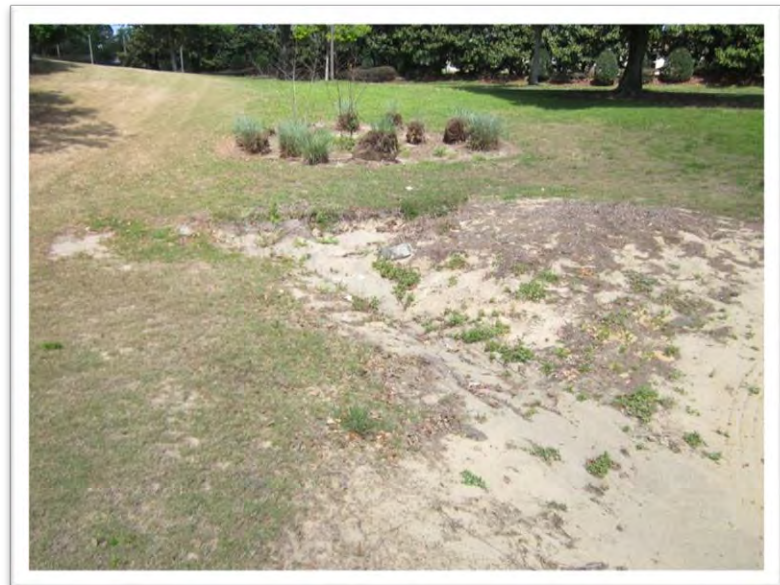
<b>Photograph No.</b>
46
<b>Photographer Location:</b>
Pond P-15-3 (Structure C)
<b>Pond Location:</b>
Hole #6 (Fairway)
<b>Comments:</b>
Inflow pipe and concrete mitered end section originating from Arlington Ridge Boulevard.

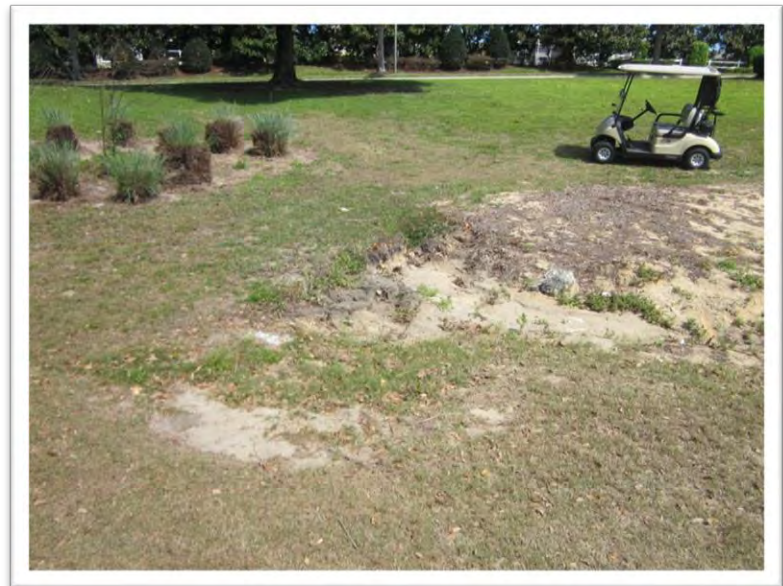
<b>Photograph No.</b>
47
<b>Photographer Location:</b>
Pond P-15-3 (Structure C)
<b>Pond Location:</b>
Hole #6 (Fairway)
<b>Comments:</b>
Note that the mitered end section and inflow pipe could not be located due to the significant erosion.

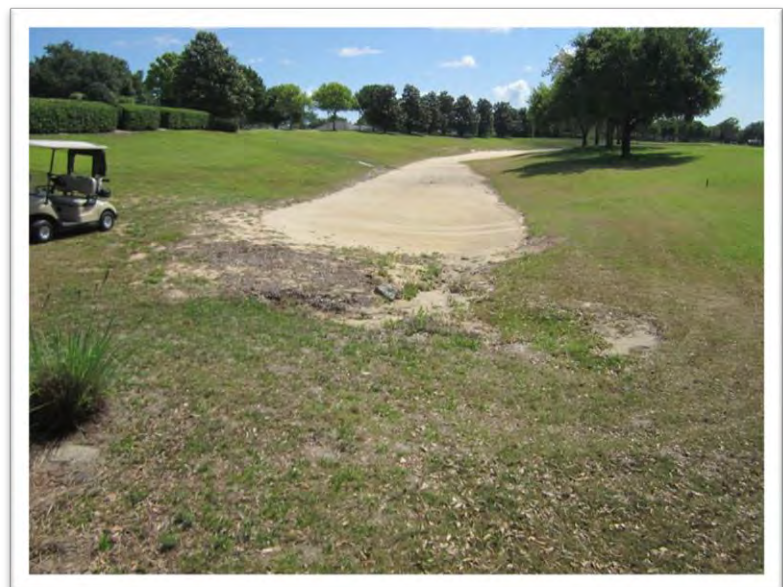
<b>Photograph No.</b>
48
<b>Photographer Location:</b>
Pond P-15-3 (Structure C)
<b>Pond Location:</b>
Hole #6 (Fairway)
<b>Comments:</b>
Need to expose the inflow pipe, re-grade, and sod area. Riprap may also be needed once the pipe is exposed and sediments removed.

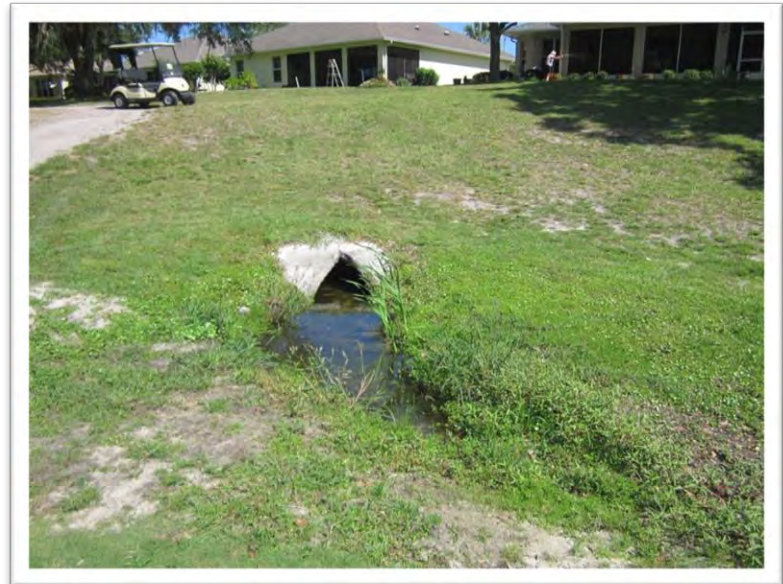
<b>Photograph No.</b>
49
<b>Photographer Location:</b>
Pond P-14-2 (Structure A)
<b>Pond Location:</b>
Hole #5 (Green)
<b>Comments:</b>
Inflow pipe and concrete mitered end section originating from the intersection of Chatham Way and Antietam Creek Trail. Inflow pipe is "sumped" below the pond bottom.

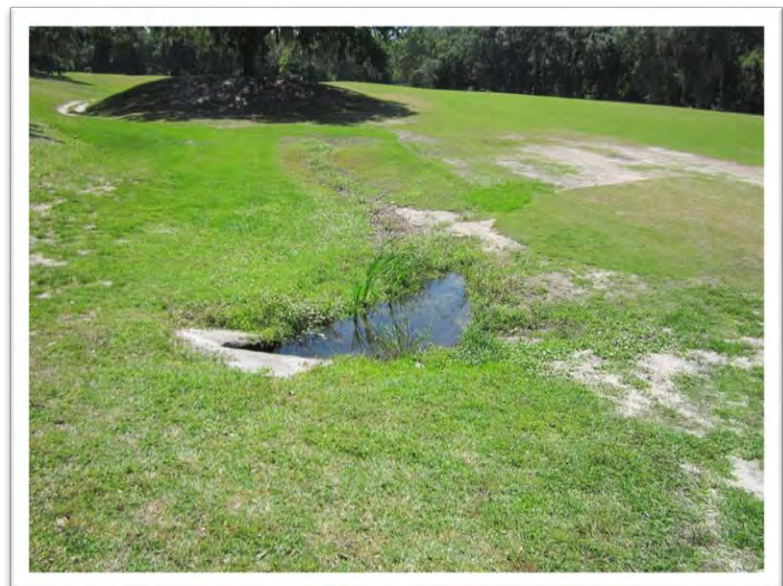
<b>Photograph No.</b>
50
<b>Photographer Location:</b>
Pond P-14-2 (Structure A)
<b>Pond Location:</b>
Hole #5 (Green)
<b>Comments:</b>
Need to re-grade to create positive drainage and eliminate the standing water in the pipe, remove the sediments within the pipe, and install concrete riprap.

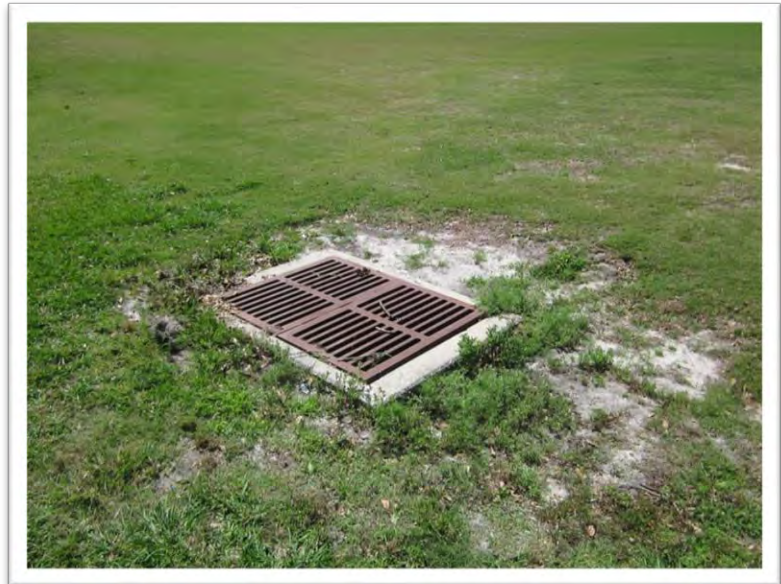
<b>Photograph No.</b>
51
<b>Photographer Location:</b>
Pond P-14-2 (Structure B)
<b>Pond Location:</b>
Hole #5 (Fairway)
<b>Comments:</b>
Type "D" ditch bottom inlet with cast iron grates (control structure for pond). Need to review the permitted construction plans to confirm the top of grade elevation with respect to pond bottom.
