**ARLINGTON RIDGE  
COMMUNITY DEVELOPMENT DISTRICT**

## PROJECT MEMORANDUM

**Subject:** **Annual Inspection Report**

The purpose of this Project Memorandum is to document the annual site inspection associated with the Stormwater Management System (i.e., stormwater ponds, control structures, outfall pipes, and inflow pipes), as well as rights-of-way (roadways) and golf course. In addition, this Project Memorandum will also recommend the immediate drainage maintenance improvements (i.e., this current fiscal year) and the short-term drainage maintenance improvements (Fiscal Year 2022/2023).

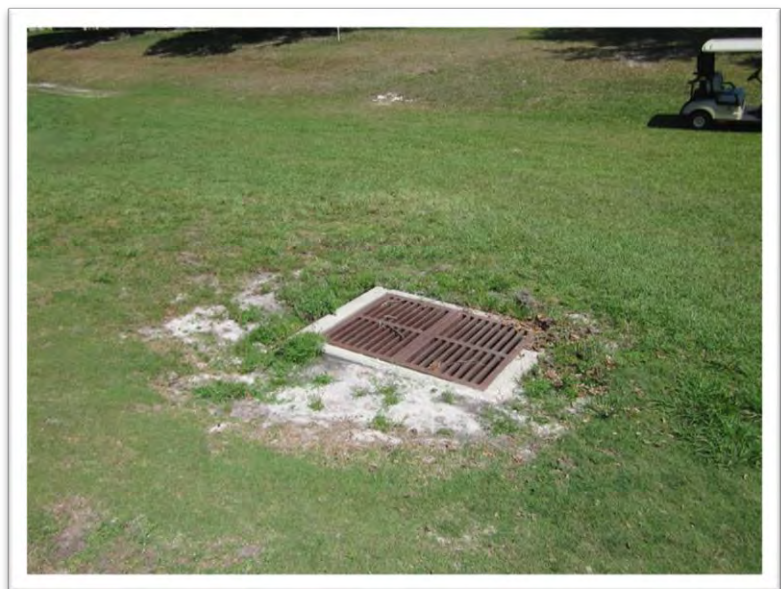
<b>Photograph No.</b>
52
<b>Photographer Location:</b>
Pond P-14-2 (Structure B)
<b>Pond Location:</b>
Hole #5 (Fairway)
<b>Comments:</b>
Minor erosion on two sides of the control structure. Need to backfill, compact, and sod.

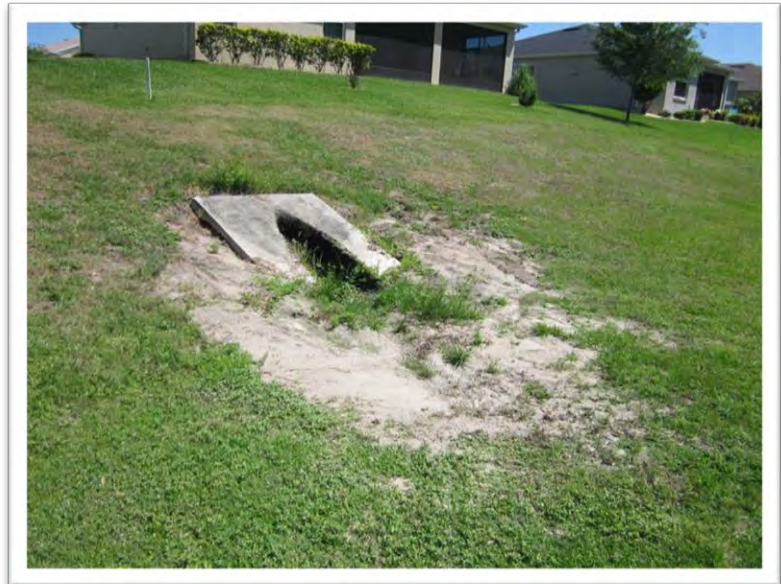
<b>Photograph No.</b>
53
<b>Photographer Location:</b>
Pond P-14-1 (Structure D)
<b>Pond Location:</b>
Hole #5 (Fairway)
<b>Comments:</b>
Inflow pipe and concrete mitered end section from Antietam Creek Trail. Note that all three sides of the mitered end section are experiencing erosion and undermining.

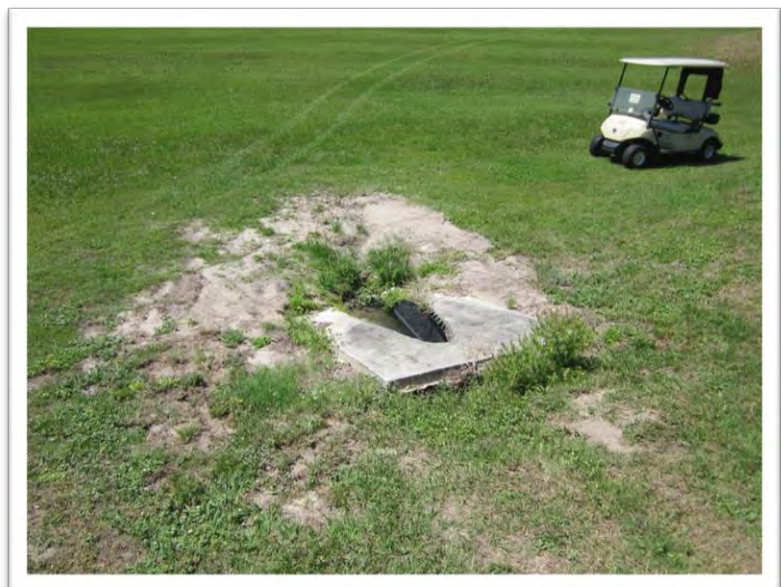
<b>Photograph No.</b>
54
<b>Photographer Location:</b>
Pond P-14-1 (Structure D)
<b>Pond Location:</b>
Hole #5 (Fairway)
<b>Comments:</b>
Backfill, compact, and sod all three sides of the mitered end section. Also, remove sediments within pipe, re-grade outlet, and install concrete riprap.

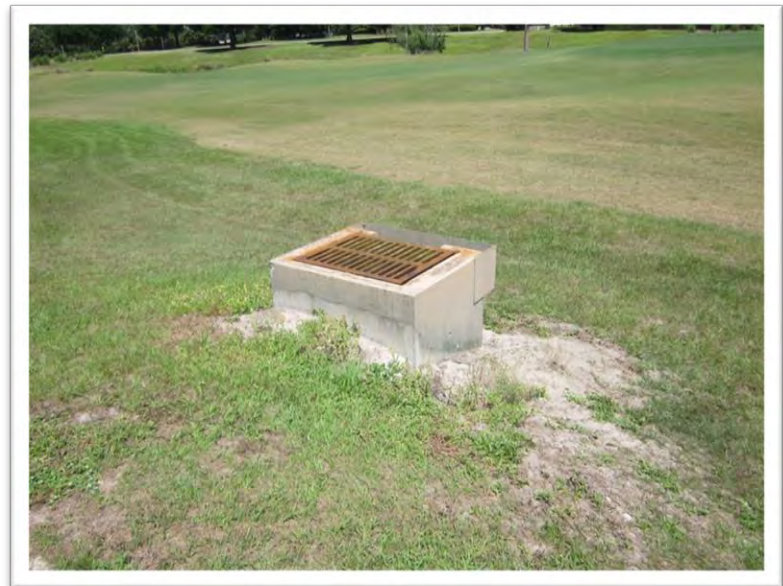
<b>Photograph No.</b>
55
<b>Photographer Location:</b>
Pond P-13-1 (Structure A)
<b>Pond Location:</b>
Hole #4 (south of Green)
<b>Comments:</b>
Type "C" ditch bottom inlet with skimmer blade (control structure).

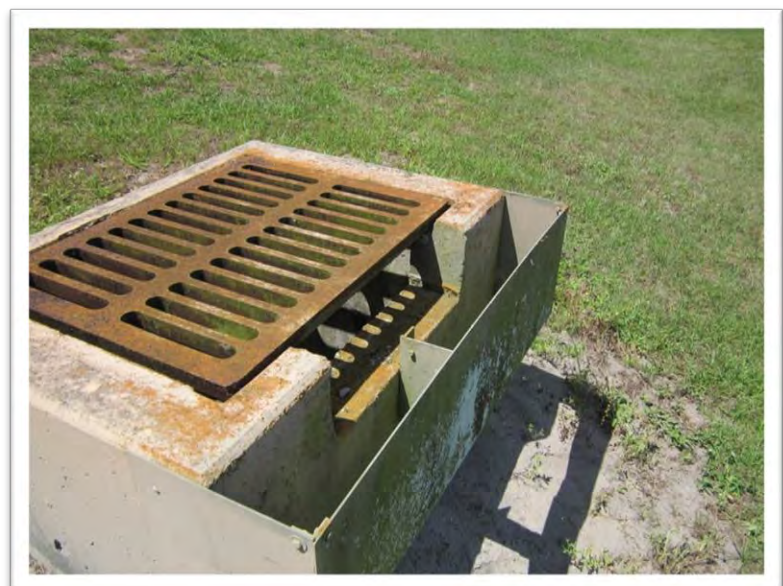
<b>Photograph No.</b>
56
<b>Photographer Location:</b>
Pond P-13-1 (Structure A)
<b>Pond Location:</b>
Hole #4 (south of Green)
<b>Comments:</b>
24-inch wide weir opening. The weir opening is 8-inches below the cast iron grate.

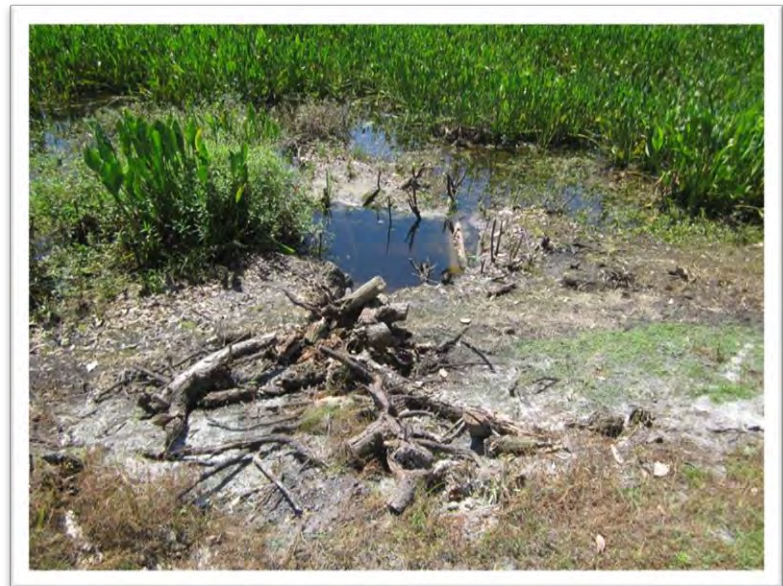
<b>Photograph No.</b>
59
<b>Photographer Location:</b>
Pond P-13-1 (Structure B)
<b>Pond Location:</b>
Hole #4 (northwest of Green)
<b>Comments:</b>
Need to remove landscape debris and sediments to expose the outlet.

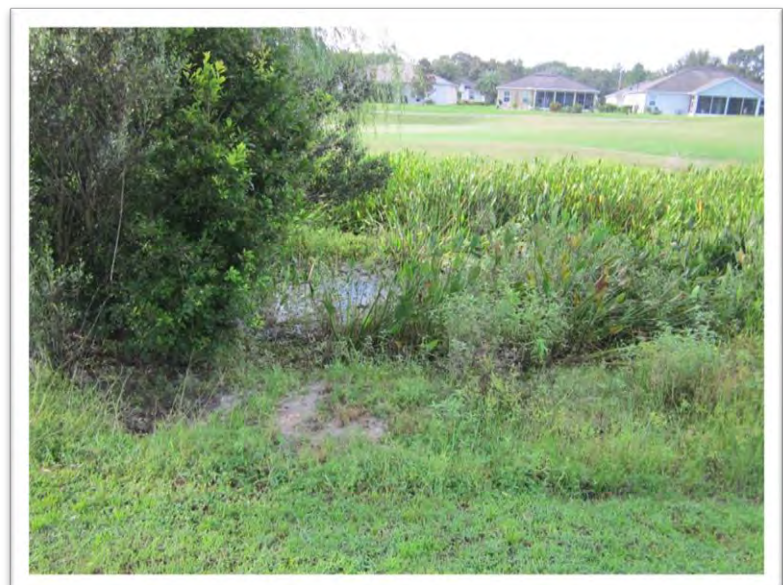
<b>Photograph No.</b>
60
<b>Photographer Location:</b>
Pond P-13-1 (Structure C)
<b>Pond Location:</b>
Hole #4 (northwest of Green)
<b>Comments:</b>
Note Structure C could not be located. Need to locate and expose the outlet.

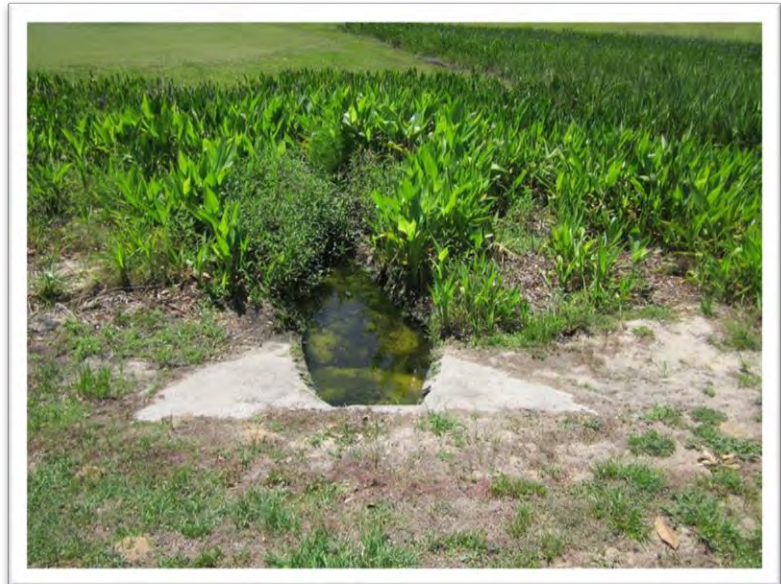
<b>Photograph No.</b>
61
<b>Photographer Location:</b>
Pond P-12-2 (Structure A)
<b>Pond Location:</b>
Hole #3 (Fairway)
<b>Comments:</b>
Inflow pipe and concrete mitered end section originating from Independence Trail.

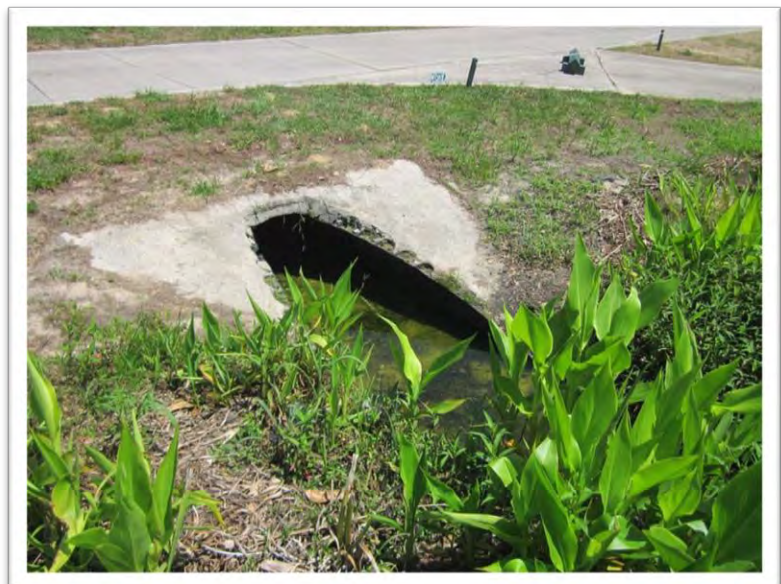
<b>Photograph No.</b>
62
<b>Photographer Location:</b>
Pond P-12-2 (Structure A)
<b>Pond Location:</b>
Hole #3 (Fairway)
<b>Comments:</b>
Inflow pipe slightly submerged. Remove sediments during dry season.

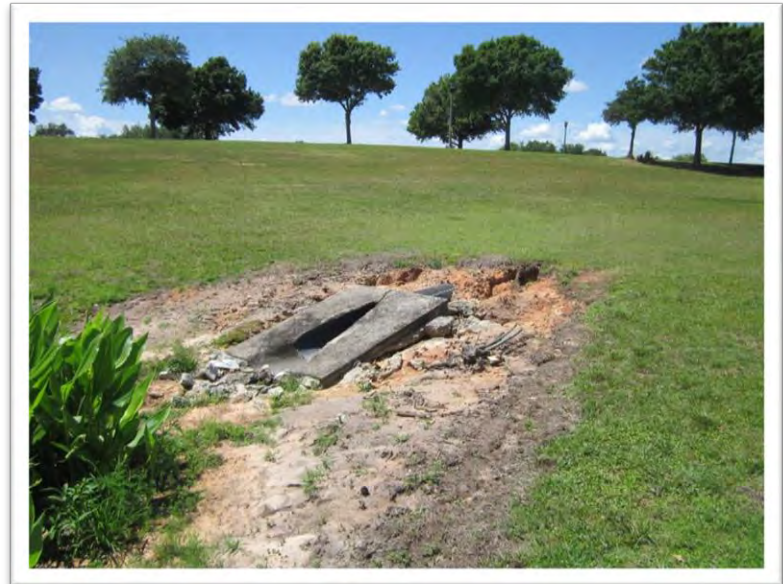
<b>Photograph No.</b>
63
<b>Photographer Location:</b>
Pond P-12-2 (Structure B)
<b>Pond Location:</b>
Hole #3 (Fairway)
<b>Comments:</b>
Inflow pipe and concrete mitered end section originating from Arlington Ridge Boulevard.

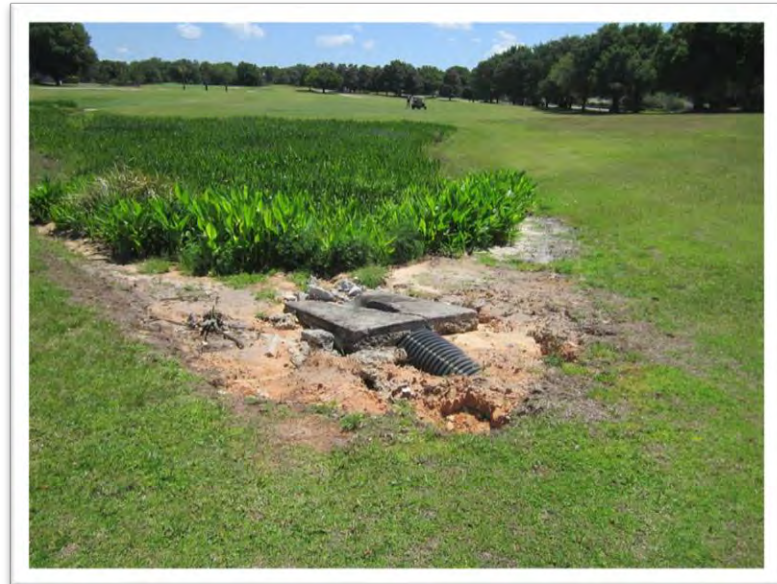
<b>Photograph No.</b>
65
<b>Photographer Location:</b>
Pond P-12-2 (Structure B)
<b>Pond Location:</b>
Hole #3 (Fairway)
<b>Comments:</b>
Backfill, compact, install turf reinforcement mat, geotextile blanket, concrete riprap, and sod.

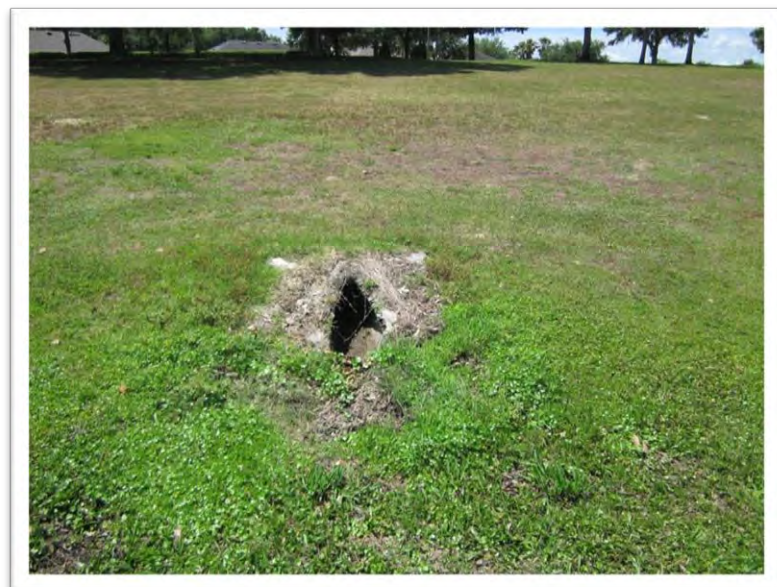
<b>Photograph No.</b>
66
<b>Photographer Location:</b>
Pond P-12-2 (Structure C)
<b>Pond Location:</b>
Hole #3 (Fairway)
<b>Comments:</b>
Inflow pipe and concrete mitered end section originating from Arlington Ridge Boulevard.

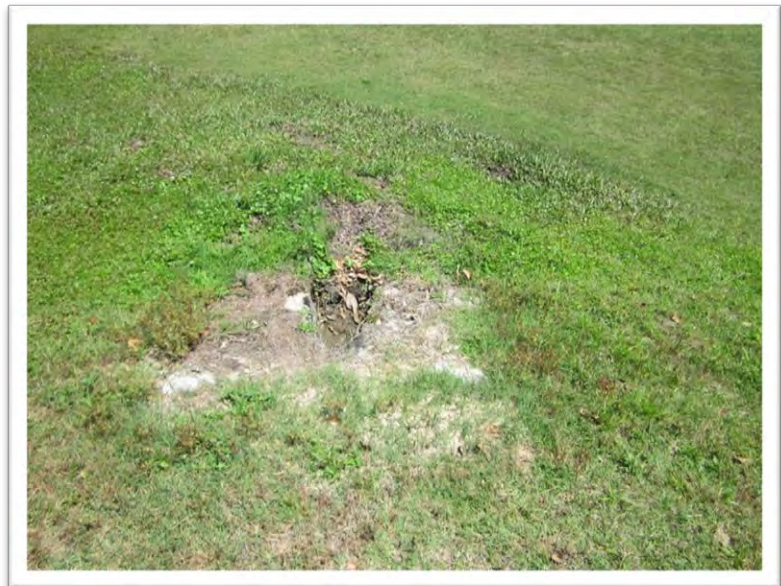
<b>Photograph No.</b>
67
<b>Photographer Location:</b>
Pond P-12-2 (Structure C)
<b>Pond Location:</b>
Hole #3 (Fairway)
<b>Comments:</b>
Remove sediments within pipe and re-grade the outlet.

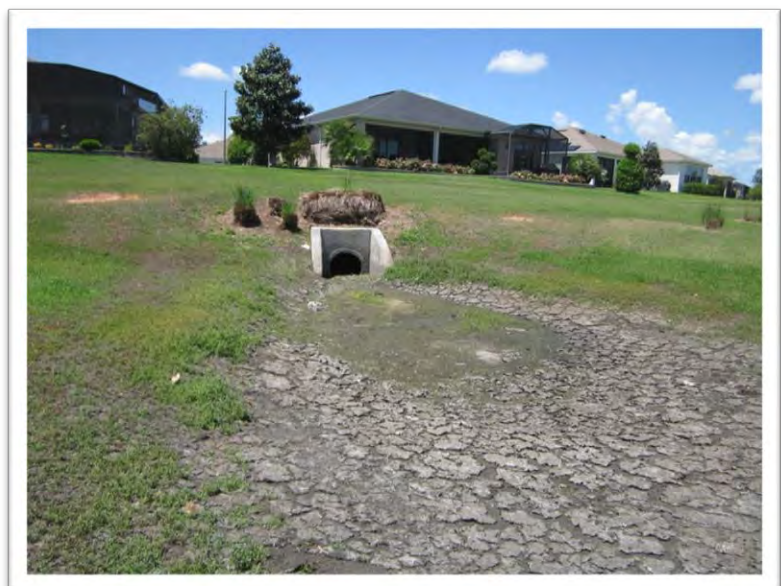
<b>Photograph No.</b>
68
<b>Photographer Location:</b>
Pond P-11-3 (Structure B)
<b>Pond Location:</b>
Hole #2 (Green)
<b>Comments:</b>
Inflow pipe and U-Type concrete endwall originating from Camerons Run.

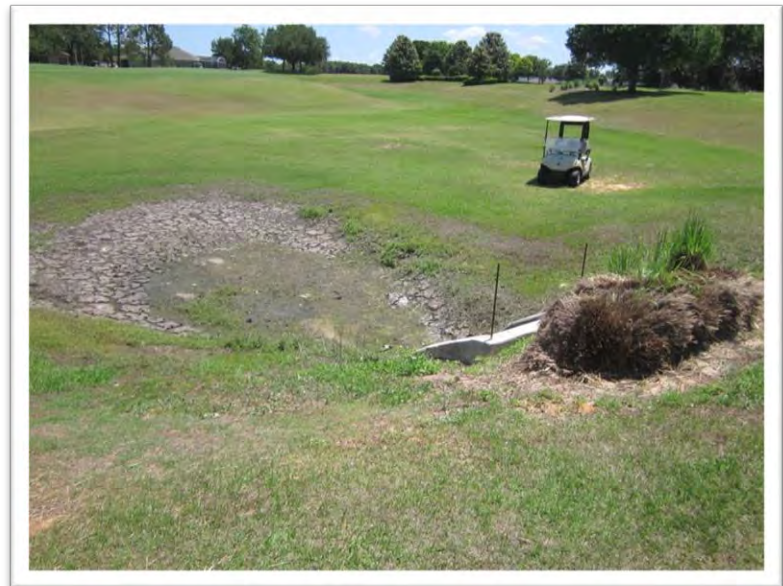
<b>Photograph No.</b>
69
<b>Photographer Location:</b>
Pond P-11-3 (Structure B)
<b>Pond Location:</b>
Hole #2 (Green)
<b>Comments:</b>
No signs of erosion and no maintenance improvements needed.

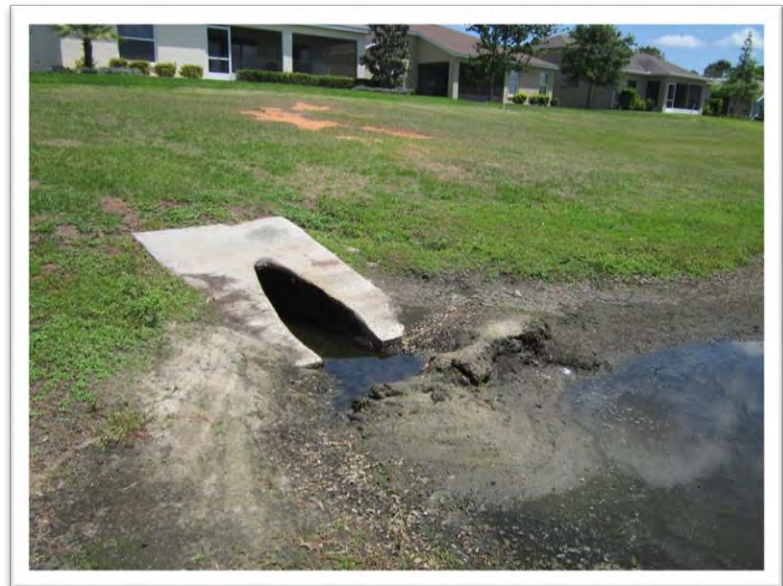
<b>Photograph No.</b>
73
<b>Photographer Location:</b>
Pond P-11-2 (Structure C)
<b>Pond Location:</b>
Hole #2 (Fairway)
<b>Comments:</b>
Inflow pipe and concrete mitered end section originating from Roanoke Drive.

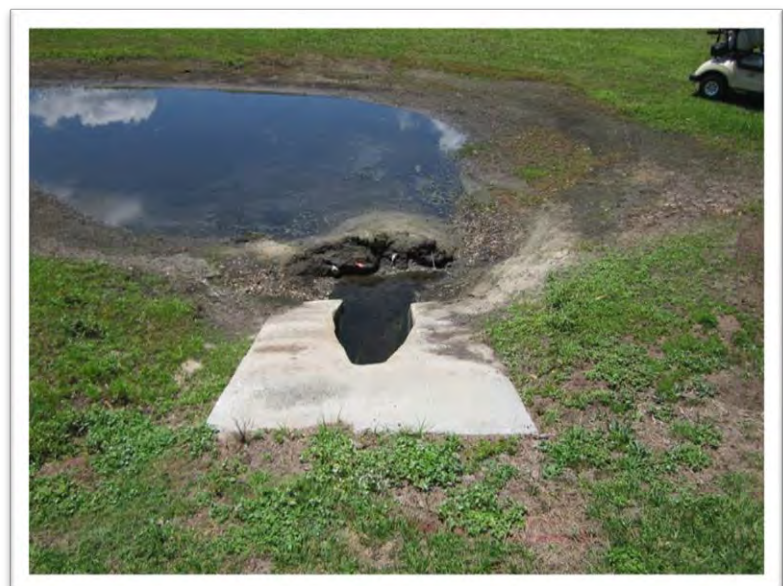
<b>Photograph No.</b>
74
<b>Photographer Location:</b>
Pond P-11-2 (Structure C)
<b>Pond Location:</b>
Hole #2 (Fairway)
<b>Comments:</b>
Remove sediments at the outlet, re-grade, and install concrete riprap.

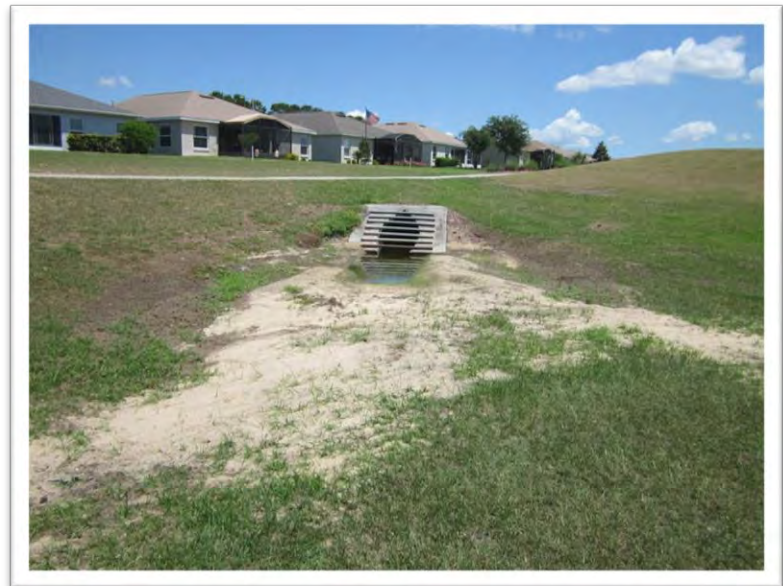
<b>Photograph No.</b>
75
<b>Photographer Location:</b>
Pond P-11-1 (Structure A)
<b>Pond Location:</b>
Hole #1 (Green) / Hole #2 (Tee)
<b>Comments:</b>
Inflow pipe at concrete mitered end section originating from Roanoke Drive and Heritage Trail.

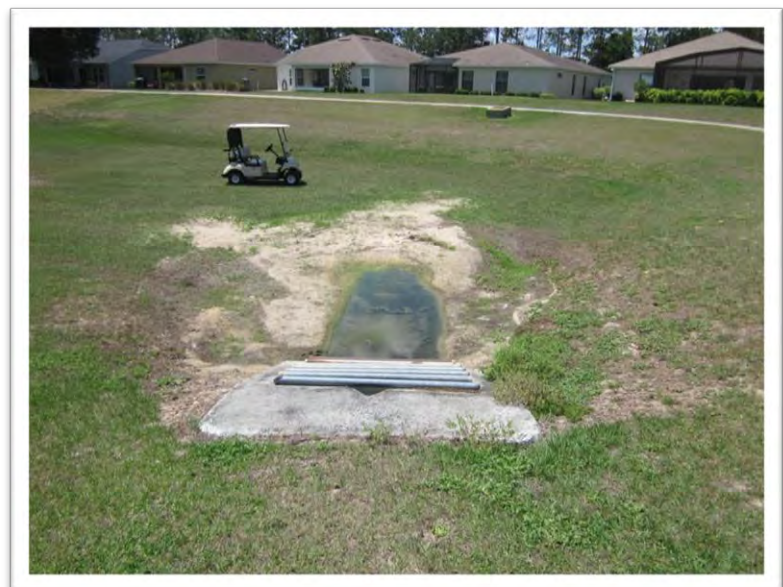
<b>Photograph No.</b>
76
<b>Photographer Location:</b>
Pond P-11-1 (Structure A)
<b>Pond Location:</b>
Hole #1 (Green) / Hole #2 (Tee)
<b>Comments:</b>
Remove sediments / re-grade pond bottom at outlet, and install concrete riprap and sod.

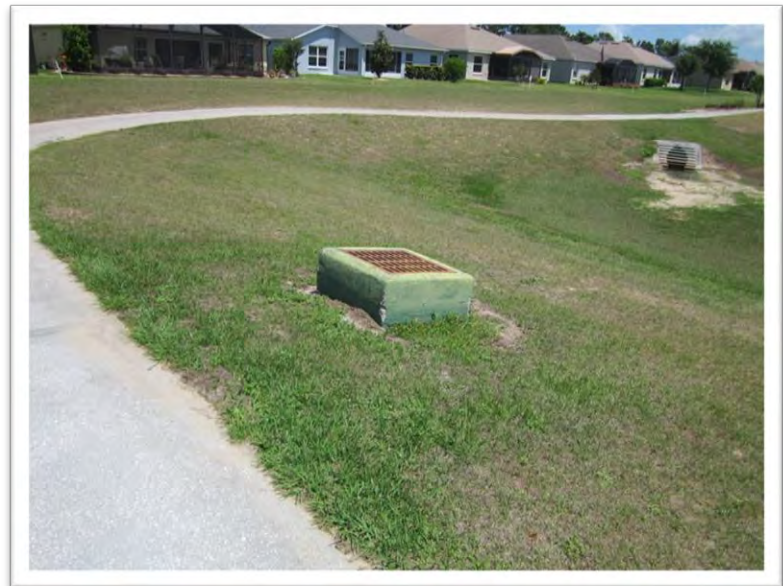
<b>Photograph No.</b>
77
<b>Photographer Location:</b>
Pond P-11-1 (Structure B)
<b>Pond Location:</b>
Hole #1 (Green) / Hole #2 (Tee)
<b>Comments:</b>
Type "D" ditch bottom inlet with no weir opening and no skimmer blade (control structure).

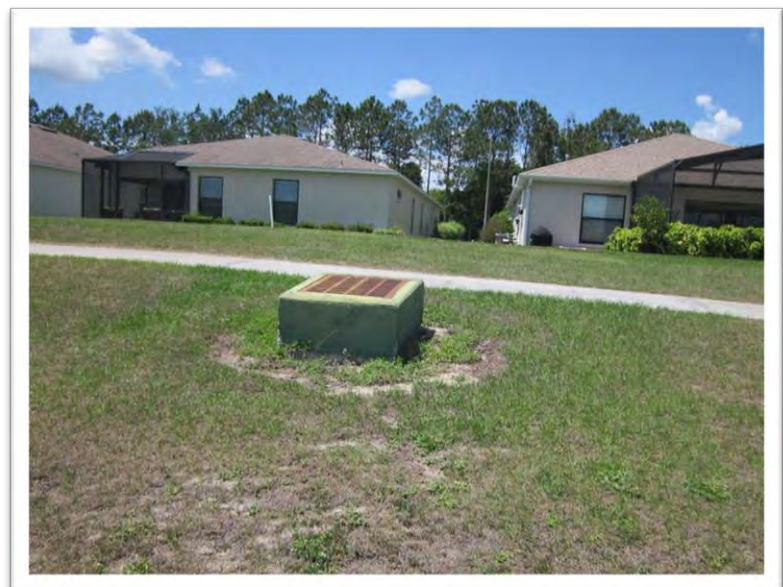
<b>Photograph No.</b>
78
<b>Photographer Location:</b>
Pond P-11-1 (Structure B)
<b>Pond Location:</b>
Hole #1 (Green) / Hole #2 (Tee)
<b>Comments:</b>
It appears this control structure eventually outfalls to Pond P-B1 (need to review the permitted construction plans to confirm).

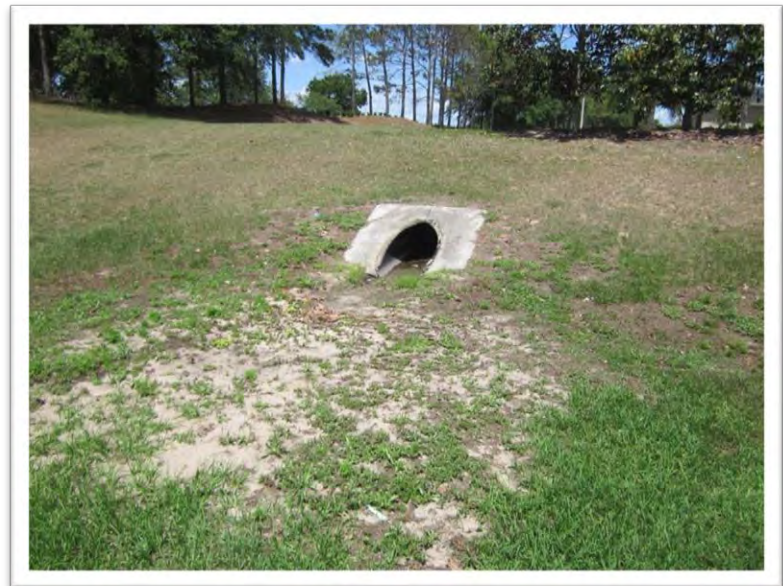
<b>Photograph No.</b>
79
<b>Photographer Location:</b>
Pond P-10-2 (Structure A)
<b>Pond Location:</b>
Hole #1 (Fairway)
<b>Comments:</b>
Inflow pipe and concrete mitered end section originating from Roanoke Drive.

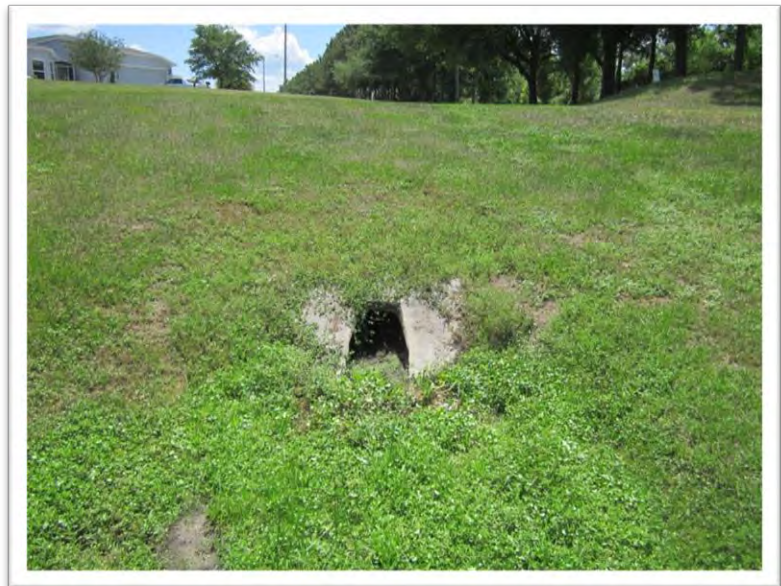
<b>Photograph No.</b>
81
<b>Photographer Location:</b>
Pond P-B1 (Structure A)
<b>Pond Location:</b>
West end of Heritage Trail
<b>Comments:</b>
Inflow pipe and concrete mitered end section originating from Roanoke Drive.

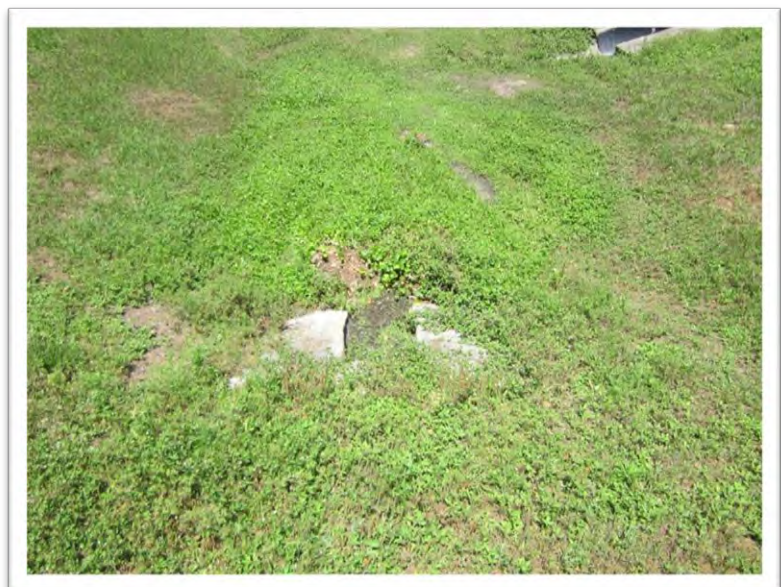
<b>Photograph No.</b>
82
<b>Photographer Location:</b>
Pond P-B1 (Structure A)
<b>Pond Location:</b>
West end of Heritage Trail
<b>Comments:</b>
Remove sediments within pipe and re-grade pond bottom at outlet.

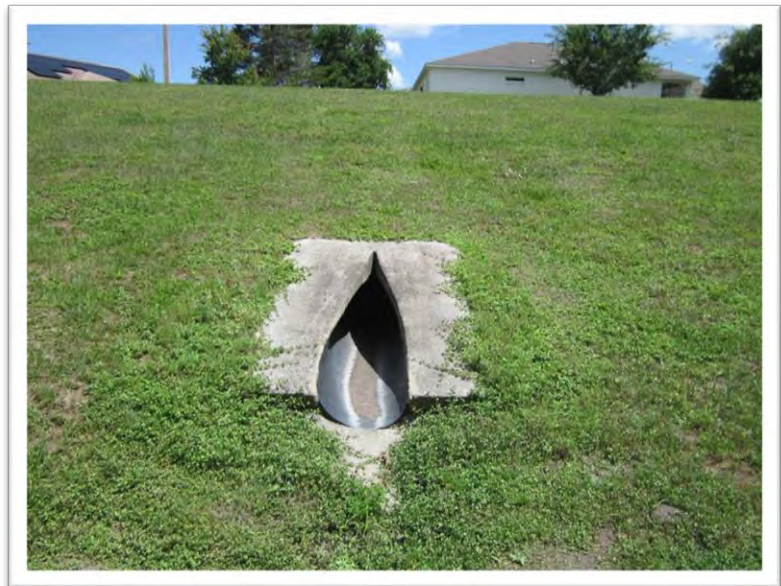
<b>Photograph No.</b>
83
<b>Photographer Location:</b>
Pond P-B1 (Structure B)
<b>Pond Location:</b>
West end of Heritage Trail
<b>Comments:</b>
Inflow pipe and concrete mitered end section originating from Heritage Trail.

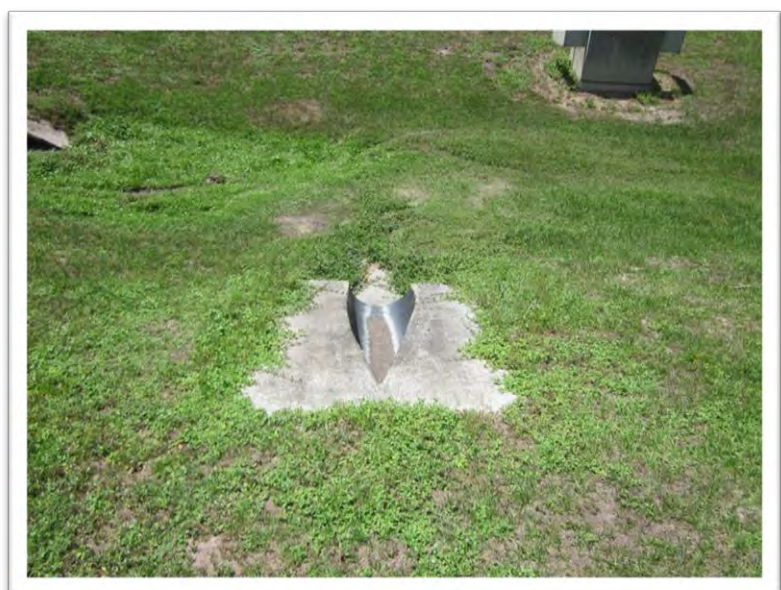
<b>Photograph No.</b>
84
<b>Photographer Location:</b>
Pond P-B1 (Structure B)
<b>Pond Location:</b>
West end of Heritage Trail
<b>Comments:</b>
No signs of erosion and no maintenance improvements needed at this time.

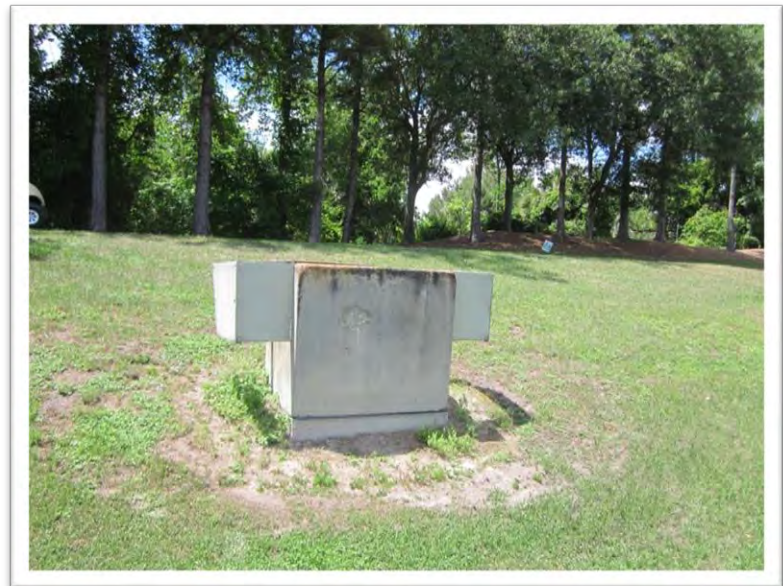
<b>Photograph No.</b>
85
<b>Photographer Location:</b>
Pond P-B1 (Structure C)
<b>Pond Location:</b>
West end of Heritage Trail
<b>Comments:</b>
Type "C" ditch bottom inlet with skimmer blade (control structure).

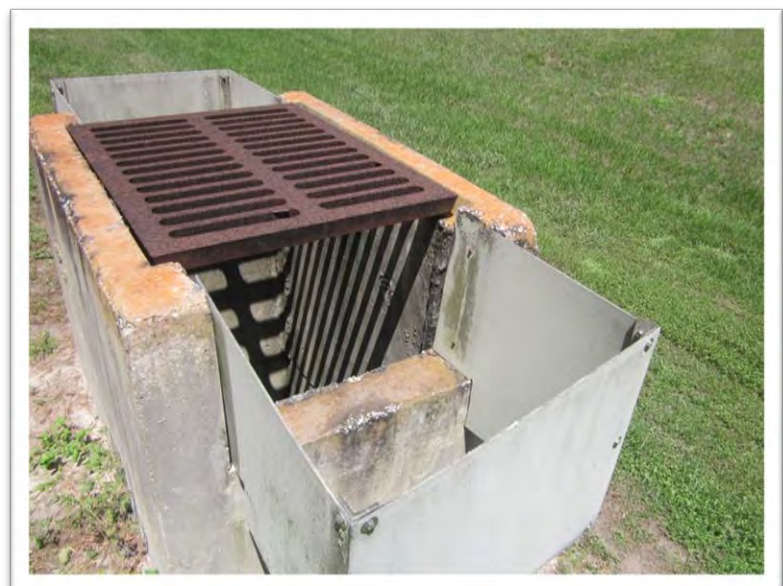
<b>Photograph No.</b>
86
<b>Photographer Location:</b>
Pond P-B1 (Structure C)
<b>Pond Location:</b>
West end of Heritage Trail
<b>Comments:</b>
25-inch wide weir openings at both ends. Weir opening 16.5-inches below the cast iron grate.

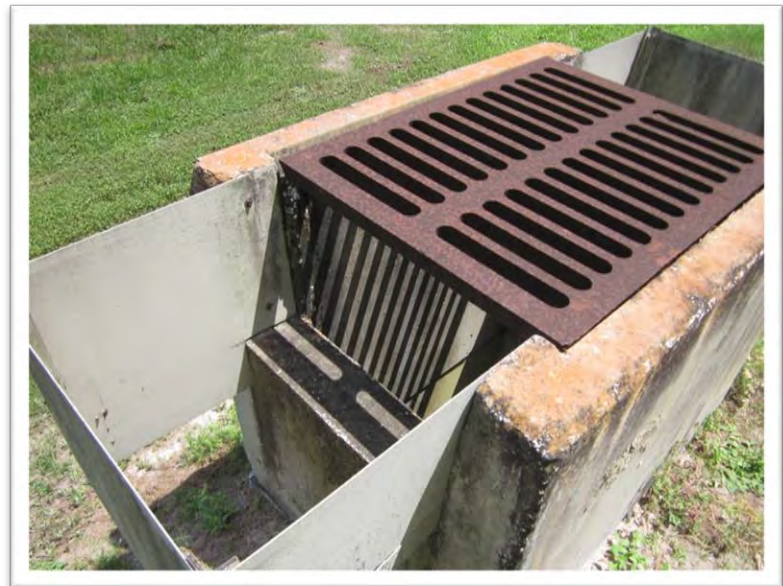
<b>Photograph No.</b>
87
<b>Photographer Location:</b>
Pond P-B1 (Structure C)
<b>Pond Location:</b>
West end of Heritage Trail
<b>Comments:</b>
25-inch wide weir openings at both ends. Weir opening 16.5-inches below the cast iron grate.

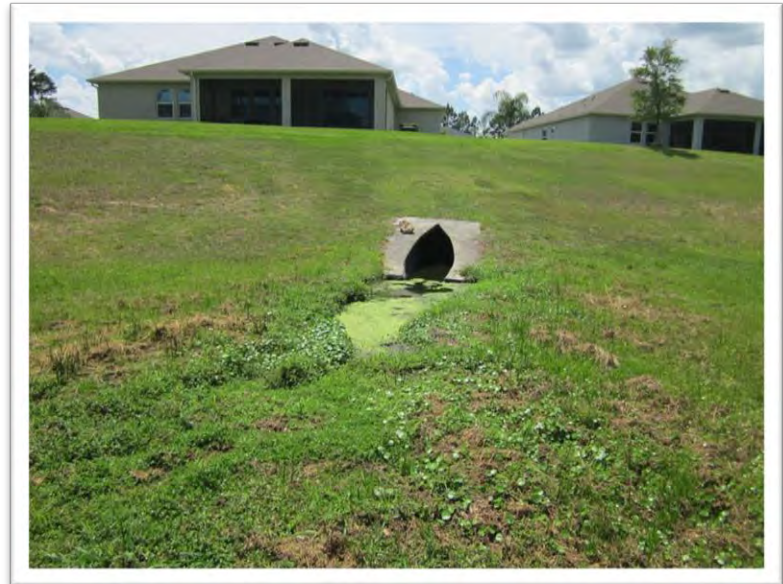
<b>Photograph No.</b>
89
<b>Photographer Location:</b>
Pond P-C1 (Structure A)
<b>Pond Location:</b>
Northeast of Heritage Trail
<b>Comments:</b>
Inflow pipe and concrete mitered end section originating from Heritage Trail.

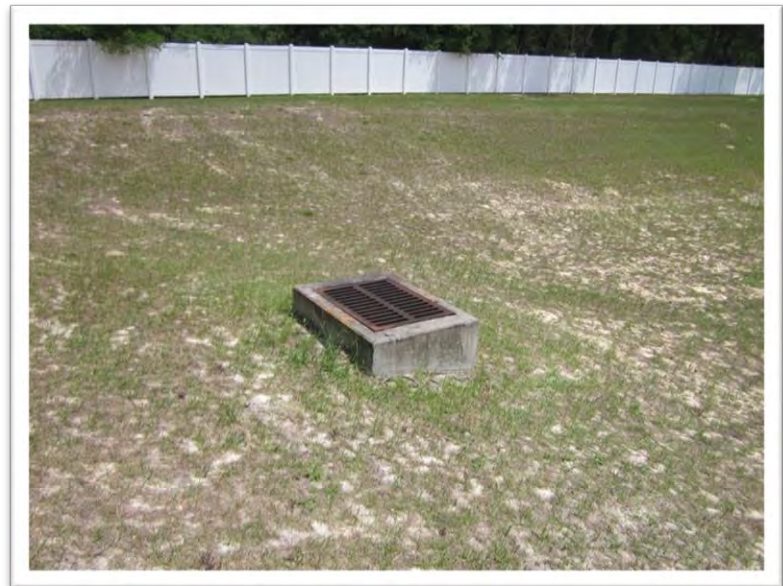
<b>Photograph No.</b>
91
<b>Photographer Location:</b>
Pond P-C1 (Structure B)
<b>Pond Location:</b>
Northeast of Heritage Trail
<b>Comments:</b>
Type "C" ditch bottom inlet with no weir opening and no skimmer blade (control structure).

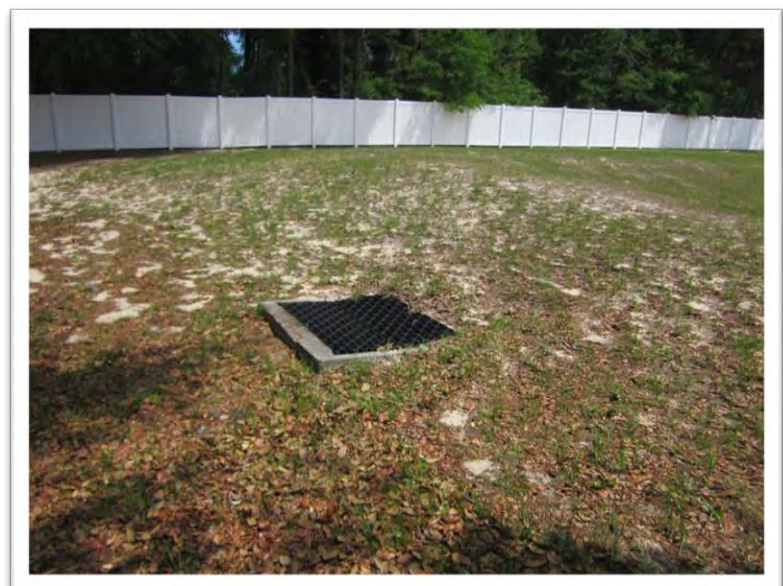
<b>Photograph No.</b>
92
<b>Photographer Location:</b>
Pond P-C1 (Structure C)
<b>Pond Location:</b>
Northeast of Heritage Trail
<b>Comments:</b>
Type "D" ditch bottom inlet downstream of the pond control structure (bubble-up structure).

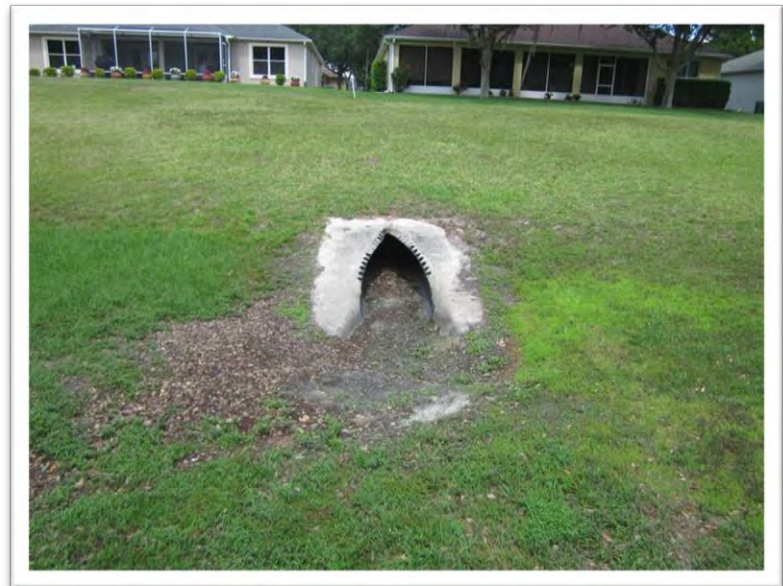
<b>Photograph No.</b>
93
<b>Photographer Location:</b>
Pond P-16-1 (Structure A)
<b>Pond Location:</b>
Hole #7 (Fairway)
<b>Comments:</b>
Inflow pipe and concrete mitered section originating from Antietam Creek Trail.

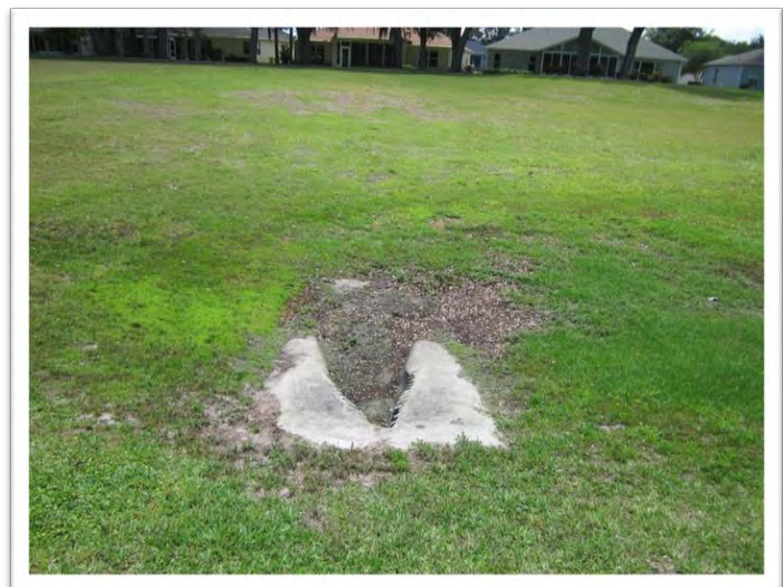
<b>Photograph No.</b>
94
<b>Photographer Location:</b>
Pond P-16-1 (Structure A)
<b>Pond Location:</b>
Hole #7 (Fairway)
<b>Comments:</b>
Minor sedimentation and erosion. Will need to monitor this location to determine possible removal of sediments and the need for concrete riprap.

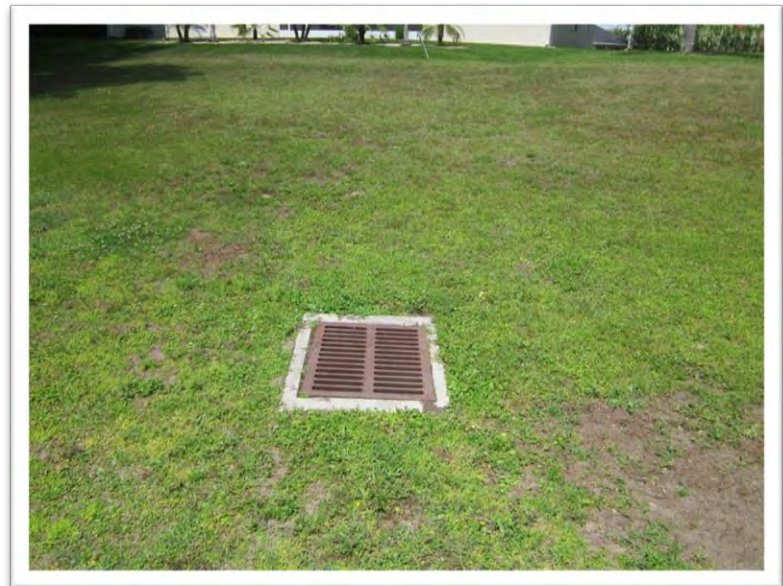
<b>Photograph No.</b>
95
<b>Photographer Location:</b>
Pond P-16-1 (Structure B)
<b>Pond Location:</b>
Hole #7 (Fairway)
<b>Comments:</b>
Type "C" ditch bottom inlet (control structure).

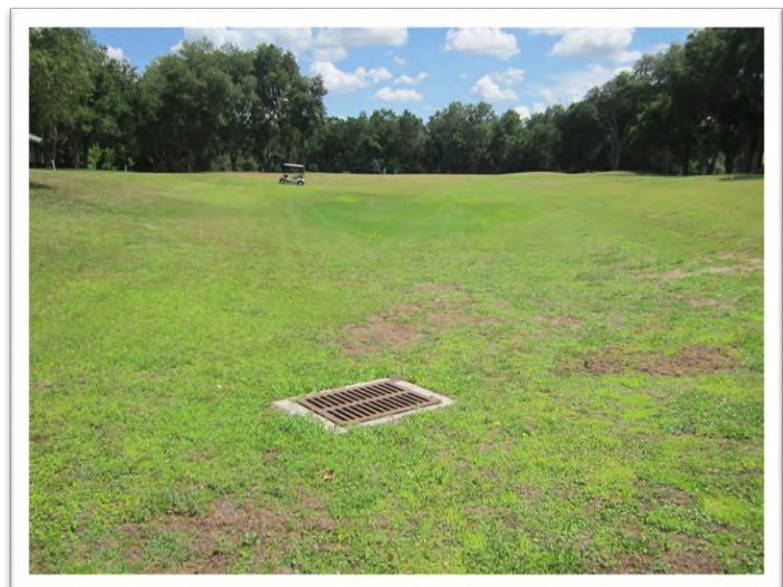
<b>Photograph No.</b>
96
<b>Photographer Location:</b>
Pond P-16-1 (Structure B)
<b>Pond Location:</b>
Hole #7 (Fairway)
<b>Comments:</b>
Need to review the permitted construction plans to confirm the top of grate elevation with respect to pond bottom.

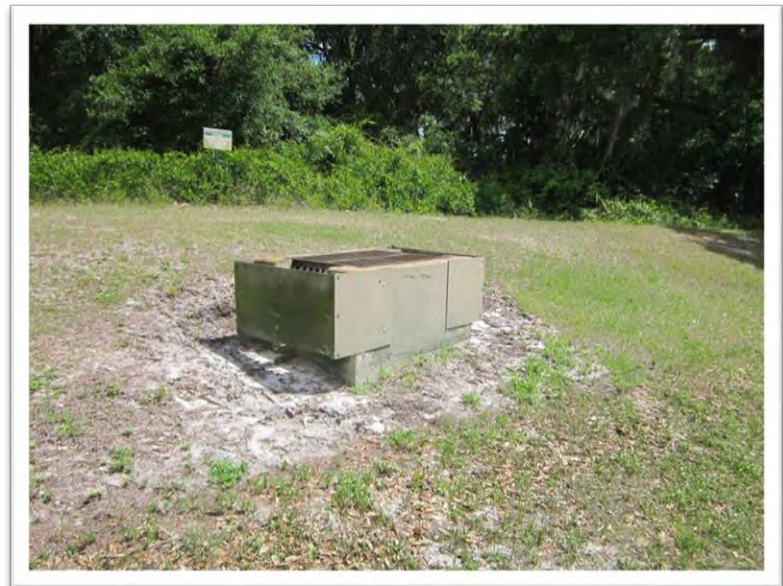
<b>Photograph No.</b>
97
<b>Photographer Location:</b>
Pond P-17-1 (Structure A)
<b>Pond Location:</b>
Hole #8 (Tee)
<b>Comments:</b>
Type "C" ditch bottom inlet with skimmer blade (control structure).

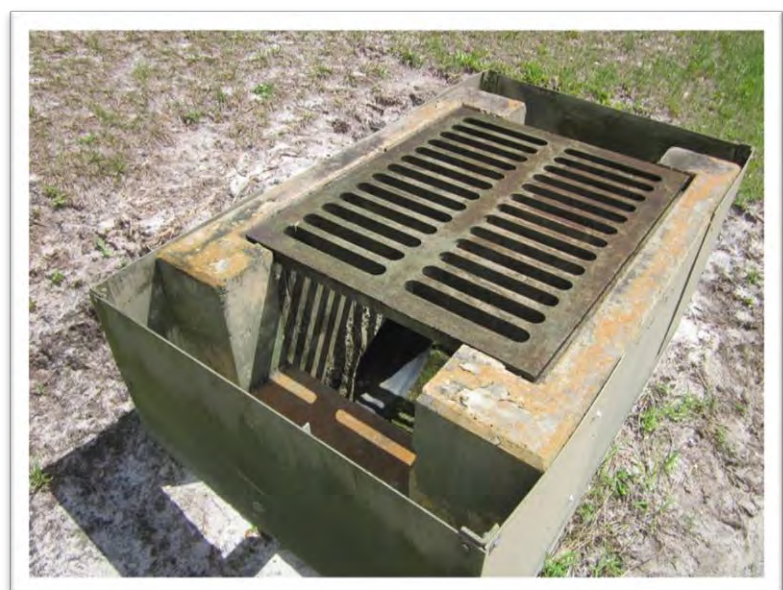
<b>Photograph No.</b>
98
<b>Photographer Location:</b>
Pond P-17-1 (Structure A)
<b>Pond Location:</b>
Hole #8 (Tee)
<b>Comments:</b>
18.5-inch wide weir opening at both ends. The weir openings are 13-inches below the cast iron grate.

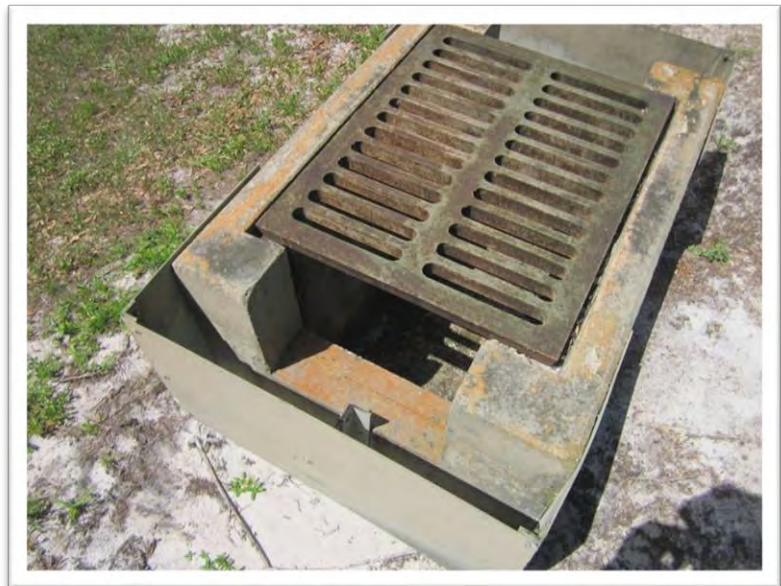
<b>Photograph No.</b>
99
<b>Photographer Location:</b>
Pond P-17-1 (Structure A)
<b>Pond Location:</b>
Hole #8 (Tee)
<b>Comments:</b>
18.5-inch wide weir opening at both ends. The weir openings are 13-inches below the cast iron grate.

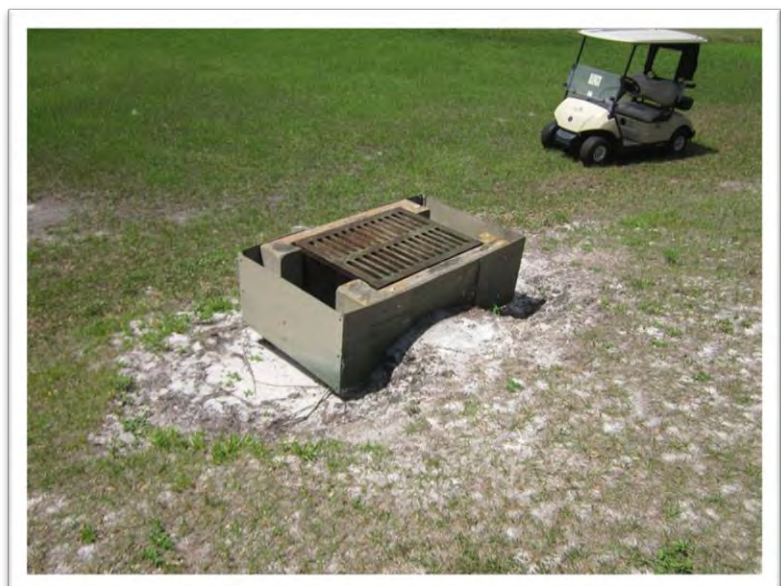
<b>Photograph No.</b>
100
<b>Photographer Location:</b>
Pond P-17-1 (Structure A)
<b>Pond Location:</b>
Hole #8 (Tee)
<b>Comments:</b>
Need to sod all four (4) sides of the control structure.

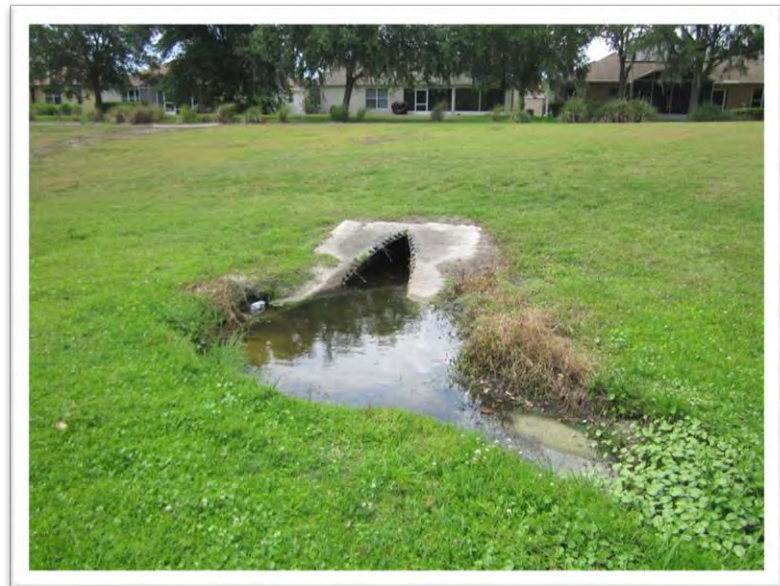
<b>Photograph No.</b>
101
<b>Photographer Location:</b>
Pond P-17-1 (Structure B)
<b>Pond Location:</b>
Hole #8 (Fairway)
<b>Comments:</b>
Inflow pipe and concrete mitered end section originating from the intersection of Bull Run and Poplar Grove Court.

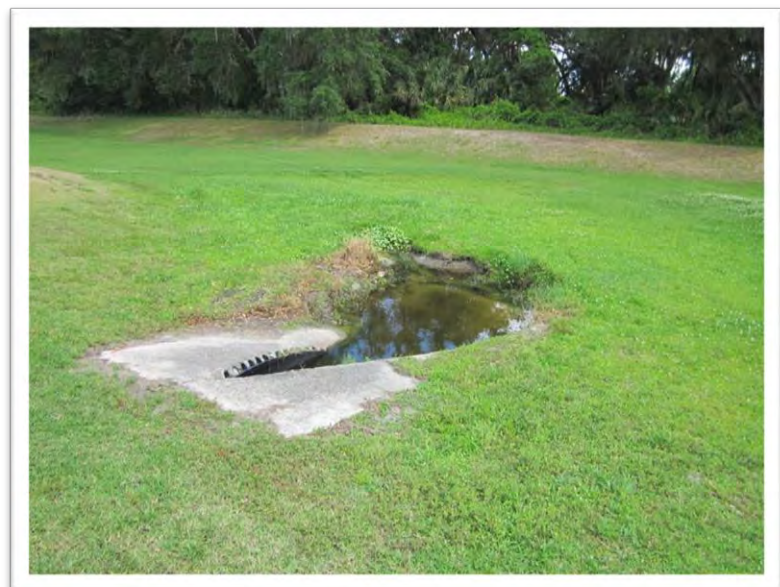
<b>Photograph No.</b>
102
<b>Photographer Location:</b>
Pond P-17-1 (Structure B)
<b>Pond Location:</b>
Hole #8 (Fairway)
<b>Comments:</b>
Need to re-grade to create positive drainage and eliminate the standing water in the pipe, remove the sediments within the pipe, and add install concrete riprap.

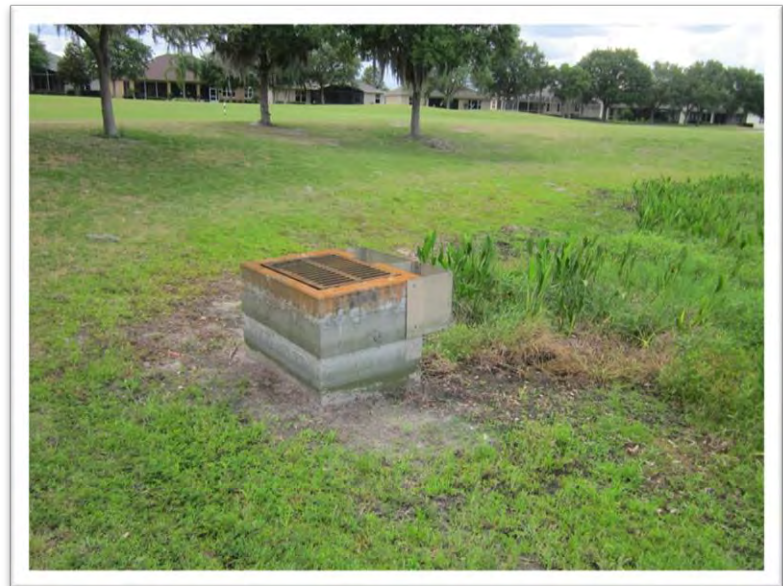
<b>Photograph No.</b>
103
<b>Photographer Location:</b>
Pond P-17-3 (Structure A)
<b>Pond Location:</b>
Hole #8 (Green)
<b>Comments:</b>
Type "C" ditch bottom inlet with skimmer blade (control structure).
