**ARLINGTON RIDGE  
COMMUNITY DEVELOPMENT DISTRICT**

## PROJECT MEMORANDUM

**Subject:** **Annual Inspection Report**

The purpose of this Project Memorandum is to document the annual site inspection associated with the Stormwater Management System (i.e., stormwater ponds, control structures, outfall pipes, and inflow pipes), as well as rights-of-way (roadways) and golf course. In addition, this Project Memorandum will also recommend the immediate drainage maintenance improvements (i.e., this current fiscal year) and the short-term drainage maintenance improvements (Fiscal Year 2022/2023).

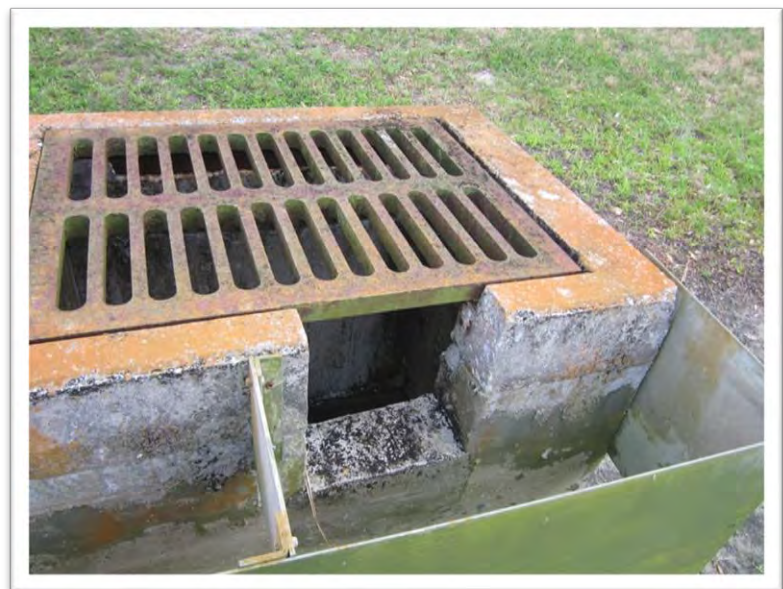
<b>Photograph No.</b>
104
<b>Photographer Location:</b>
Pond P-17-3 (Structure A)
<b>Pond Location:</b>
Hole #8 (Green)
<b>Comments:</b>
12.5-inch weir opening. The weir opening 13-inches below the cast iron grate.

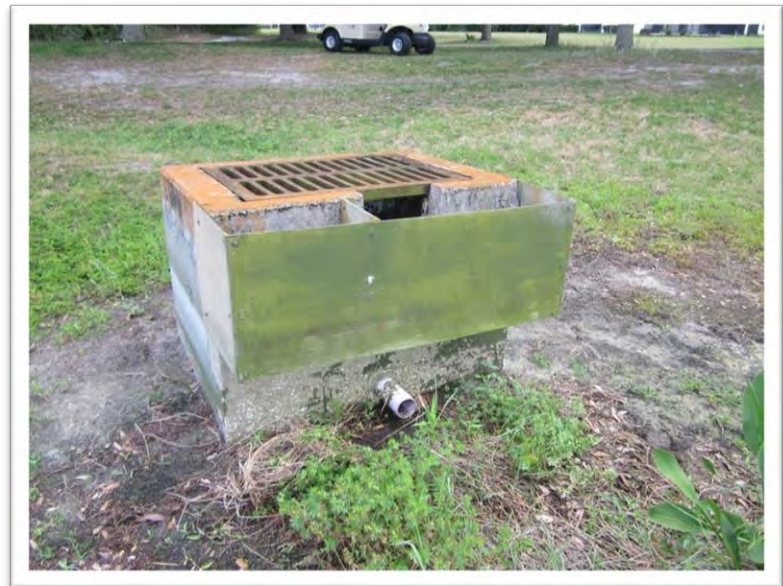
<b>Photograph No.</b>
105
<b>Photographer Location:</b>
Pond P-17-3 (Structure A)
<b>Pond Location:</b>
Hole #8 (Green)
<b>Comments:</b>
3-inch PVC bleed-down orifice 16-inches below the weir opening (confirm if the orifice was permitted).

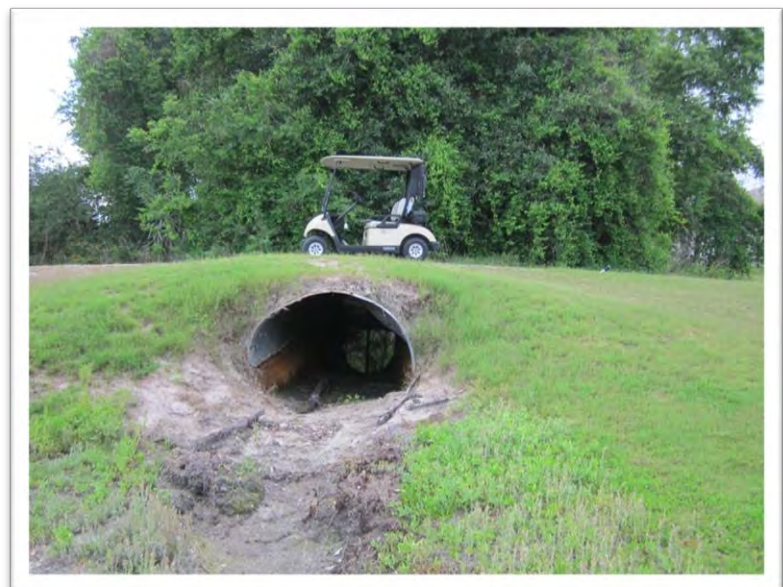
<b>Photograph No.</b>
106
<b>Photographer Location:</b>
Hole #9 (Tee)
<b>Pond Location:</b>
N/A
<b>Comments:</b>
66-inch CMP culvert under cart path. Note the inside of the culvert has deformed.

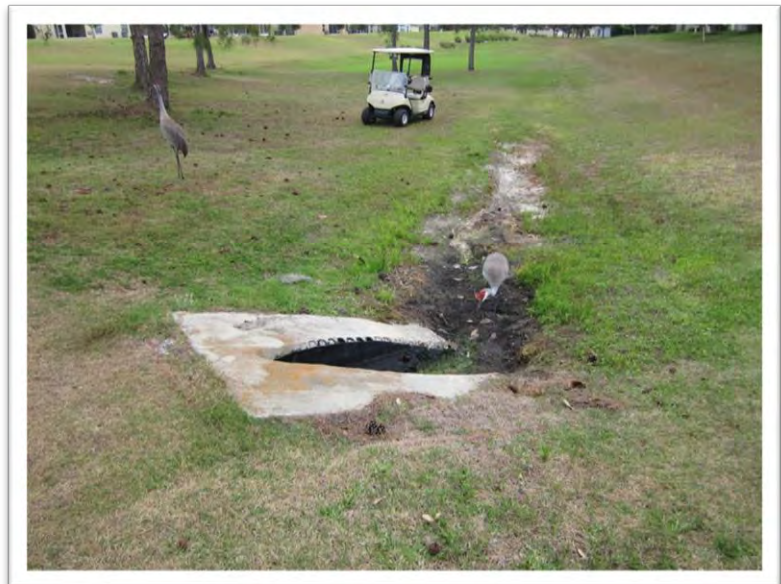
<b>Photograph No.</b>
4
<b>Photographer Location:</b>
Pond P-1-1 (Structure A)
<b>Pond Location:</b>
Hole #10 (Tee Box)
<b>Comments:</b>
Remove sediments within pipe, re-grade, and add concrete riprap.

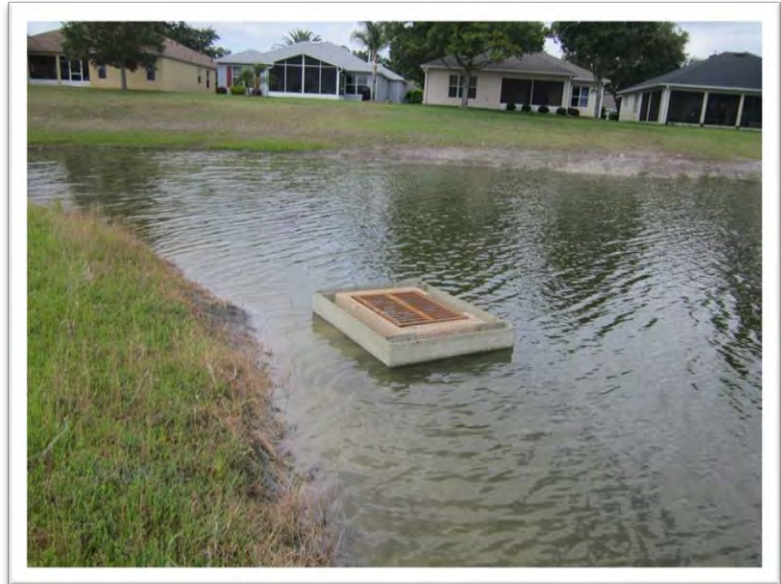
<b>Photograph No.</b>
5
<b>Photographer Location:</b>
Pond P-1-3 (Structure A)
<b>Pond Location:</b>
Hole #10 (Green)
<b>Comments:</b>
Type "C" ditch bottom inlet with skimmer blade (control structure).

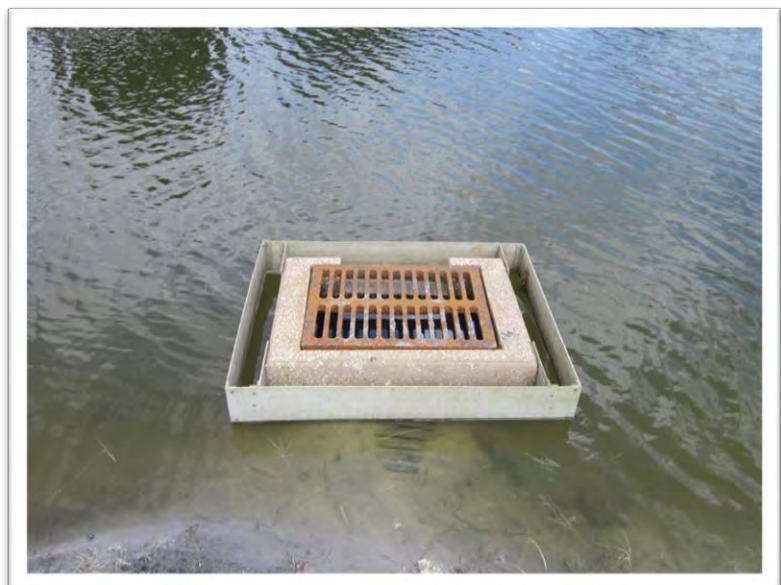
<b>Photograph No.</b>
6
<b>Photographer Location:</b>
Pond P-1-3 (Structure A)
<b>Pond Location:</b>
Hole #10 (Green)
<b>Comments:</b>
24-inch wide weir opening. The weir opening is 6-inches below the cast iron grate.

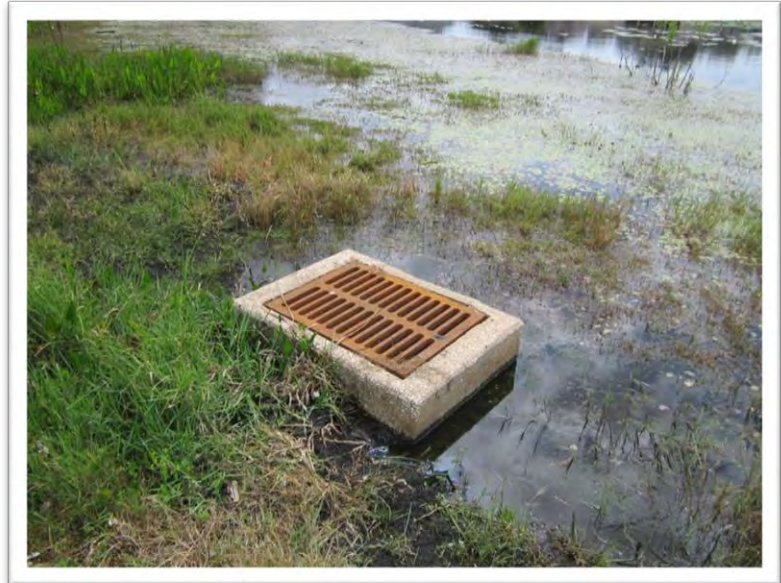
<b>Photograph No.</b>
7
<b>Photographer Location:</b>
Pond P-1-3 (Structure B)
<b>Pond Location:</b>
Hole #10 (Green)
<b>Comments:</b>
Type "C" ditch bottom inlet (bubble-up structure) located within the conservation area.

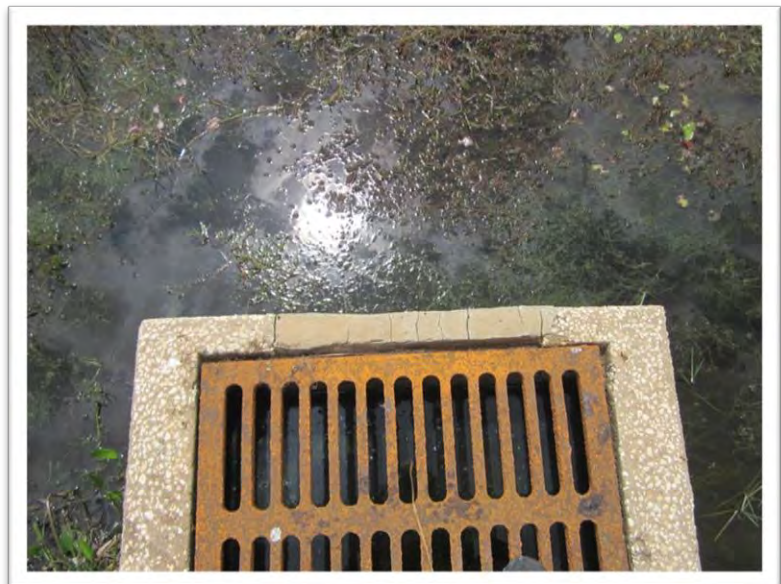
<b>Photograph No.</b>
8
<b>Photographer Location:</b>
Pond P-1-3 (Structure B)
<b>Pond Location:</b>
Hole #10 (Green)
<b>Comments:</b>
It appears the weir opening has been filled-in with concrete (refer to the permitted construction plans).

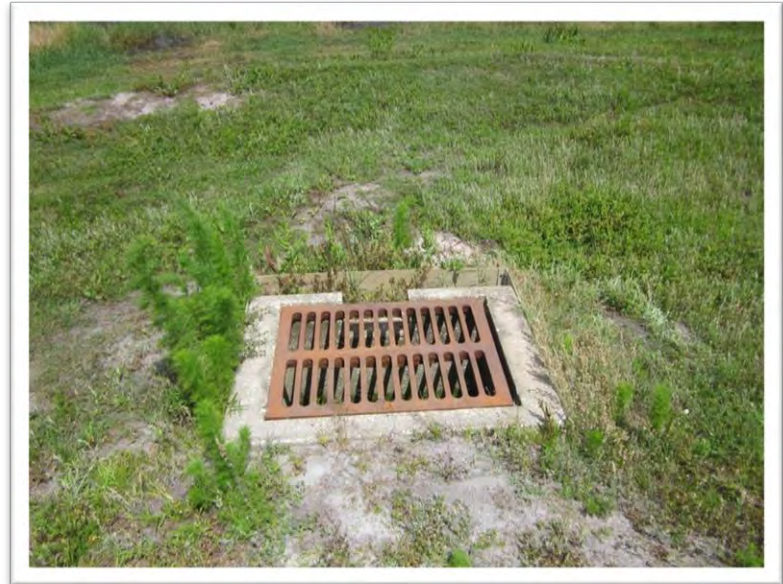
<b>Photograph No.</b>
9
<b>Photographer Location:</b>
Conservation Area (Structure C)
<b>Pond Location:</b>
Hole #10 (Green)
<b>Comments:</b>
Type "C" ditch bottom inlet with skimmer blade (control structure). <b>Need to remove the vegetation adjacent to the structure, as well as in front of and behind the skimmer blade.</b>

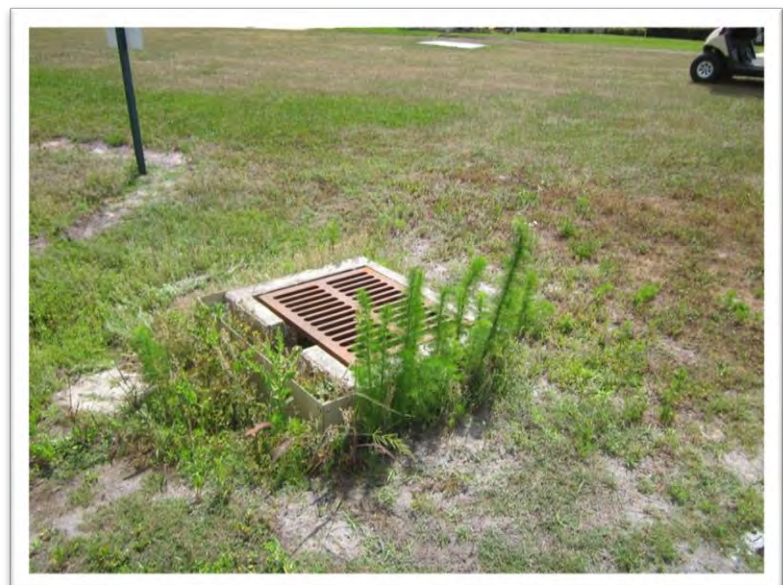
<b>Photograph No.</b>
10
<b>Photographer Location:</b>
Conservation Area (Structure C)
<b>Pond Location:</b>
Hole #10 (Green)
<b>Comments:</b>
12-inch wide weir opening. The weir opening is 6-inches below the cast iron grate.

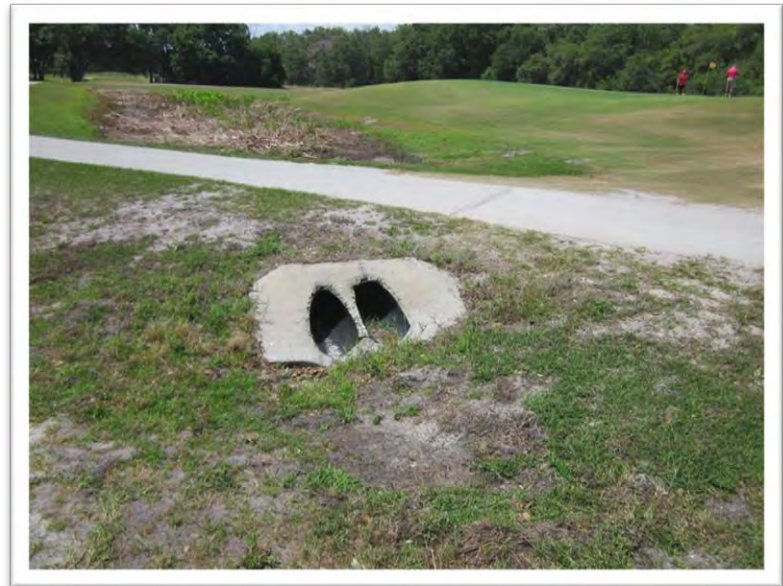
<b>Photograph No.</b>
11
<b>Photographer Location:</b>
Pond P-2-1 (Structure A)
<b>Pond Location:</b>
Hole #11 (Green)
<b>Comments:</b>
Concrete mitered end section associated with double 12-inch HDPE culverts under the cart path.

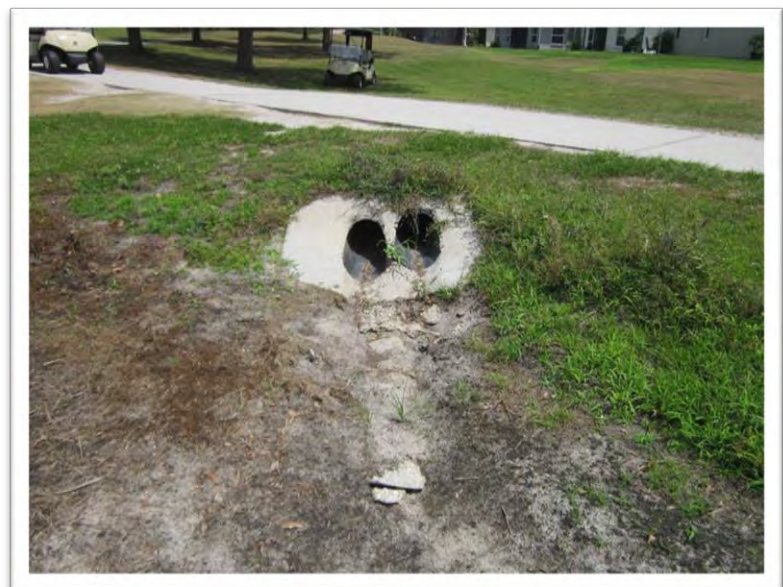
<b>Photograph No.</b>
12
<b>Photographer Location:</b>
Pond P-2-3 (Structure A)
<b>Pond Location:</b>
Hole #11 (Green)
<b>Comments:</b>
Concrete mitered end section associated with double 12-inch HDPE culverts under the cart path.

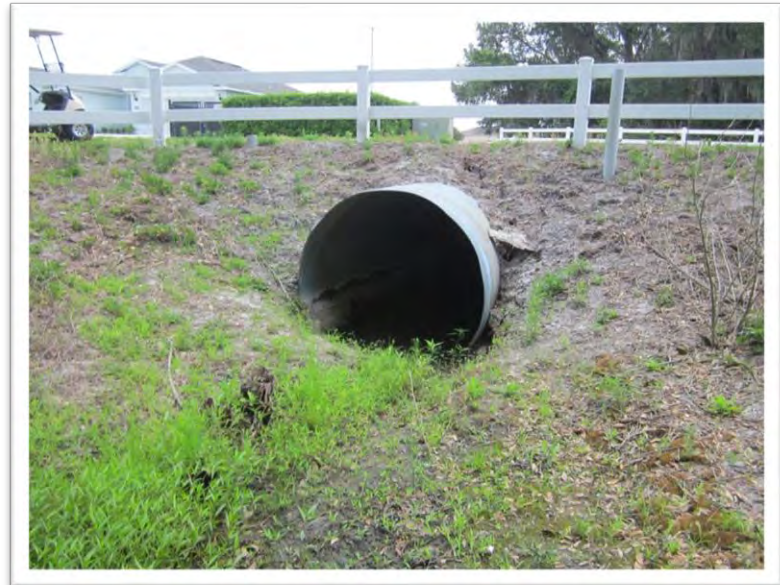
<b>Photograph No.</b>
13
<b>Photographer Location:</b>
Arlington Ridge Boulevard (Structure A)
<b>Location:</b>
3833/4017 Arlington Ridge Boulevard
<b>Comments:</b>
66-inch CMP culvert under Arlington Ridge Boulevard. Need to remove sediments upstream of the culvert.

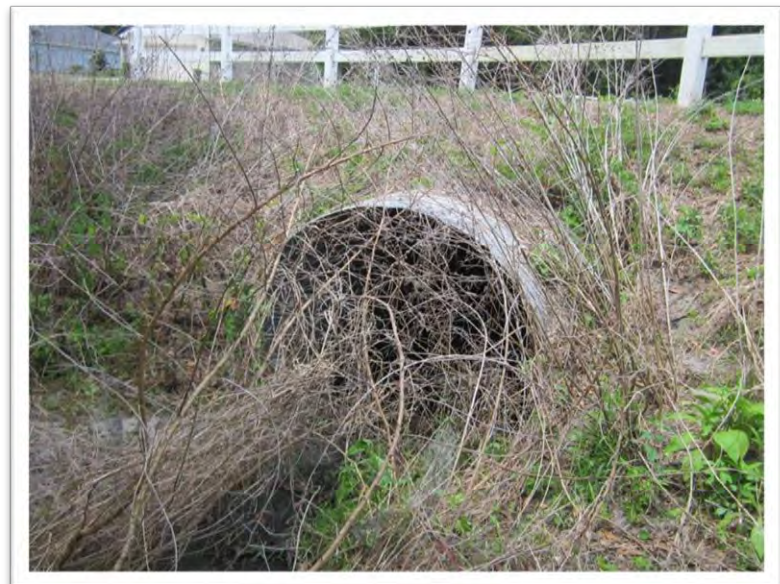
<b>Photograph No.</b>
14
<b>Photographer Location:</b>
Arlington Ridge Boulevard (Structure A)
<b>Location:</b>
4016 Arlington Ridge Boulevard
<b>Comments:</b>
66-inch CMP culvert under Arlington Ridge Boulevard. Need to remove brush / vegetation downstream of the culvert.

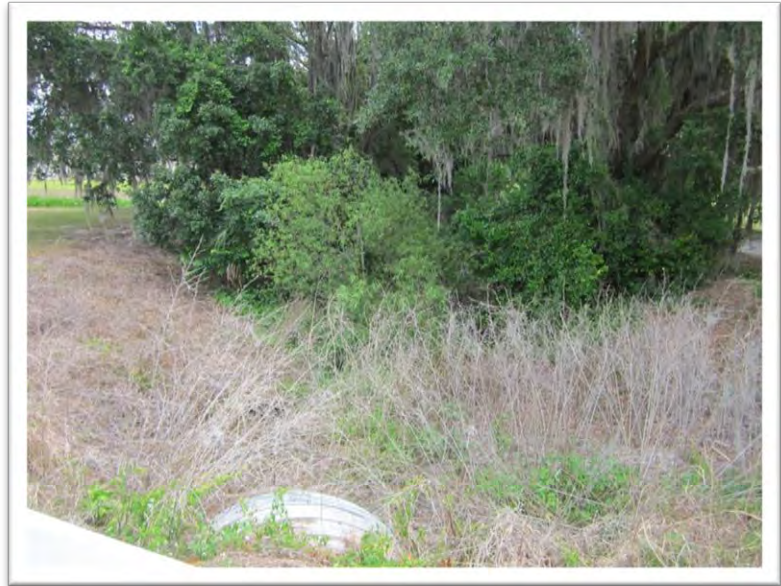
<b>Photograph No.</b>
15
<b>Photographer Location:</b>
Arlington Ridge Boulevard (Structure A)
<b>Location:</b>
4016 Arlington Ridge Boulevard
<b>Comments:</b>
Remove brush / vegetation between culvert and woods.

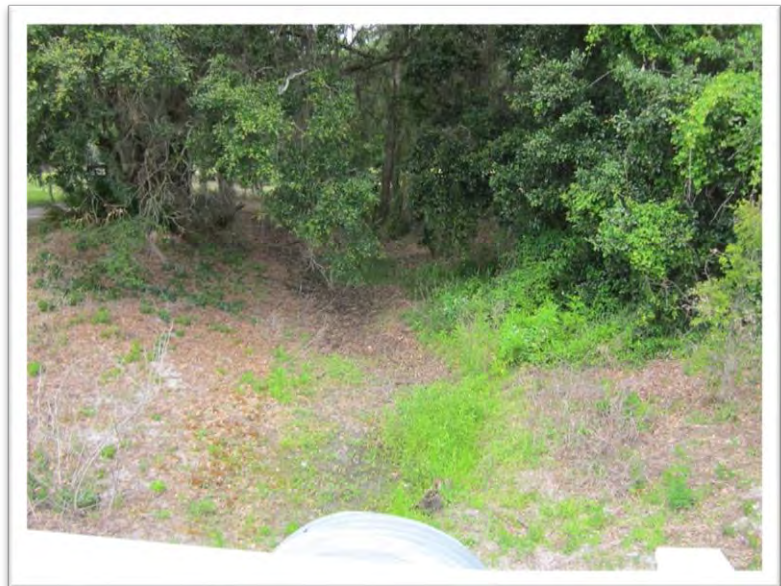
<b>Photograph No.</b>
16
<b>Photographer Location:</b>
Arlington Ridge Boulevard (Structure A)
<b>Location:</b>
3833/4017 Arlington Ridge Boulevard
<b>Comments:</b>
Upstream channel currently well maintained.

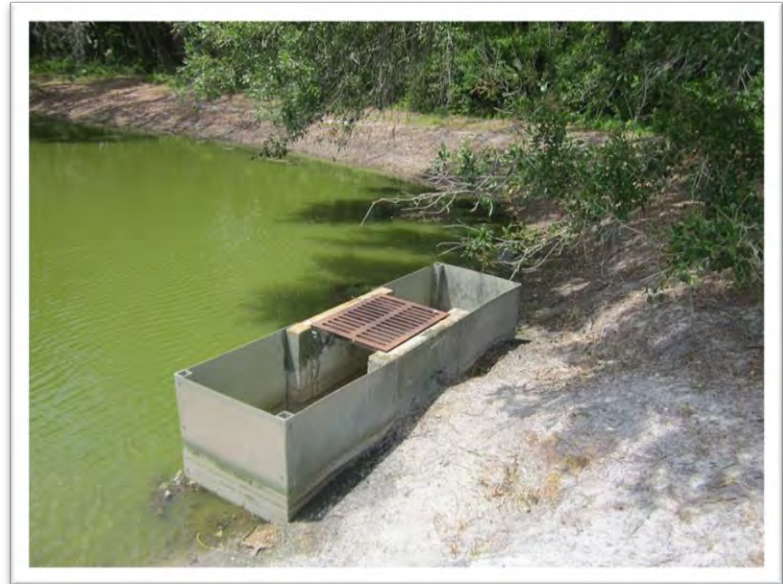
<b>Photograph No.</b>
17
<b>Photographer Location:</b>
Pond P-3-2 (Structure A)
<b>Pond Location:</b>
Hole #12 (Tee Box)
<b>Comments:</b>
Type "C" ditch bottom inlet with skimmer blade (control structure).

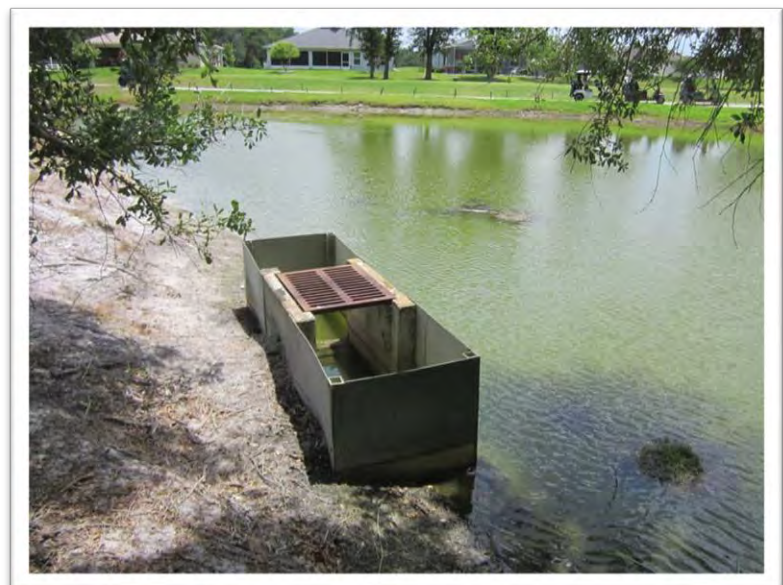
<b>Photograph No.</b>
18
<b>Photographer Location:</b>
Pond P-3-2 (Structure A)
<b>Pond Location:</b>
Hole #12 (Tee Box)
<b>Comments:</b>
25-inch wide weir openings at both ends. The weir openings are 30-inches below the cast iron grate.

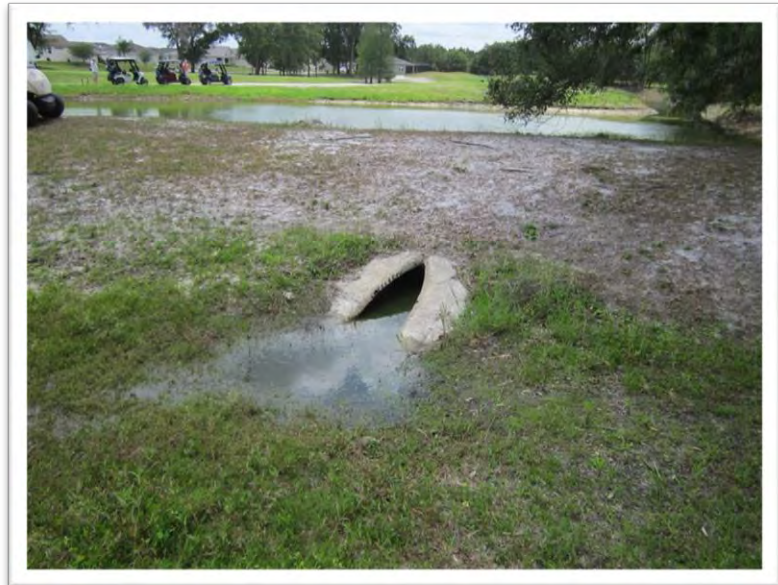
<b>Photograph No.</b>
19
<b>Photographer Location:</b>
Pond P-3-1 (Structure A)
<b>Pond Location:</b>
Hole #11 (Green)
<b>Comments:</b>
Outflow pipe and concrete mitered end section originating from the Pond P-3-2- control structure.

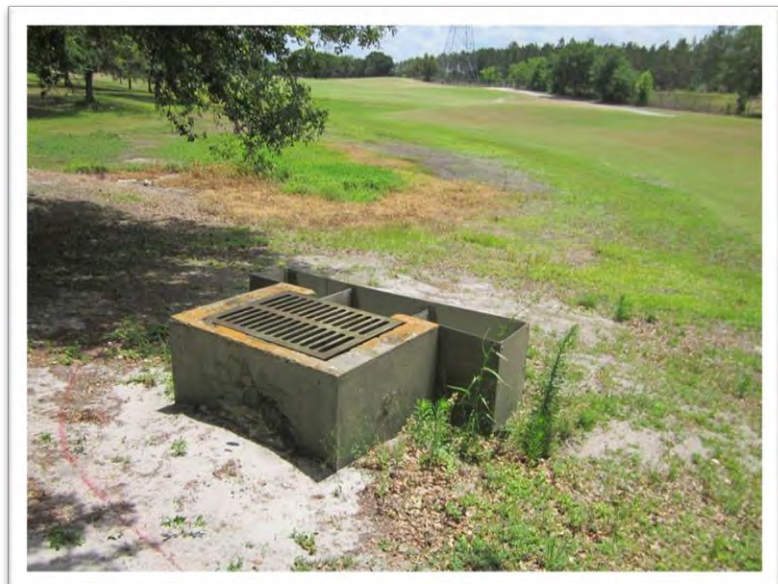
<b>Photograph No.</b>
20
<b>Photographer Location:</b>
Pond P-4-1 (Structure A)
<b>Pond Location:</b>
Hole #13 (Tee Box)
<b>Comments:</b>
Type "C" ditch bottom inlet with skimmer blade (control structure).

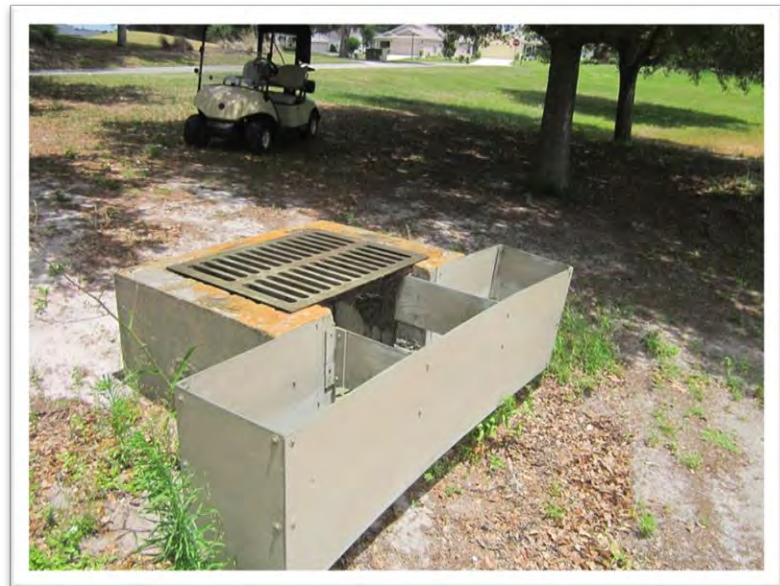
<b>Photograph No.</b>
21
<b>Photographer Location:</b>
Pond P-4-1 (Structure A)
<b>Pond Location:</b>
Hole #13 (Tee Box)
<b>Comments:</b>
25-inch wide weir opening. The weir opening is 20.5-inches below the cast iron grate. The skimmer blade needs to be re-attached to the control structure.

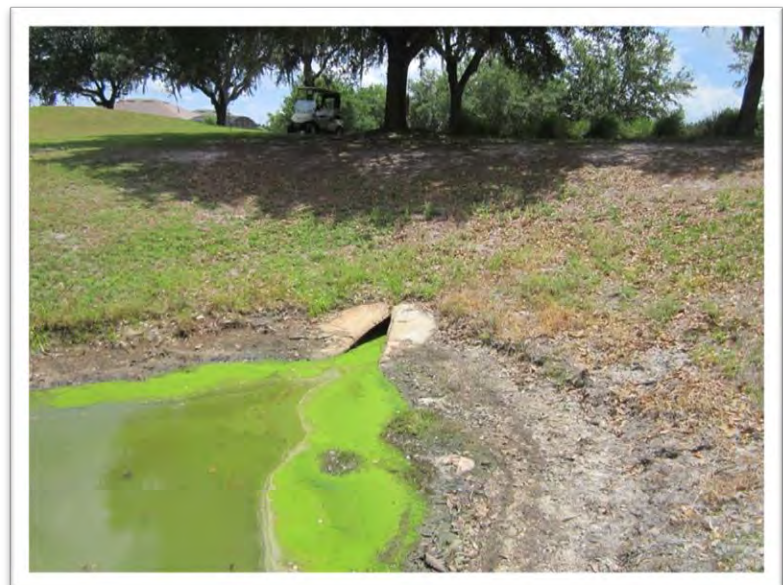
<b>Photograph No.</b>
22
<b>Photographer Location:</b>
Pond P-3-2 (Structure B)
<b>Pond Location:</b>
Hole #12 (Green)
<b>Comments:</b>
Outfall pipe and concrete mitered end section originating from the Pond P-4-1 control structure.

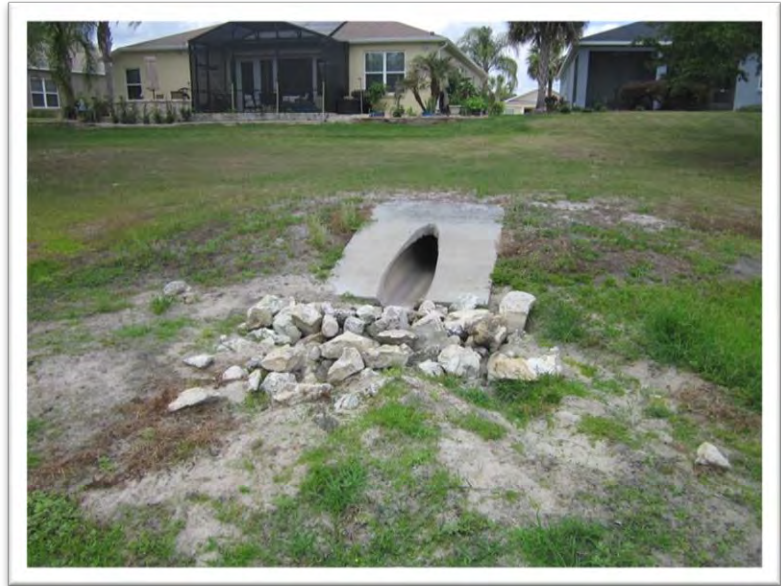
<b>Photograph No.</b>
23
<b>Photographer Location:</b>
Pond P-4-1 (Structure B)
<b>Pond Location:</b>
Hole #13 (Fairway)
<b>Comments:</b>
Inflow pipe and concrete mitered end section originating from Arlington Ridge Boulevard. Erosion occurring underneath the existing riprap.

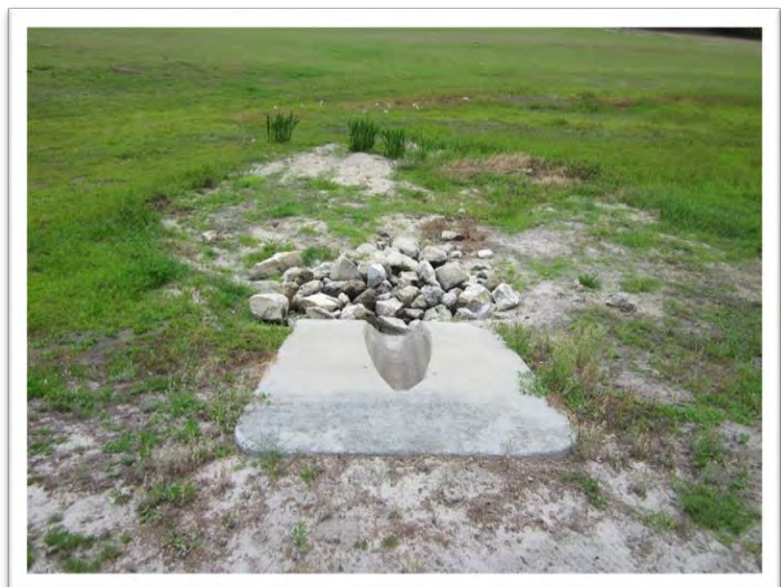
<b>Photograph No.</b>
24
<b>Photographer Location:</b>
Pond P-4-1 (Structure B)
<b>Pond Location:</b>
Hole #13 (Fairway)
<b>Comments:</b>
Need to backfill and compact the eroded area, install a geotextile underlayment, and install concrete riprap.

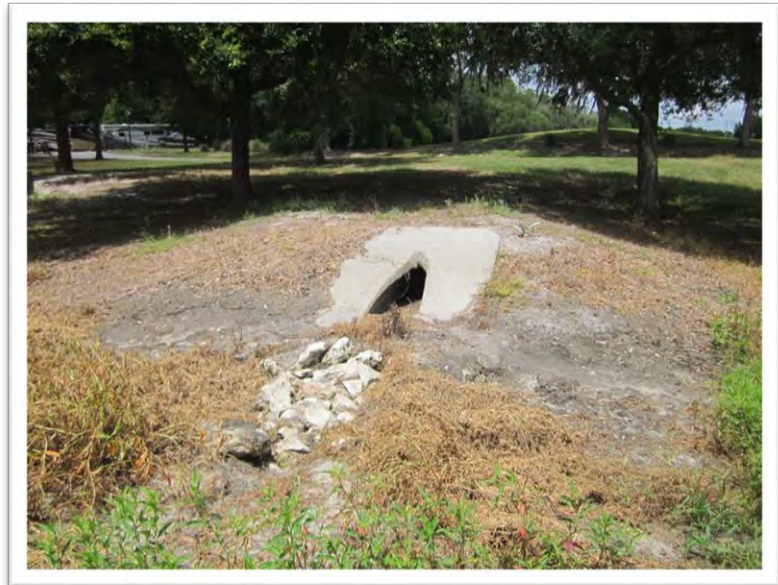
<b>Photograph No.</b>
25
<b>Photographer Location:</b>
Pond P-4-1 (Structure C)
<b>Pond Location:</b>
Hole #13 (Tee Box)
<b>Comments:</b>
Inflow pipe and concrete mitered end section originating from Arlington Ridge Boulevard. Erosion occurring underneath the existing riprap.

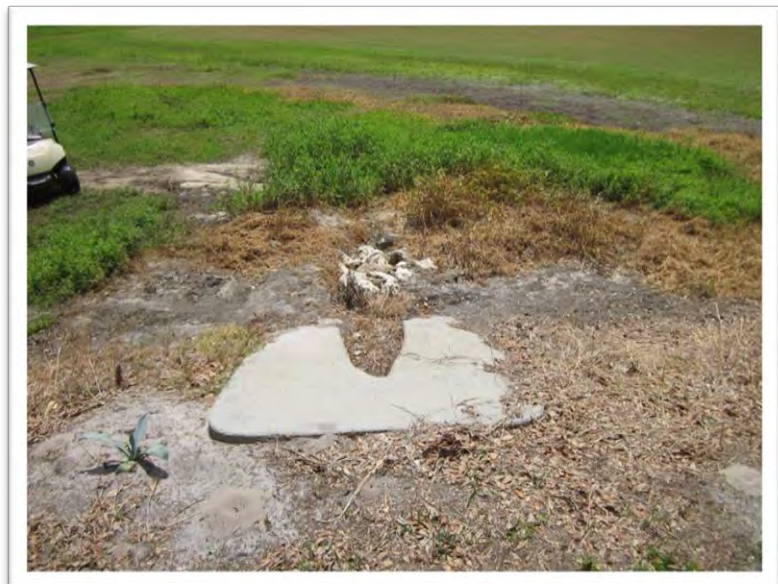
<b>Photograph No.</b>
26
<b>Photographer Location:</b>
Pond P-4-1 (Structure C)
<b>Pond Location:</b>
Hole #13 (Tee Box)
<b>Comments:</b>
Need to backfill and compact the eroded area, install a geotextile underlayment, and install concrete riprap.

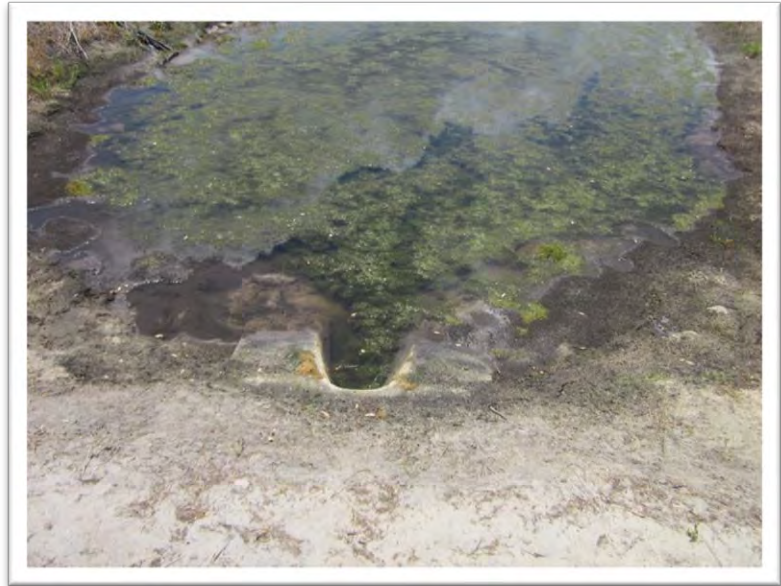
<b>Photograph No.</b>
27
<b>Photographer Location:</b>
Pond P-5-1 (Structure A)
<b>Pond Location:</b>
Hole #14 (Fairway)
<b>Comments:</b>
Concrete mitered end section associated with culvert that connects Pond P-5-1 to Pond P-5-2.

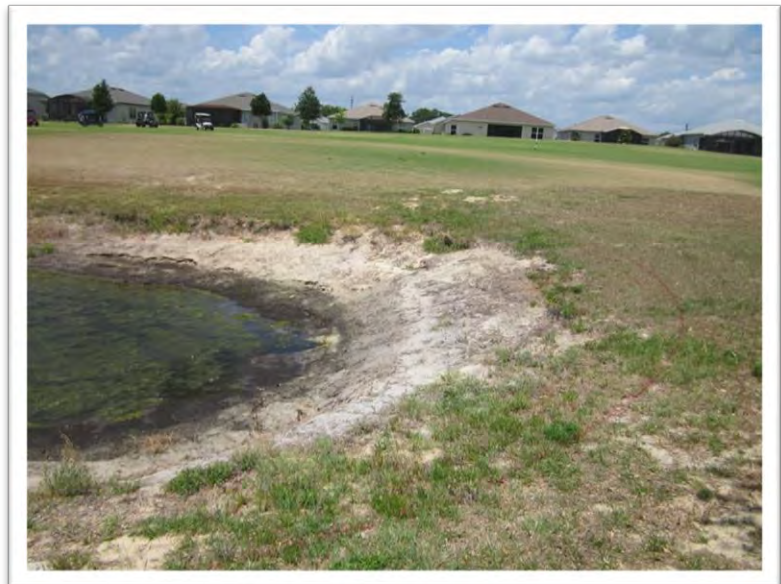
<b>Photograph No.</b>
28
<b>Photographer Location:</b>
Pond P-5-1 (Structure A)
<b>Pond Location:</b>
Hole #14 (Fairway)
<b>Comments:</b>
Need to sod the pond side slope and remove the sediments within the culvert.

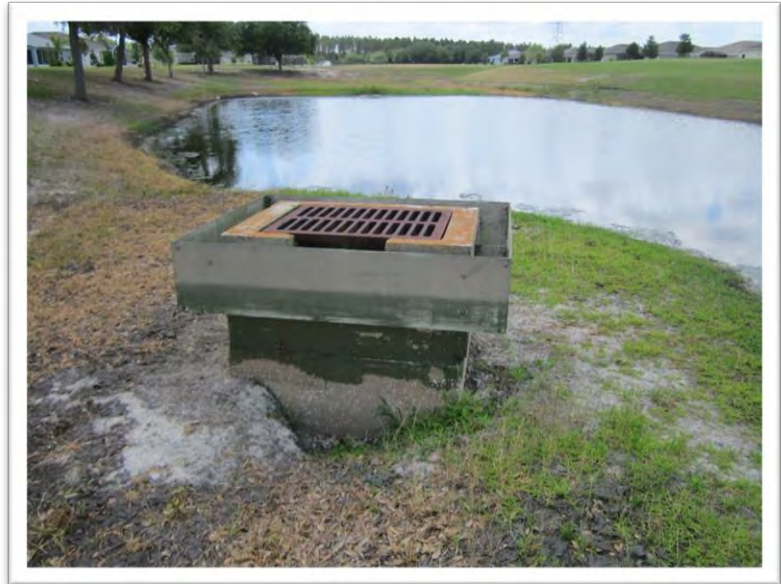
<b>Photograph No.</b>
29
<b>Photographer Location:</b>
Pond P-5-2 (Structure A)
<b>Pond Location:</b>
Hole #14 (Green)
<b>Comments:</b>
Type "C" ditch bottom inlet with skimmer blade (control structure). <b>Need to backfill, compact, and sod the scour area adjacent to the control structure.</b>

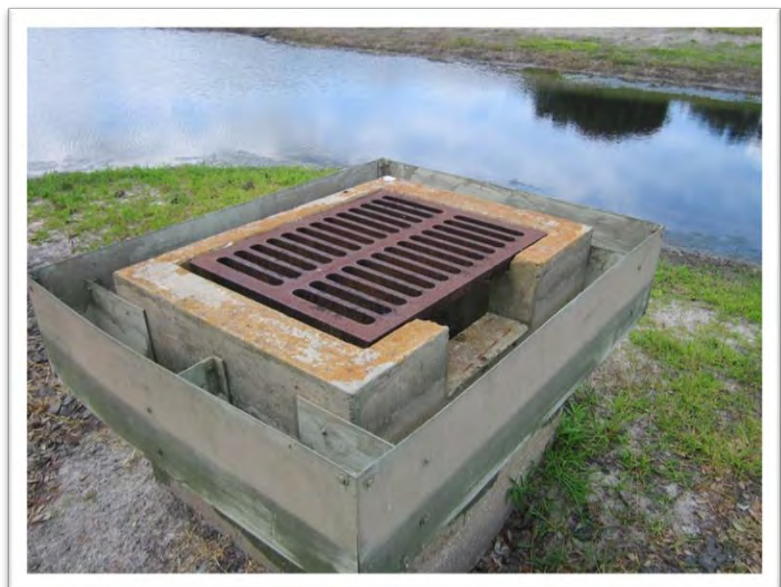
<b>Photograph No.</b>
30
<b>Photographer Location:</b>
Pond P-5-2 (Structure A)
<b>Pond Location:</b>
Hole #14 (Green)
<b>Comments:</b>
19-inch wide weir opening. The weir opening is 8-inches below the cast iron grate.

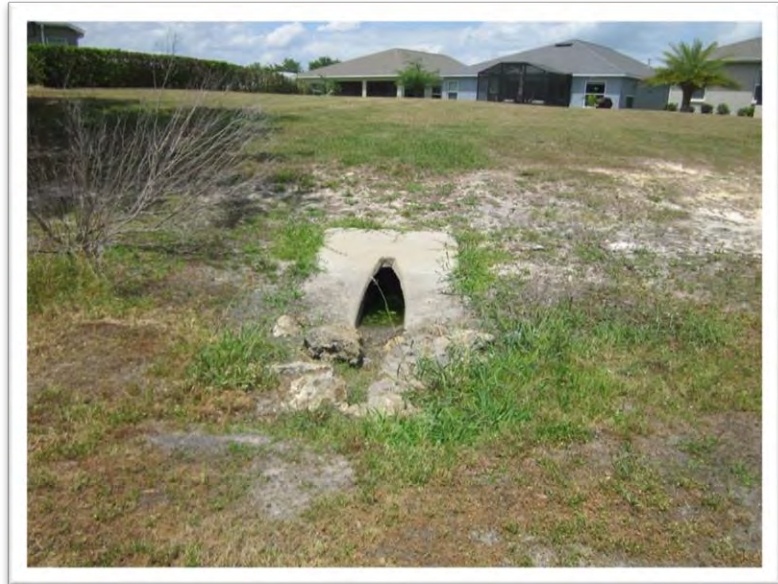
<b>Photograph No.</b>
31
<b>Photographer Location:</b>
Pond P-5-2 (Structure B)
<b>Pond Location:</b>
Hole #14 (Green)
<b>Comments:</b>
Inflow pipe and concrete mitered end section originating from Arlington Ridge Boulevard. Note that the invert of the inflow pipe is "sumped" below the pond bottom.

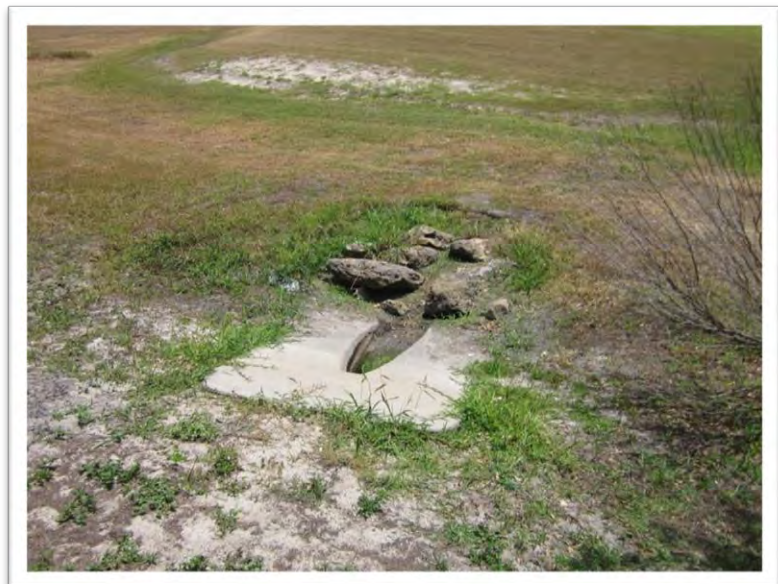
<b>Photograph No.</b>
32
<b>Photographer Location:</b>
Pond P-5-2 (Structure B)
<b>Pond Location:</b>
Hole #14 (Green)
<b>Comments:</b>
Remove sediments within pipe, re-grade pond bottom for positive flow, and install concrete riprap.

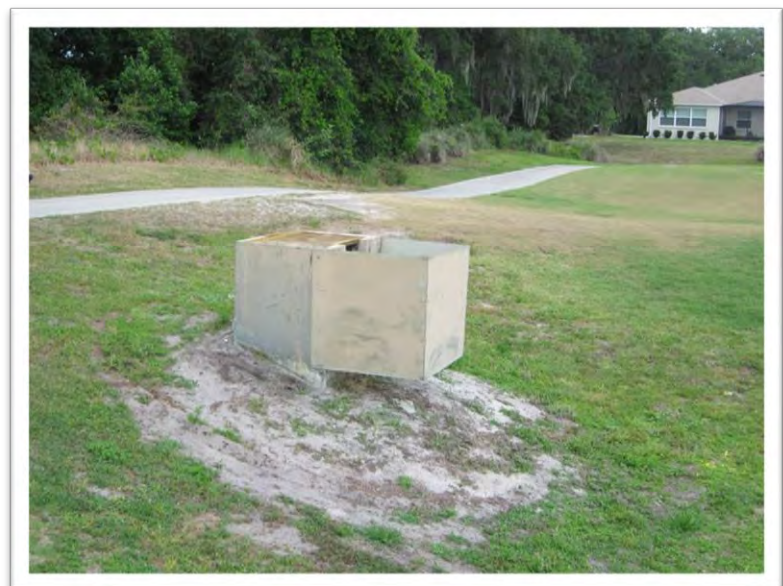
<b>Photograph No.</b>
36
<b>Photographer Location:</b>
Pond P-6-2 (Structure B)
<b>Pond Location:</b>
Hole #15 (Green)
<b>Comments:</b>
Type "C" ditch bottom inlet with skimmer blade (control structure). Need to add sod adjacent to the control structure.

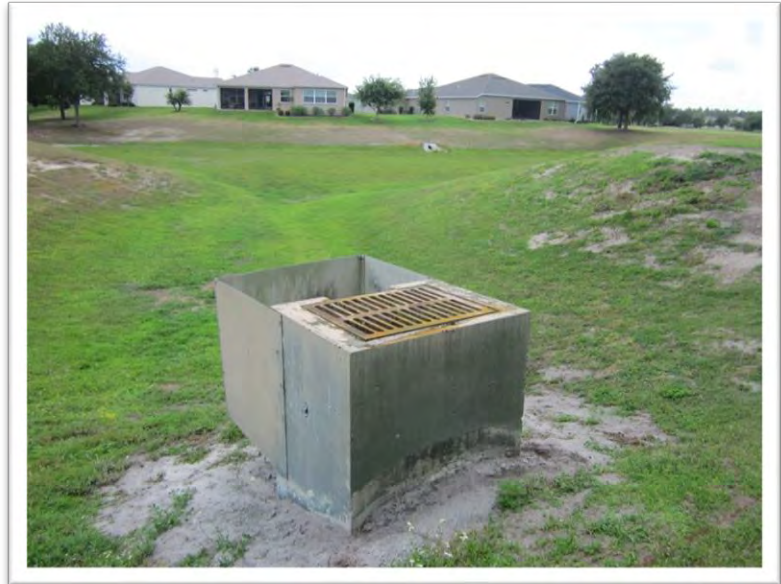
<b>Photograph No.</b>
37
<b>Photographer Location:</b>
Pond P-6-2 (Structure B)
<b>Pond Location:</b>
Hole #15 (Green)
<b>Comments:</b>
19-inch wide weir opening. The weir opening is 36-inches below the cast iron grate.

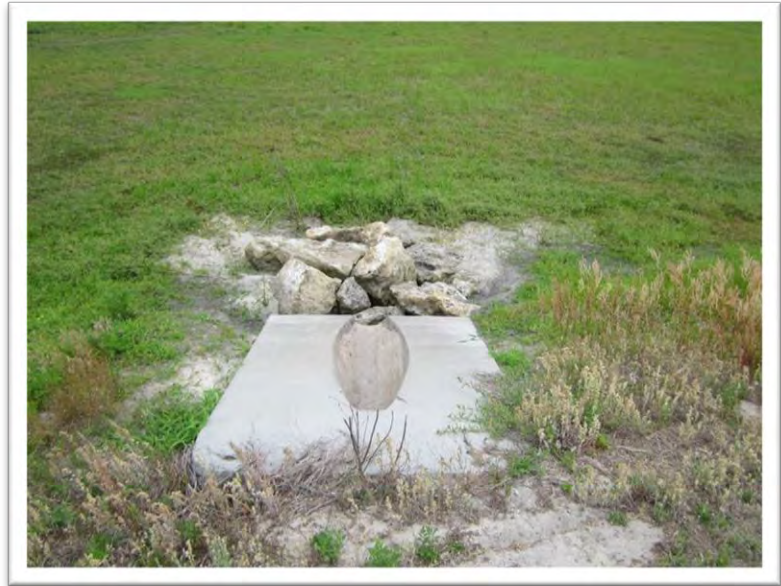
<b>Photograph No.</b>
39
<b>Photographer Location:</b>
Pond P-6-2 (Structure C)
<b>Pond Location:</b>
Hole #16 (Tee Box)
<b>Comments:</b>
Remove existing riprap, re-grade pond bottom, install geotextile underlayment, and install concrete riprap.

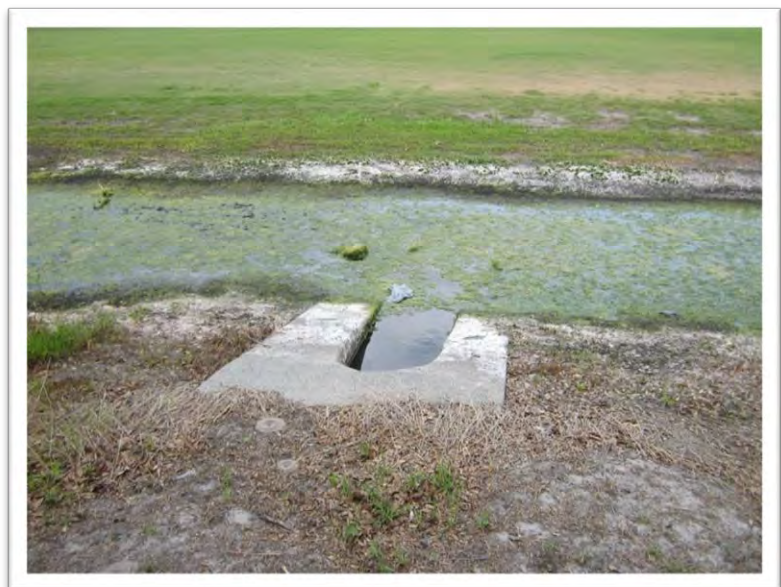
<b>Photograph No.</b>
40
<b>Photographer Location:</b>
Pond P-7-2 (Structure A)
<b>Pond Location:</b>
Hole #16 (Fairway)
<b>Comments:</b>
Inflow pipe and concrete mitered end section originating from Otter Creek Lane.

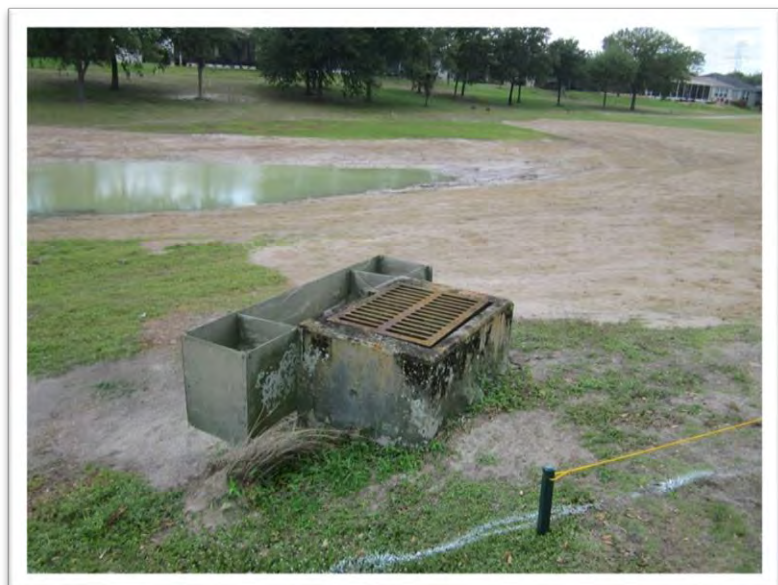
<b>Photograph No.</b>
42
<b>Photographer Location:</b>
Pond P-7-2 (Structure B)
<b>Pond Location:</b>
Hole #16 (Fairway)
<b>Comments:</b>
Type "C" ditch bottom inlet with skimmer blade (control structure).

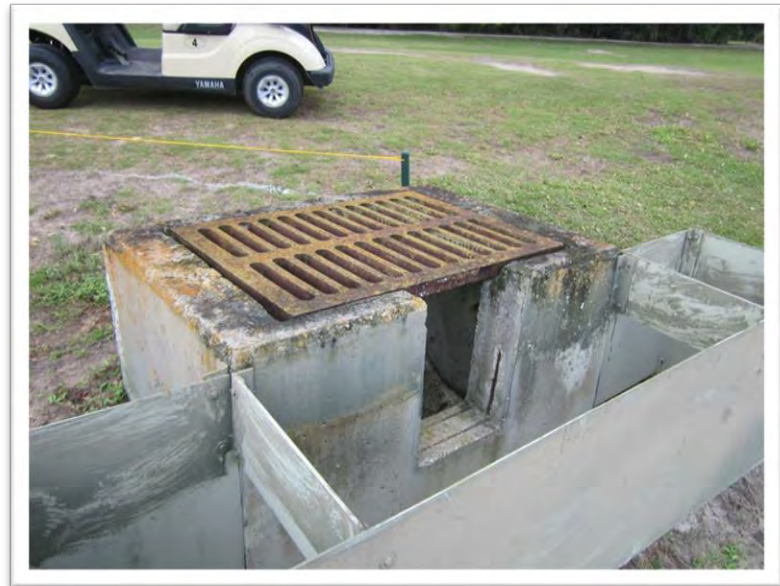
<b>Photograph No.</b>
43
<b>Photographer Location:</b>
Pond P-7-2 (Structure B)
<b>Pond Location:</b>
Hole #16 (Fairway)
<b>Comments:</b>
13-inch wide weir opening. The weir opening 18-inches below the cast iron grate.

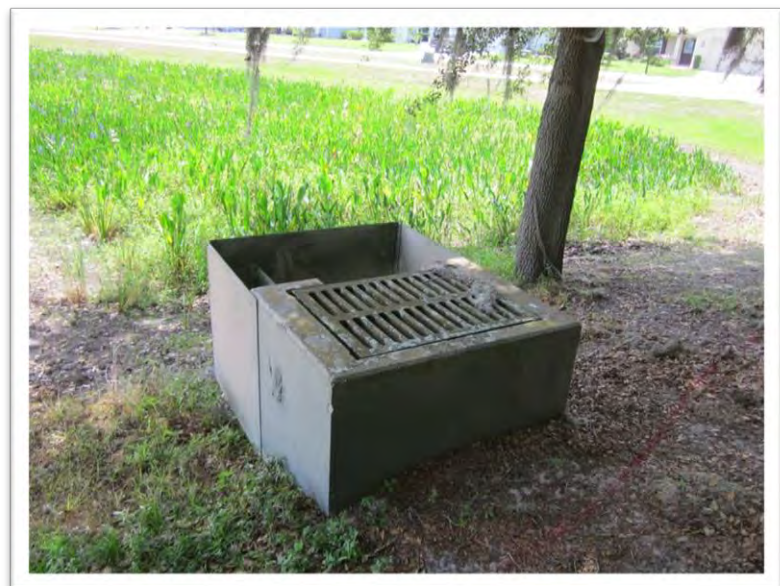
<b>Photograph No.</b>
44
<b>Photographer Location:</b>
Pond P-7-3 (Structure A)
<b>Pond Location:</b>
Hole #16 (Green)
<b>Comments:</b>
Type "C" ditch bottom inlet with skimmer blade (control structure).

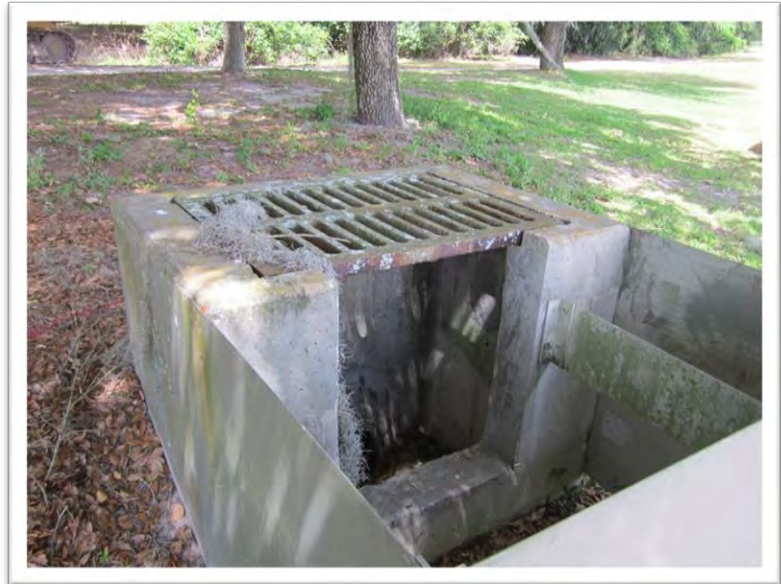
<b>Photograph No.</b>
45
<b>Photographer Location:</b>
Pond P-7-3 (Structure A)
<b>Pond Location:</b>
Hole #16 (Green)
<b>Comments:</b>
24.5-inch wide weir opening. The weir opening is 28.5-inches below the cast iron grate.

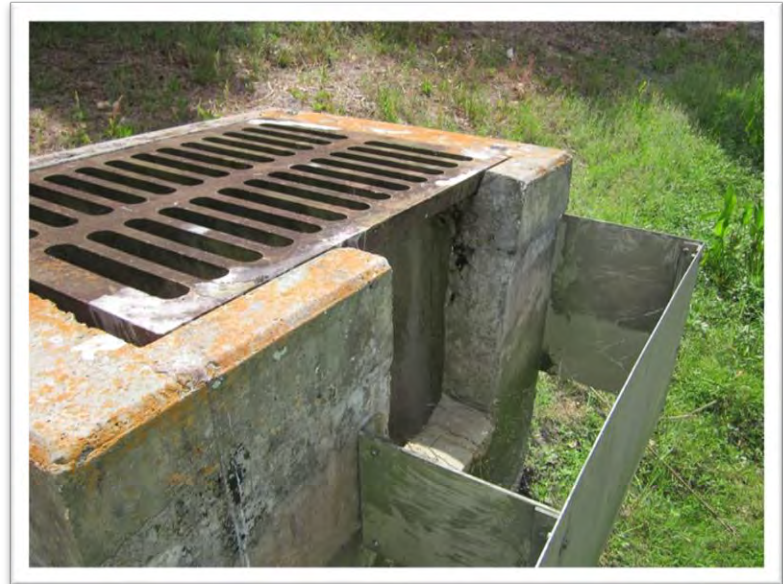
<b>Photograph No.</b>
47
<b>Photographer Location:</b>
Pond P-8-1 (Structure A)
<b>Pond Location:</b>
Hole #17 (Tee Box)
<b>Comments:</b>
18-inch wide weir opening. The weir opening is 23.5-inches below the cast iron grate.

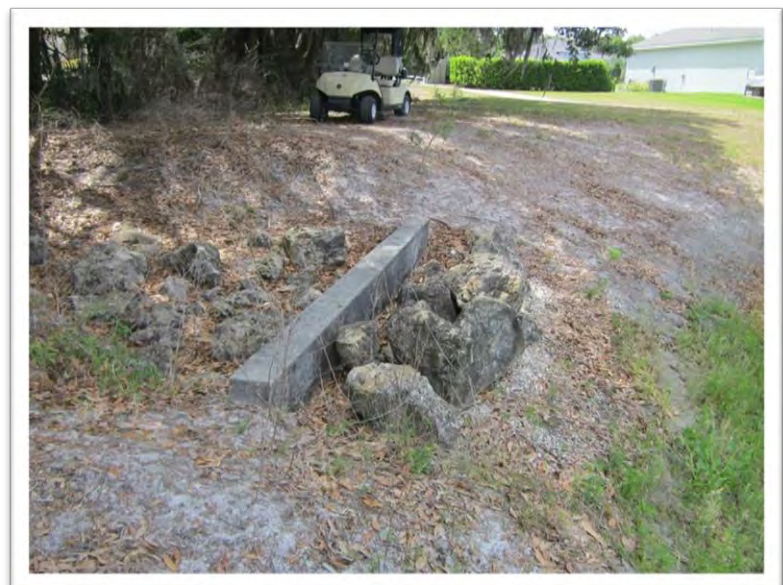
<b>Photograph No.</b>
48
<b>Photographer Location:</b>
Pond P-8-1 (Structure B)
<b>Pond Location:</b>
Hole #17 (Tee Box)
<b>Comments:</b>
Concrete overflow weir between Pond P-8-1 and the drainage way.

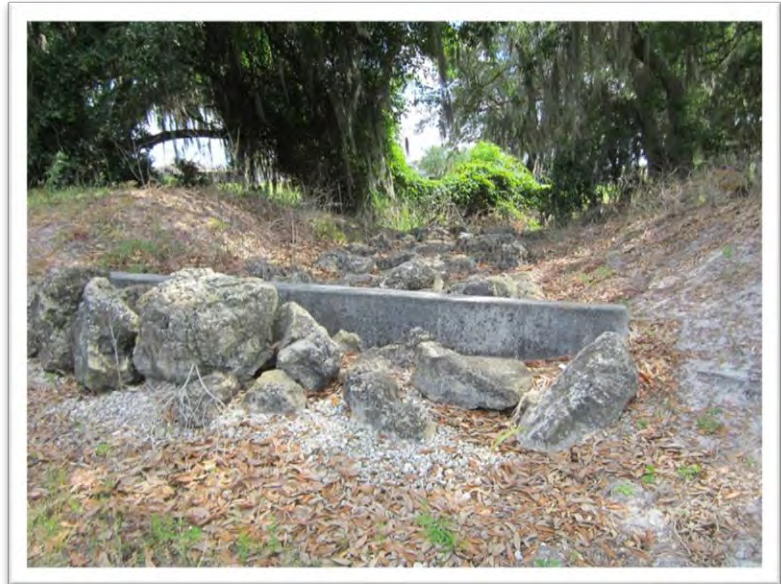
<b>Photograph No.</b>
49
<b>Photographer Location:</b>
Pond P-8-1 (Structure B)
<b>Pond Location:</b>
Hole #17 (Tee Box)
<b>Comments:</b>
Concrete overflow weir is 11.5-foot wide.
