**ARLINGTON RIDGE  
COMMUNITY DEVELOPMENT DISTRICT**

## PROJECT MEMORANDUM

**Subject:** **Annual Inspection Report**

The purpose of this Project Memorandum is to document the annual site inspection associated with the Stormwater Management System (i.e., stormwater ponds, control structures, outfall pipes, and inflow pipes), as well as rights-of-way (roadways) and golf course. In addition, this Project Memorandum will also recommend the immediate drainage maintenance improvements (i.e., this current fiscal year) and the short-term drainage maintenance improvements (Fiscal Year 2022/2023).

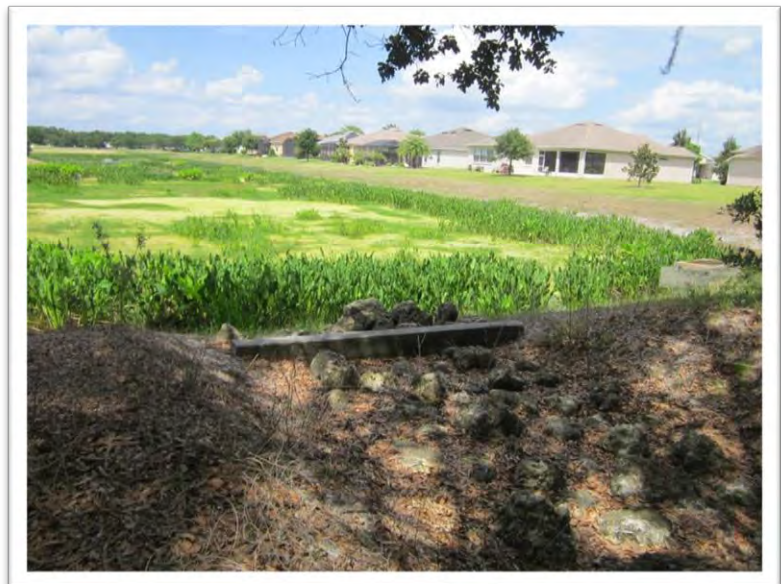
<b>Photograph No.</b>
50
<b>Photographer Location:</b>
Pond P-8-1 (Structure B)
<b>Pond Location:</b>
Hole #17 (Tee Box)
<b>Comments:</b>
Concrete overflow weir between Pond P-8-1 and the drainage way.

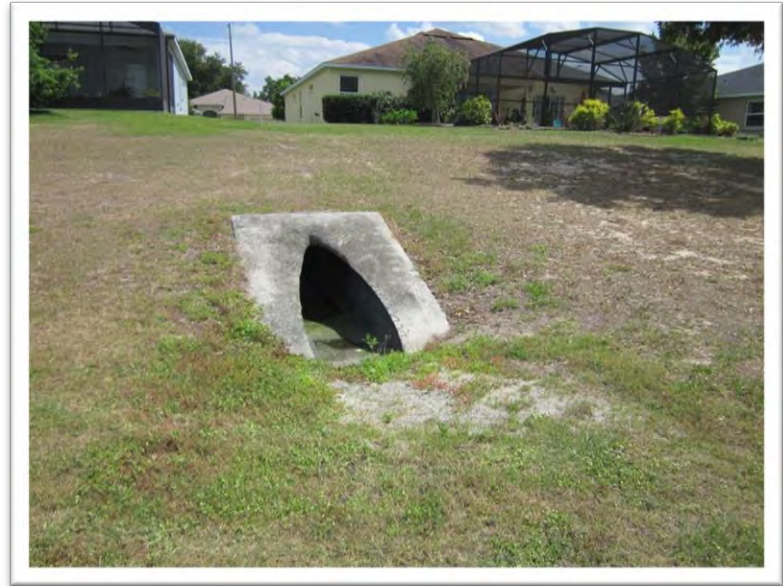
<b>Photograph No.</b>
51
<b>Photographer Location:</b>
Pond P-9-1 (Structure A)
<b>Pond Location:</b>
Hole #18 (Fairway)
<b>Comments:</b>
Inflow pipe and concrete mitered end section originating from Manassas Drive. Inflow pipe is slightly sumped below pond bottom. No signs of erosion.

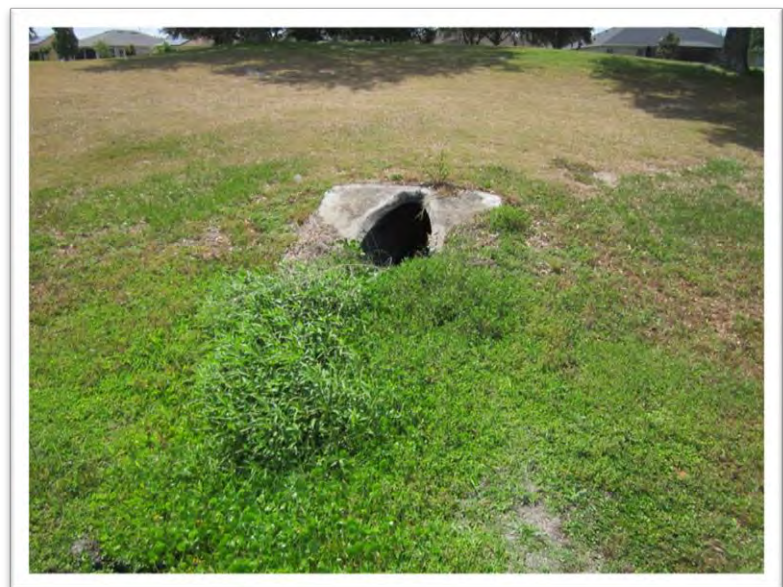
<b>Photograph No.</b>
52
<b>Photographer Location:</b>
Pond P-9-1 (Structure B)
<b>Pond Location:</b>
Hole #18 (Fairway)
<b>Comments:</b>
Inflow pipe and concrete mitered end section originating from August Springs Circle.

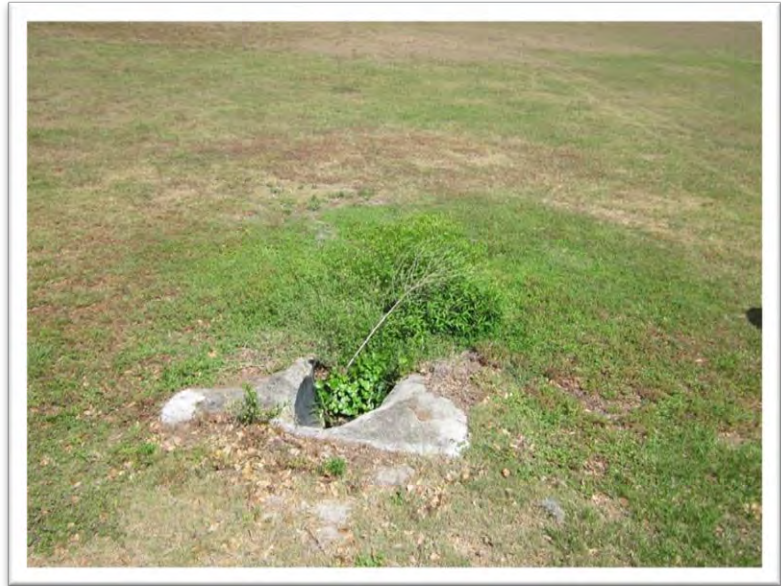
<b>Photograph No.</b>
53
<b>Photographer Location:</b>
Pond P-9-1 (Structure B)
<b>Pond Location:</b>
Hole #18 (Fairway)
<b>Comments:</b>
Remove sediments within pipe.

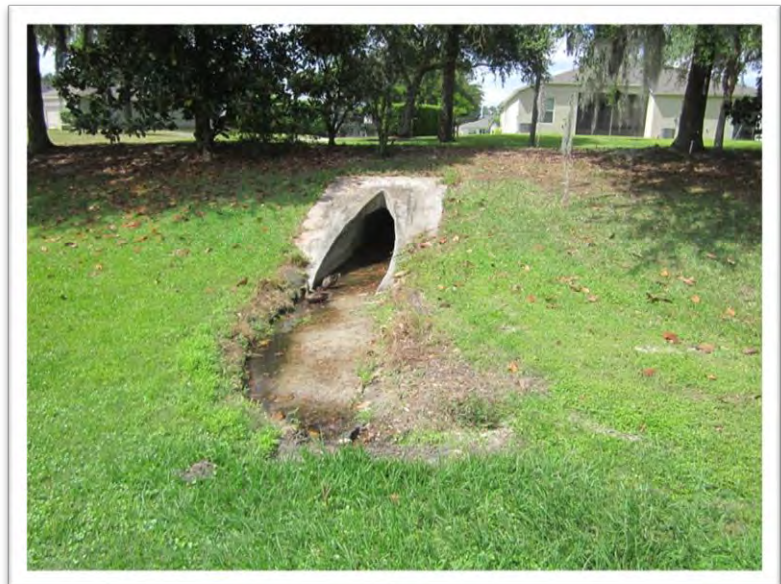
<b>Photograph No.</b>
54
<b>Photographer Location:</b>
Pond P-9-1 (Structure C)
<b>Pond Location:</b>
Hole #18 (Green)
<b>Comments:</b>
Inflow pipe and concrete mitered end section originating from Arlington Ridge Boulevard.

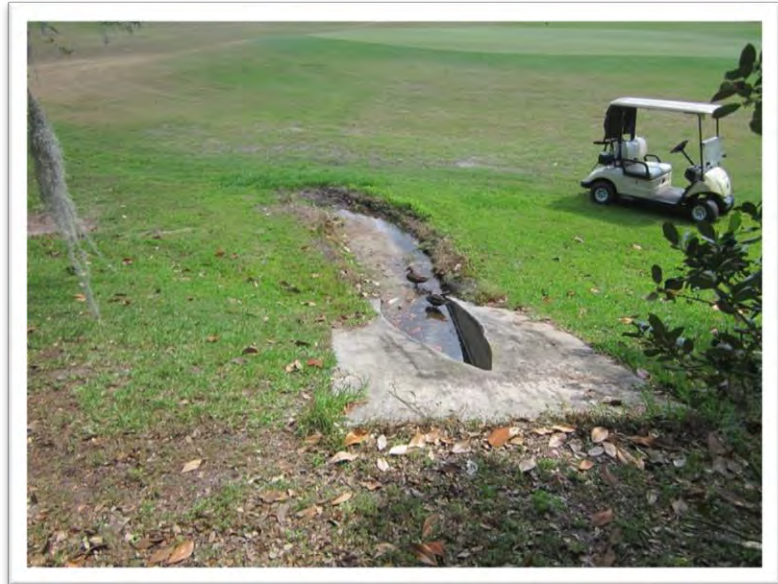
<b>Photograph No.</b>
55
<b>Photographer Location:</b>
Pond P-9-1 (Structure C)
<b>Pond Location:</b>
Hole #18 (Green)
<b>Comments:</b>
Remove sediments within pipe, re-grade pond bottom for positive flow, and install concrete riprap.

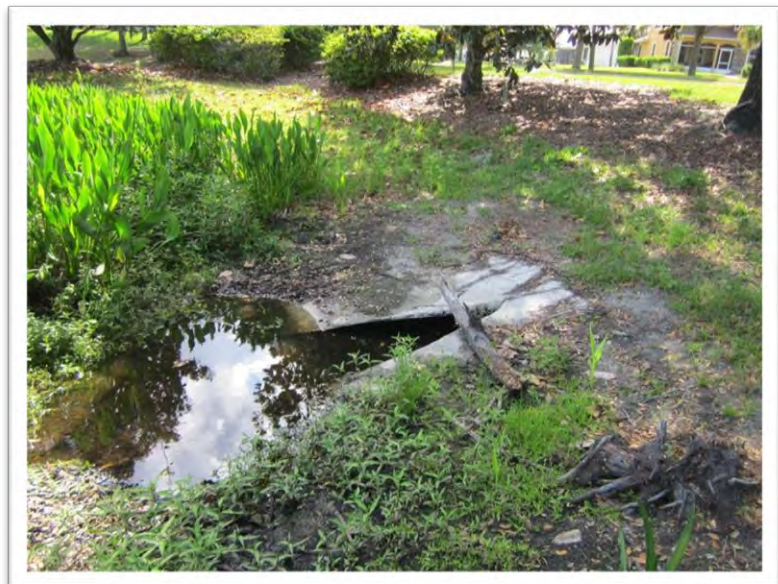
<b>Photograph No.</b>
56
<b>Photographer Location:</b>
Pond P-17-3 (Structure B)
<b>Pond Location:</b>
Hole #9 (Green)
<b>Comments:</b>
Inflow pipe and concrete mitered end section originating from Arlington Ridge Boulevard.

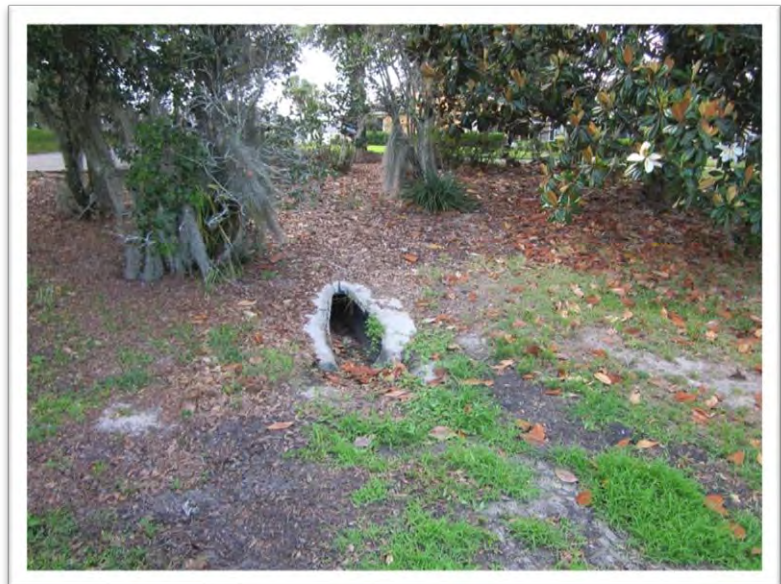
<b>Photograph No.</b>
58
<b>Photographer Location:</b>
Pond P-17-3 (Structure C)
<b>Pond Location:</b>
Hole #9 (Green)
<b>Comments:</b>
Inflow pipe and concrete mitered end section originating from Arlington Ridge Boulevard.

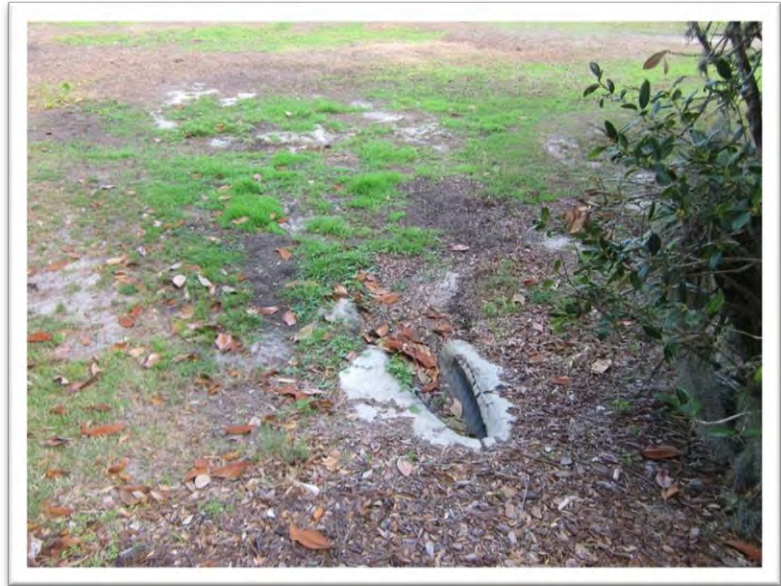
<b>Photograph No.</b>
59
<b>Photographer Location:</b>
Pond P-17-3 (Structure C)
<b>Pond Location:</b>
Hole #9 (Green)
<b>Comments:</b>
Remove sediments within pipe.

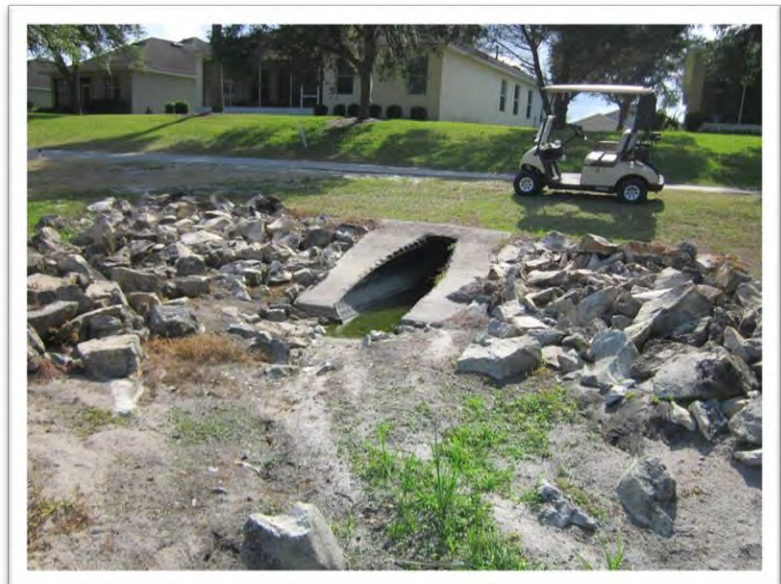
<b>Photograph No.</b>
60
<b>Photographer Location:</b>
Pond P-17-3 (Structure D)
<b>Pond Location:</b>
Hole #9 (Green)
<b>Comments:</b>
Inflow pipe and concrete mitered end section originating from Arlington Ridge Boulevard. Inflow pipe invert slightly sumped below pond bottom.

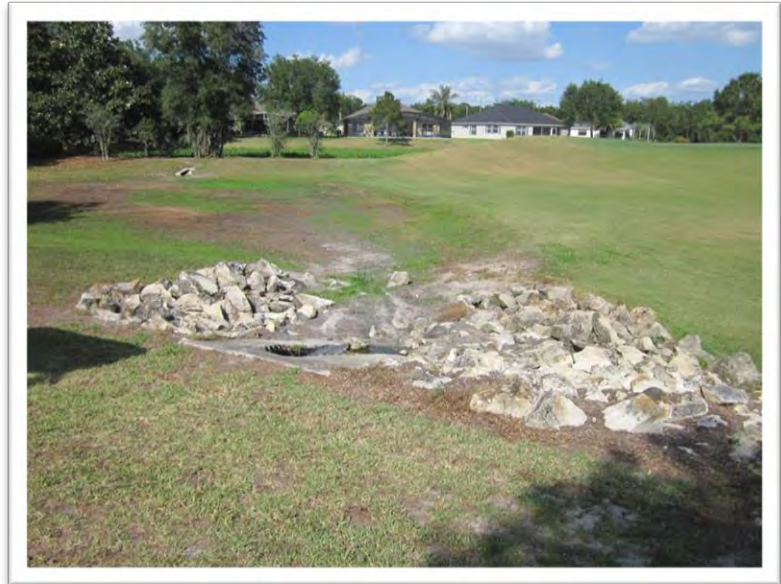
<b>Photograph No.</b>
61
<b>Photographer Location:</b>
Pond P-17-3 (Structure D)
<b>Pond Location:</b>
Hole #9 (Green)
<b>Comments:</b>
Downstream area may need to be re-graded for positive flow in the future.

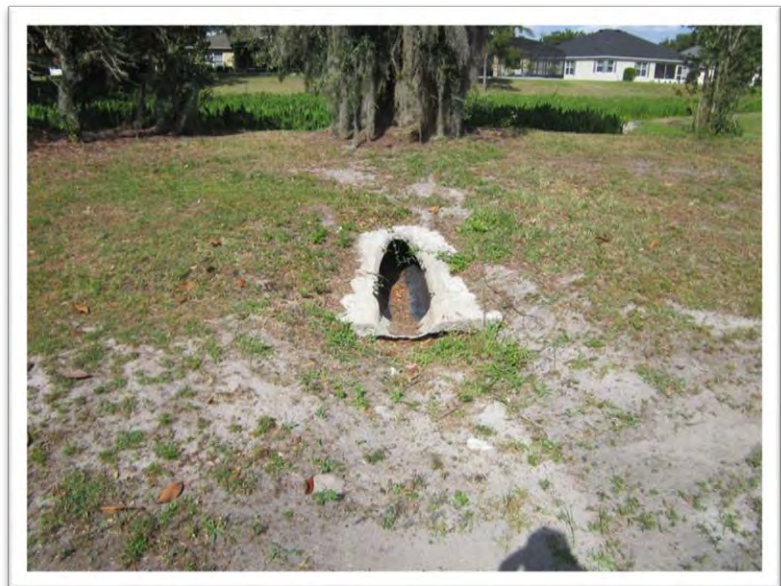
<b>Photograph No.</b>
62
<b>Photographer Location:</b>
Pond P-17-3 (Structure E)
<b>Pond Location:</b>
Hole #9 (Green)
<b>Comments:</b>
Concrete mitered end section associated with the culvert that connects the dry pond with the wet pond. <b>Need to backfill and compact underneath the mitered end section and install concrete riprap.</b>

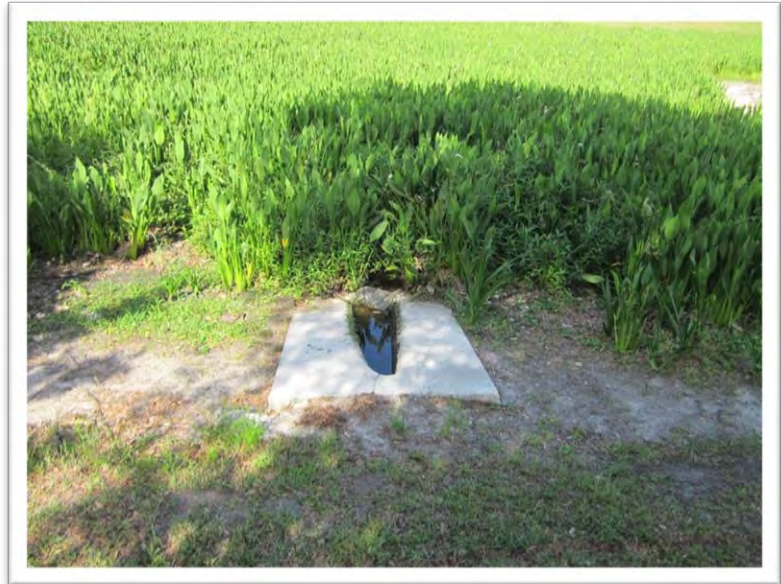
<b>Photograph No.</b>
63
<b>Photographer Location:</b>
Pond P-17-3 (Structure E)
<b>Pond Location:</b>
Hole #9 (Green)
<b>Comments:</b>
Concrete mitered end section associated with the culvert that connects the dry pond with the wet pond.

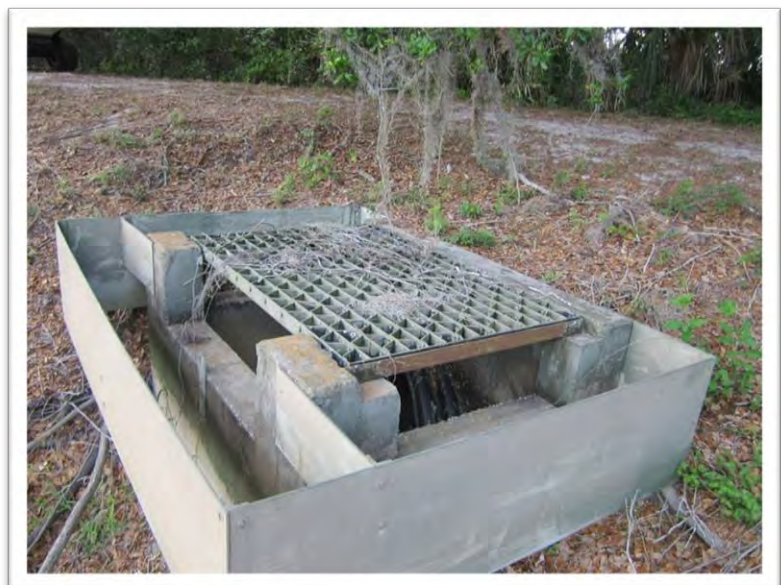
<b>Photograph No.</b>
64
<b>Photographer Location:</b>
Pond P-17-4 (Structure A)
<b>Pond Location:</b>
Hole #9 (Tee Box)
<b>Comments:</b>
Type "E" ditch bottom inlet with skimmer blade (control structure).

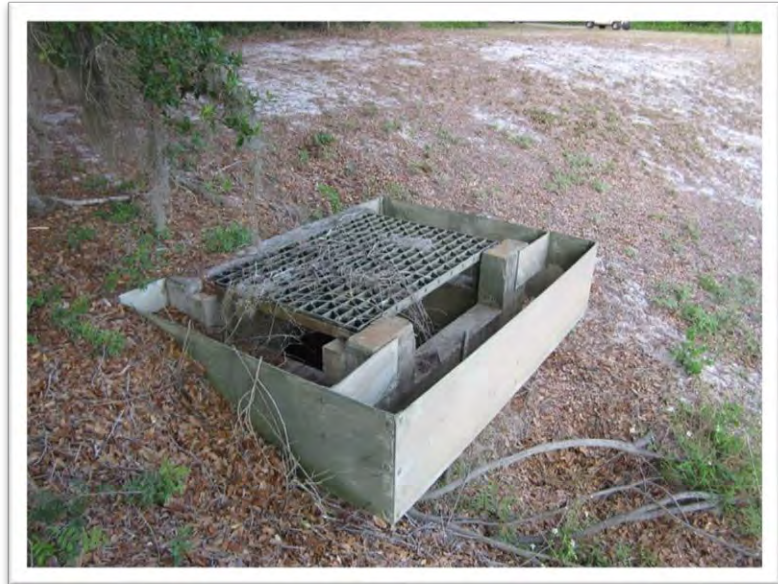
<b>Photograph No.</b>
65
<b>Photographer Location:</b>
Pond P-17-4 (Structure A)
<b>Pond Location:</b>
Hole #9 (Tee Box)
<b>Comments:</b>
Two (2) 28-inch wide weir openings and one (1) 36-inch wide weir opening. All three (3) weir openings are 12-inches below the steel grate.

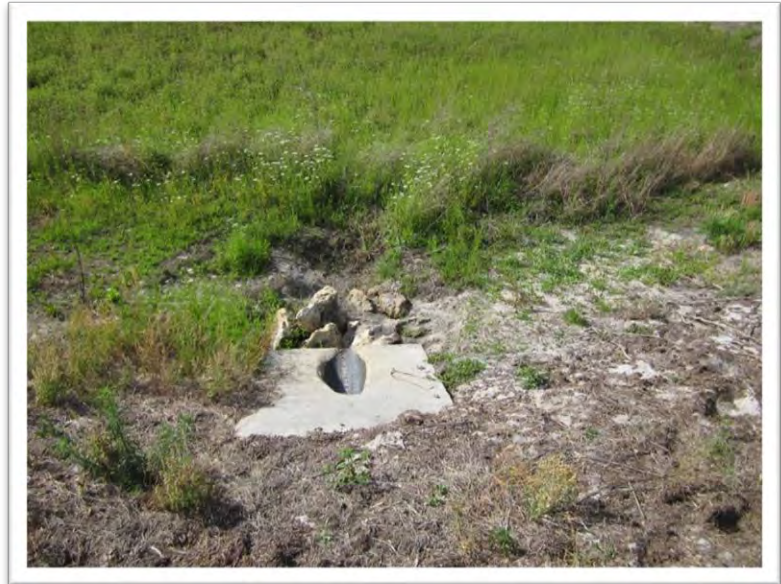
<b>Photograph No.</b>
67
<b>Photographer Location:</b>
Pond P-17-4 (Structure B)
<b>Pond Location:</b>
Hole #9 (Tee Box)
<b>Comments:</b>
Backfill and compact, install geotextile underlayment, and install concrete riprap.

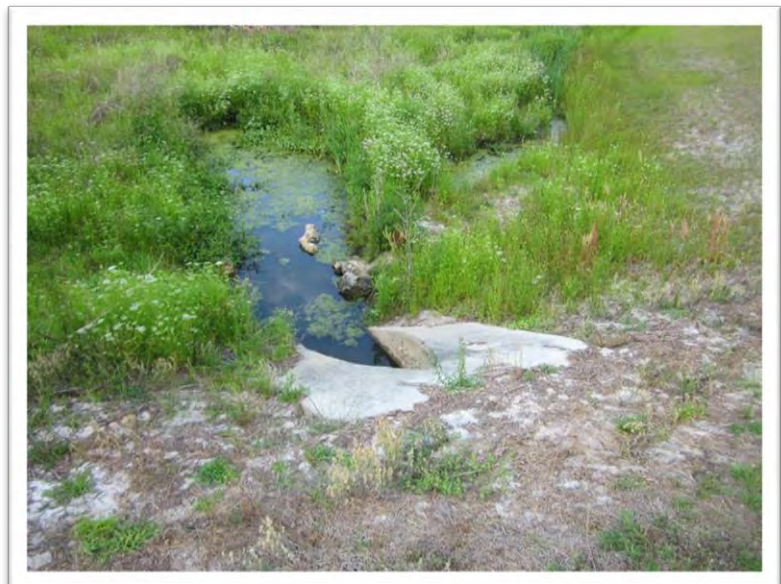
<b>Photograph No.</b>
68
<b>Photographer Location:</b>
Pond P-17-4 (Structure C)
<b>Pond Location:</b>
Hole #9 (Tee Box)
<b>Comments:</b>
Inflow pipe and concrete mitered end section originating from Bent Creek Lane and Arlington Ridge Boulevard.

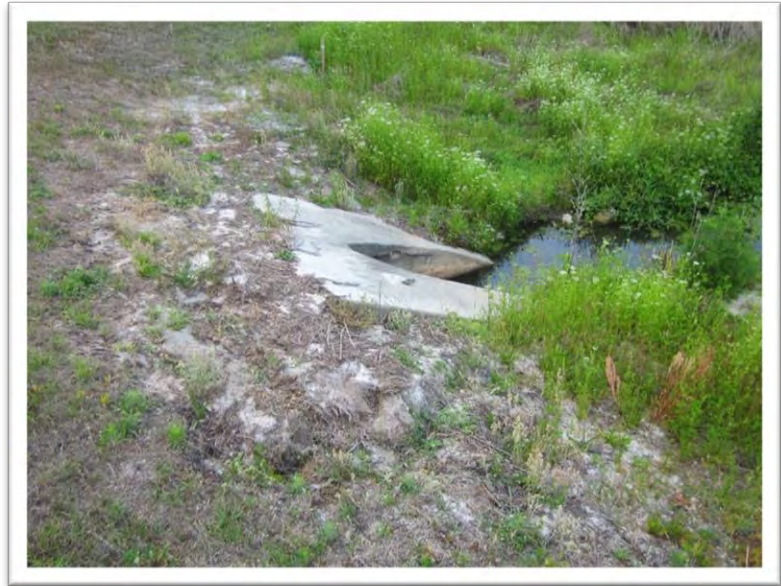
<b>Photograph No.</b>
69
<b>Photographer Location:</b>
Pond P-17-4 (Structure C)
<b>Pond Location:</b>
Hole #9 (Tee Box)
<b>Comments:</b>
Backfill, re-grade, and sod the side slope adjacent to the mitered end section.

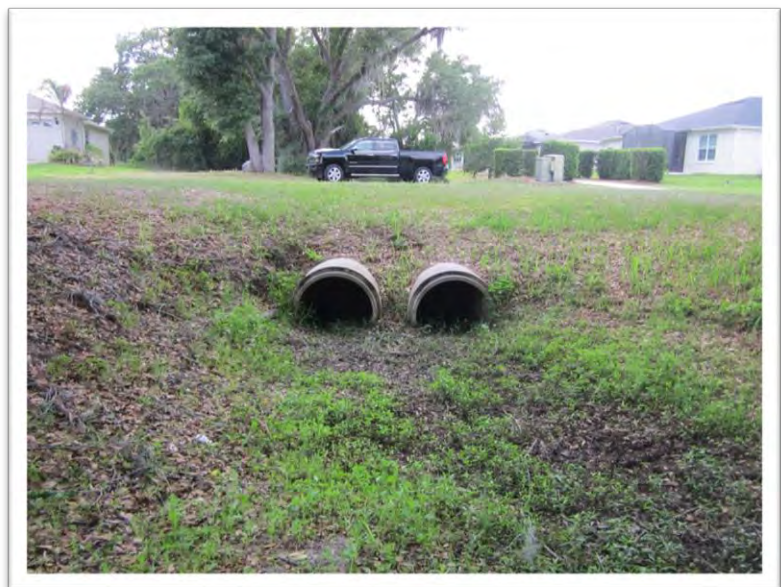
<b>Photograph No.</b>
70
<b>Photographer Location:</b>
Arlington Ridge Boulevard
<b>Location:</b>
3609 / 3613 Arlington Ridge Boulevard
<b>Comments:</b>
Existing double 36-inch RCP culverts.

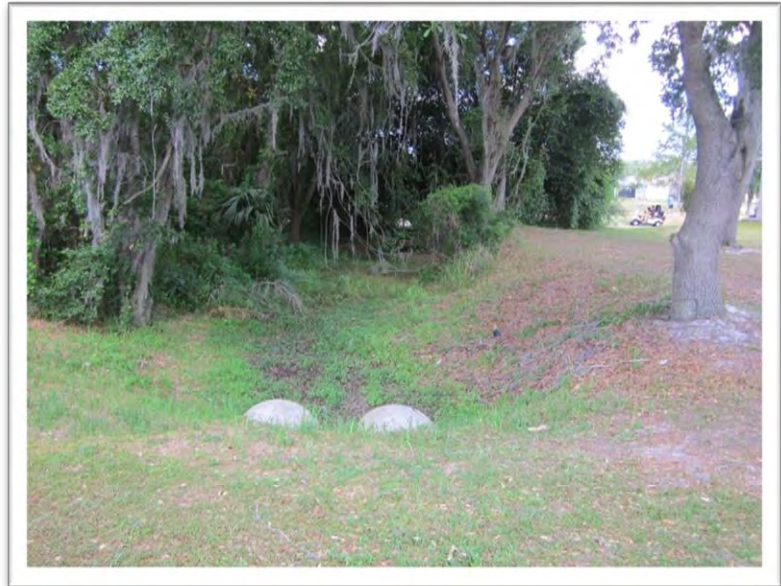
<b>Photograph No.</b>
71
<b>Photographer Location:</b>
Arlington Ridge Boulevard
<b>Location:</b>
3609 / 3613 Arlington Ridge Boulevard
<b>Comments:</b>
Existing channel downstream of the culverts.

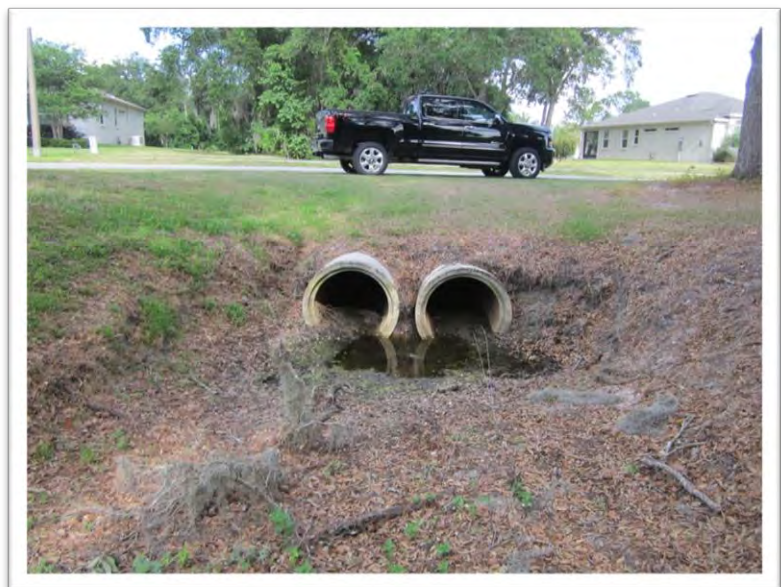
<b>Photograph No.</b>
72
<b>Photographer Location:</b>
Arlington Ridge Boulevard
<b>Location:</b>
3614 Arlington Ridge Boulevard
<b>Comments:</b>
Existing double 36-inch RCP culverts with minor downstream erosion. Install concrete riprap.

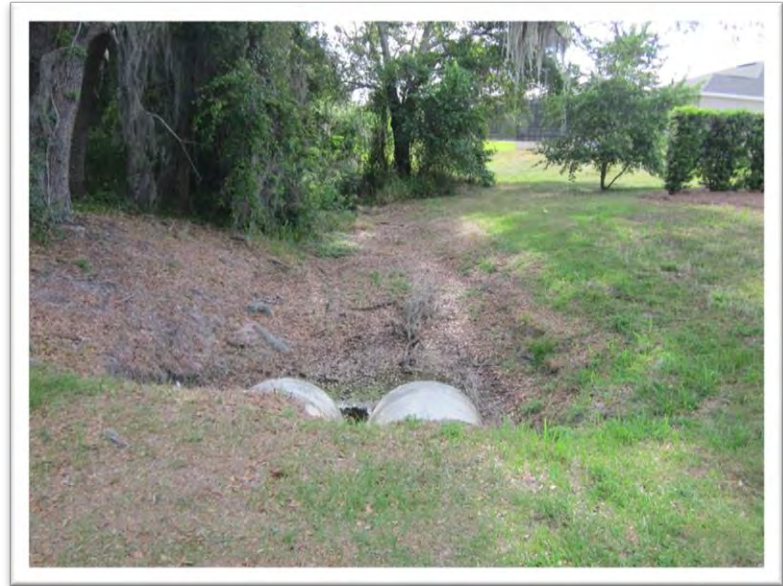
<b>Photograph No.</b>
73
<b>Photographer Location:</b>
Arlington Ridge Boulevard
<b>Location:</b>
3614 Arlington Ridge Boulevard
<b>Comments:</b>
Existing channel upstream of the culverts.

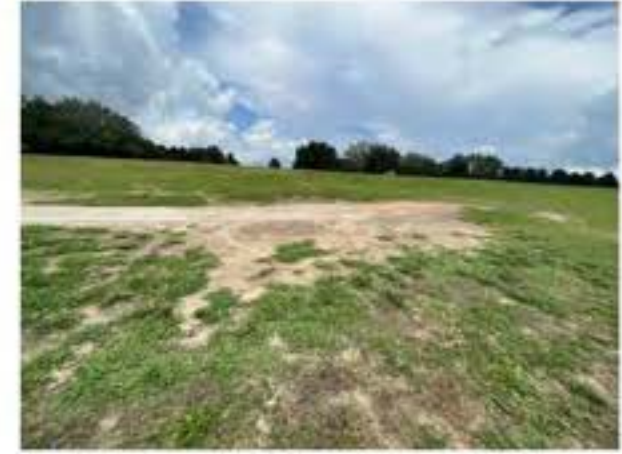
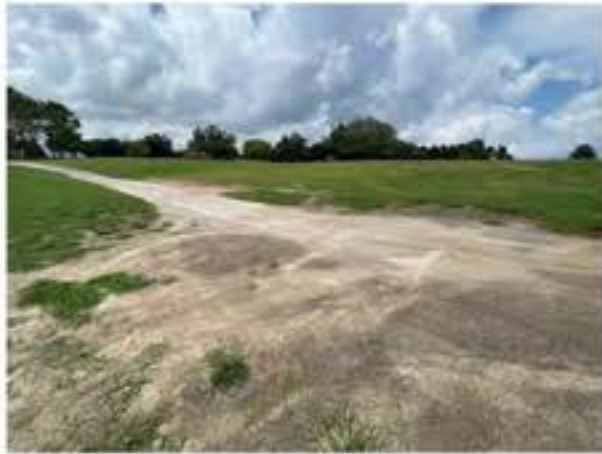
GolfCourse-14\_Photo 1

Deficiencies ID	Infrastructure Type	Deficiency Type	Address	Notes	Photo ID	Field Date
14	Golf Course	GolfCourse: Bunker/Sod Washout	Golf Course		GolfCourse-14	08/30/22
63	Golf Course	GolfCourse: Bunker/Sod Washout	Golf Course		GolfCourse-63	08/30/22
78	Golf Course	GolfCourse: Bunker/Sod Washout	Golf Course		GolfCourse-78	08/30/22
79	Golf Course	GolfCourse: Bunker/Sod Washout	Golf Course		GolfCourse-79	08/30/22
81	Golf Course	GolfCourse: Bunker/Sod Washout	Golf Course		GolfCourse-81	08/30/22
82	Golf Course	GolfCourse: Bunker/Sod Washout	Golf Course		GolfCourse-82	08/30/22
83	Golf Course	GolfCourse: Bunker/Sod Washout	Golf Course		GolfCourse-83	08/30/22
8	Golf Course	GolfCourse: Cartpath Damage	Golf Course		GolfCourse-8	08/30/22
20	Golf Course	GolfCourse: Cartpath Damage	Golf Course		GolfCourse-20	08/30/22
22	Golf Course	GolfCourse: Cartpath Damage	Golf Course		GolfCourse-22	08/30/22
54	Golf Course	GolfCourse: Cartpath Damage	Golf Course		GolfCourse-54	08/30/22

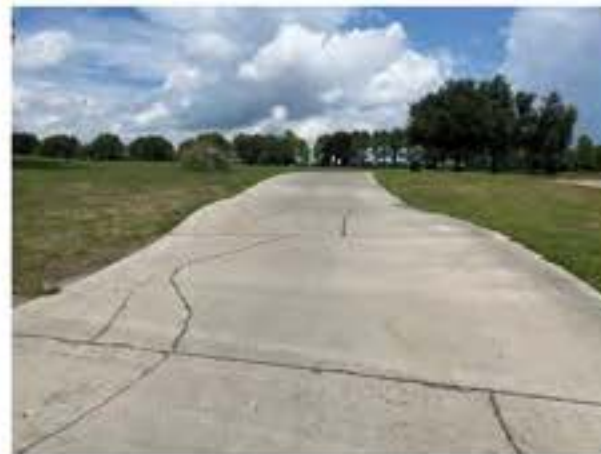
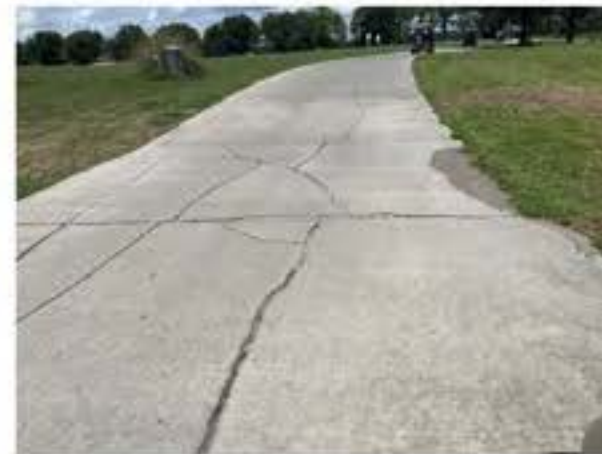
GolfCourse-61\_Photo 1

61	Golf Course	GolfCourse: Cartpath Damage	Golf Course		GolfCourse-61	08/30/22
62	Golf Course	GolfCourse: Cartpath Damage	Golf Course		GolfCourse-62	08/30/22
75	Golf Course	GolfCourse: Cartpath Damage	Golf Course		GolfCourse-75	08/30/22
76	Golf Course	GolfCourse: Cartpath Damage	Golf Course		GolfCourse-76	08/30/22
90	Golf Course	GolfCourse: Cartpath Damage	Golf Course		GolfCourse-90	08/30/22
71	Other	Other	4143 Arlington Ridge Boulevard	Water Ponding on Roadway	Other-71	08/30/22
72	Roadway/Pavement	Roadway/Pavement: Cracking	26833 Augusta Springs Circle	Water sitting in road causing damage to asphalt	Roadway-72	08/30/22
28	Roadway/Pavement	Roadway/Pavement: Damage	27331 Roanoke Drive		Roadway-28	08/30/22
66	Roadway/Pavement	Roadway/Pavement: Other (Add Notes)	26844 White Plains Way	Roadway Subsidence	Roadway-66	08/30/22
67	Roadway/Pavement	Roadway/Pavement: Other (Add Notes)	26803 White Plains Way	Roadway Subsidence	Roadway-67	08/30/22

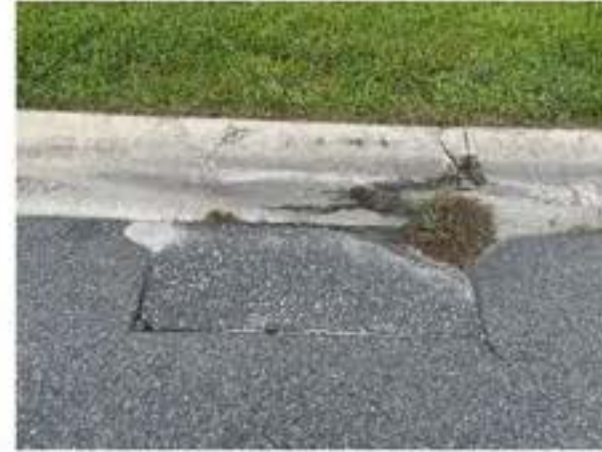
Gutter-69\_Photo 1

69	Curb and Gutter/ValleyGutter	Curb and Gutter: Cracking	26749 White Plains Way		Gutter-69	08/30/22
10	Drainage Inlet/Manhole	Drainage Inlets/Manholes: Other (Add Notes)	4326 Antietam Creek Trail	Inlet appears to be sinking	Inlet-10	08/30/22

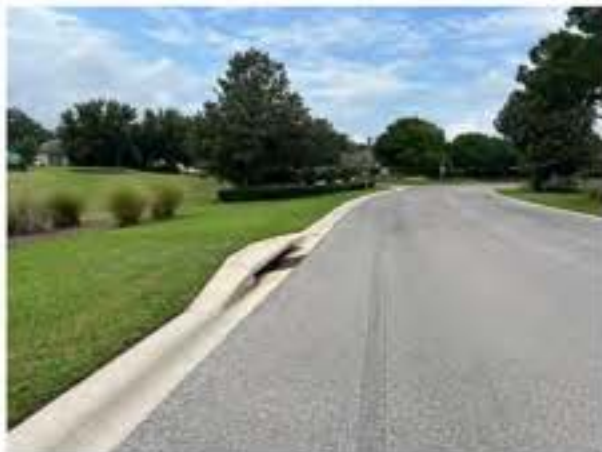
Markings-2\_Photo 1

Deficiencies ID	Infrastructure Type	Deficiency Type	Address	Notes	Photo ID	Field Date
2	Asphalt Marking	Marking: Cart Path Lane Stripping	Arlington Ridge Boulevard		Markings-2	08/30/22
3	Asphalt Marking	Marking: Cart Path Lane Stripping	Arlington Ridge Boulevard		Markings-3	08/30/22
15	Asphalt Marking	Marking: Cart Path Lane Stripping	Arlington Ridge Boulevard		Markings-15	08/30/22
16	Asphalt Marking	Marking: Cart Path Lane Stripping	Arlington Ridge Boulevard		Markings-16	08/30/22
17	Asphalt Marking	Marking: Cart Path Lane Stripping	Arlington Ridge Boulevard		Markings-17	08/30/22
18	Asphalt Marking	Marking: Cart Path Lane Stripping	Arlington Ridge Boulevard		Markings-18	08/30/22
29	Asphalt Marking	Marking: Cart Path Lane Stripping	Arlington Ridge Boulevard		Markings-29	08/30/22
30	Asphalt Marking	Marking: Cart Path Lane Stripping	Arlington Ridge Boulevard		Markings-30	08/30/22
33	Asphalt Marking	Marking: Cart Path Lane Stripping	Arlington Ridge Boulevard		Markings-33	08/30/22

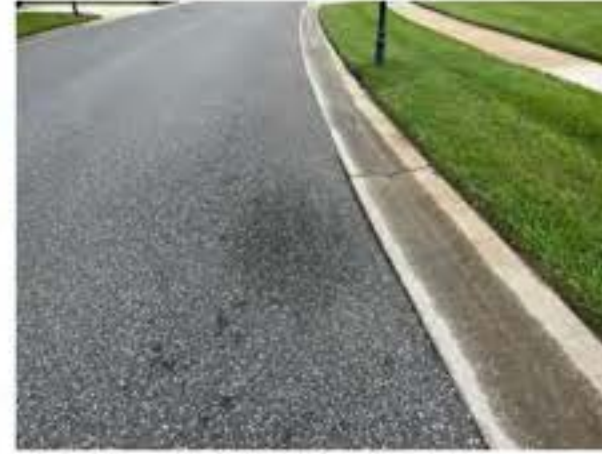
Roadway-70\_Photo 1

70	Roadway/Pavement	Roadway/Pavement: Other (Add Notes)	26715 White Plains Way	It looks like subsidence but no cracking	Roadway-70	08/30/22
74	Roadway/Pavement	Roadway/Pavement: Other (Add Notes)	4121 Arlington Ridge Boulevard	Roadway Subsidence (area has been patched before)	Roadway-74	08/30/22
93	Roadway/Pavement	Roadway/Pavement: Other (Add Notes)	4013 Richmond Crossing	Roadway Subsidence (area has been patched before)	Roadway-93	08/30/22
94	Roadway/Pavement	Roadway/Pavement: Other (Add Notes)	4006 Richmond Crossing	Roadway Subsidence? Appears that a boring was done in area	Roadway-94	08/30/22
